Profile/Photo Observation Report

Date:	03/28/2018	Weather:		Coding:	PACP 6.0
Pipe Length (ft):	101.8	Owner:	NA	Pre Clean:	Not Known
P.O.#:		Surveyor:	Selasie Honu	PSR:	P-910-013-012
Customer:		Clean Date:	01/01/1900	Shape:	C

Street:	Norris	Flow Control:	Not Controlled
City:	Hobart, IN	Year Renewed:	
Location:	Sidewalk	Tape/Media #:	
Purpose:	Maintenance Related	Dia/Height:	8"
Use:	Sanitary	Material:	PVC
Drain Area:	NA	Lining:	
Category:	NA		
Comment:

Location Details:		Direction of Survey:	Upstream
US MH:	M-910-012	DS MH:	M-910-013
		Total Length Surveyed (ft):	98.3

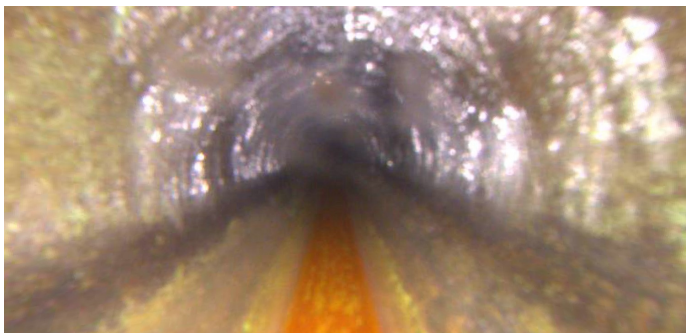
Code: **DAGS**
Description: **Deposits Attached Grease**

Distance (ft): **.0**
Structural Grade: **0**
O&M Grade: **2**
Clock Start/From: **8**
Clock To: **4**
1st Value:
2nd Value:
Value Percent: **5.000**
Continuous Index: **S01**
Within 8" of Joint: **NO**
Remarks:

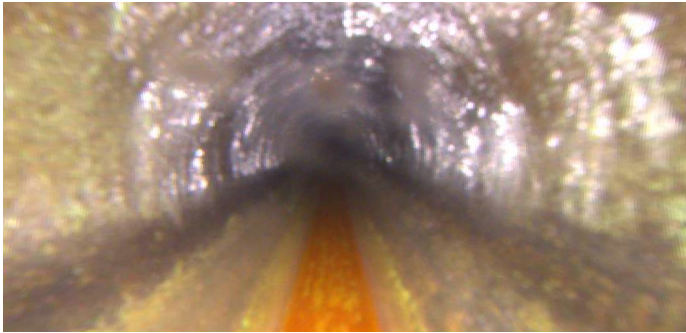
Code: **AMH**
Description: **Manhole**

Distance (ft): **.0**
Structural Grade: **0**
O&M Grade: **0**
Clock Start/From:
Clock To:
1st Value:
2nd Value:
Value Percent:
Continuous Index:
Within 8" of Joint: **NO**
Remarks: **M-910-013**

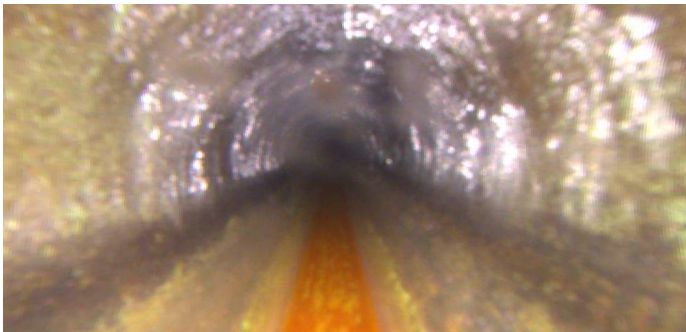
Code: **MWL**
Description: **Water Level**

Distance (ft): **.0**
Structural Grade: **0**
O&M Grade: **0**
Clock Start/From:
Clock To:
1st Value:
2nd Value:
Value Percent: **5.000**
Continuous Index:
Within 8" of Joint: **NO**
Remarks:

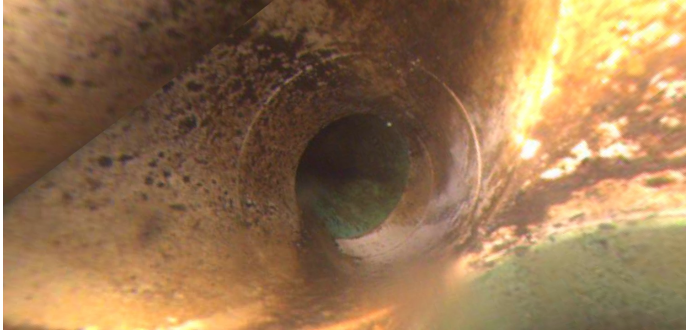
Code: **TF**
Description: **Tap Factory**

Distance (ft): **46.4**
Structural Grade: **0**
O&M Grade: **0**
Clock Start/From: **2**
Clock To:
1st Value: **4.000**
2nd Value:
Value Percent:
Continuous Index:
Within 8" of Joint:
Remarks:

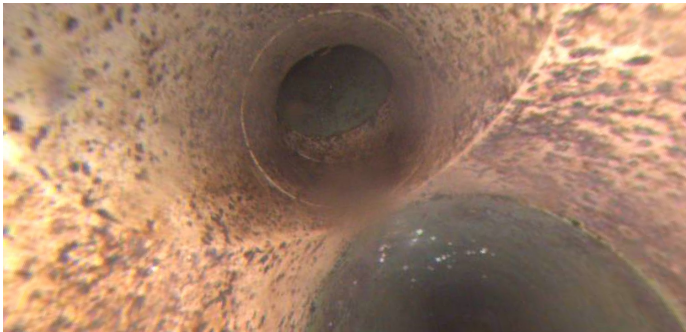
Code: **TF**
Description: **Tap Factory**

Distance (ft): **83.9**
Structural Grade: **0**
O&M Grade: **0**
Clock Start/From: **1**
Clock To:
1st Value: **4.000**
2nd Value:
Value Percent:
Continuous Index:
Within 8" of Joint:
Remarks:

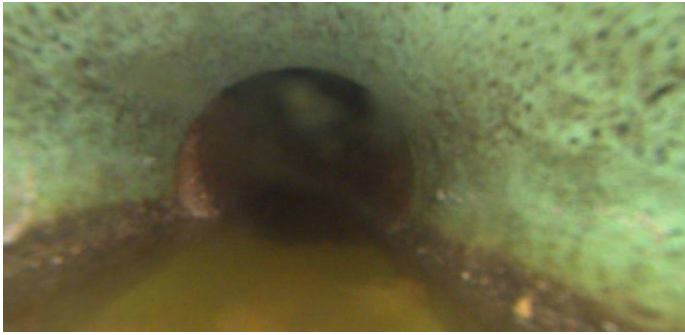
Code: **DAGS**
Description: **Deposits Attached Grease**

Distance (ft): **95.6**
Structural Grade: **0**
O&M Grade: **2**
Clock Start/From: **8**
Clock To: **4**
1st Value:
2nd Value:
Value Percent: **5.000**
Continuous Index: **F01**
Within 8" of Joint: **NO**
Remarks:

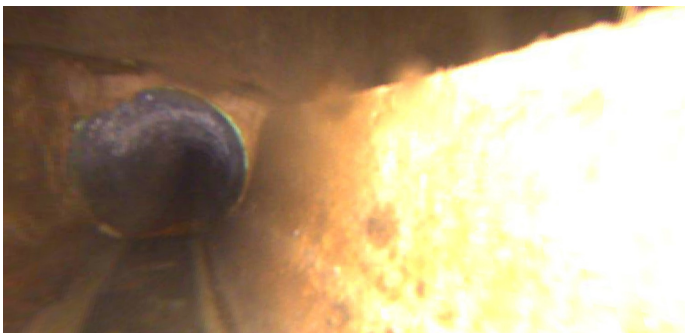
Code: **AMH**
Description: **Manhole**

Distance (ft): **98.3**
Structural Grade: **0**
O&M Grade: **0**
Clock Start/From:
Clock To:
1st Value:
2nd Value:
Value Percent:
Continuous Index:
Within 8" of Joint: **NO**
Remarks: **M-910-012**
