Profile/Photo Observation Report

Street:	NORRIS DR	Flow Control:	Not Controlled
City:	Hobart, IN	Year Renewed:	
Location:	Sidewalk	Tape/Media #:	
Purpose:	Maintenance Related	Dia/Height:	8"
Use:	Sanitary	Material:	PVC
Drain Area:	NA	Lining:	
Category:	NA		
Comment:	Unknown reason for stop.

Location Details:		Direction of Survey:	Upstream
US MH:	M-910-014	DS MH:	M-910-015
		Total Length Surveyed (ft):	202.8

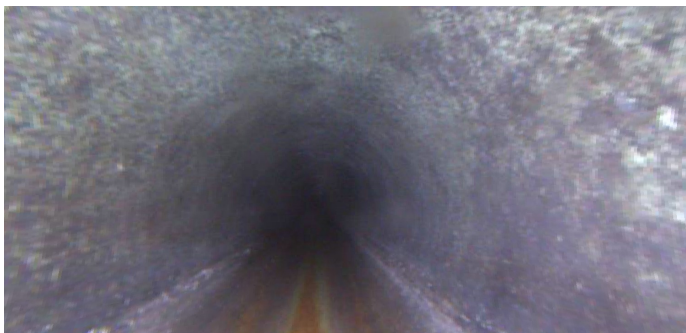
Code: **AMH**
Description: **Manhole**

Distance (ft): **.0**
Structural Grade: **0**
O&M Grade: **0**
Clock Start/From:
Clock To:
1st Value:
2nd Value:
Value Percent:
Continuous Index:
Within 8" of Joint: **NO**
Remarks: **M-910-015**

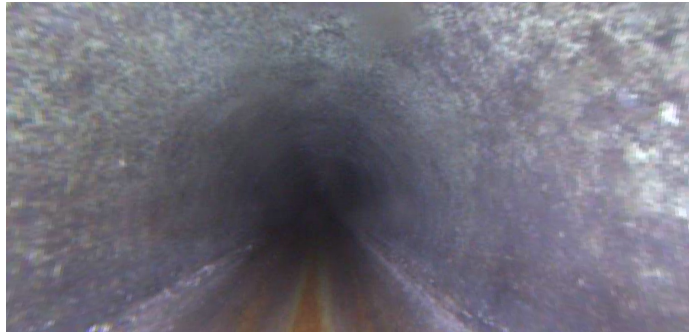
Code: **MWL**
Description: **Water Level**

Distance (ft): **.0**
Structural Grade: **0**
O&M Grade: **0**
Clock Start/From:
Clock To:
1st Value:
2nd Value:
Value Percent: **5.000**
Continuous Index:
Within 8" of Joint: **NO**
Remarks:

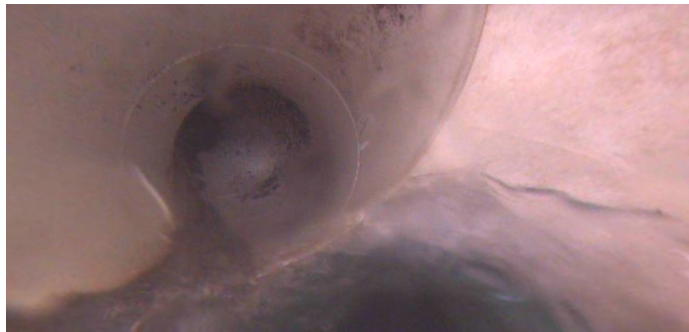
Code: **TFA**
Description: **Tap Factory Active**

Distance (ft): **99.1**
Structural Grade: **0**
O&M Grade: **0**
Clock Start/From: **1**
Clock To:
1st Value: **4.000**
2nd Value:
Value Percent:
Continuous Index:
Within 8" of Joint:
Remarks:

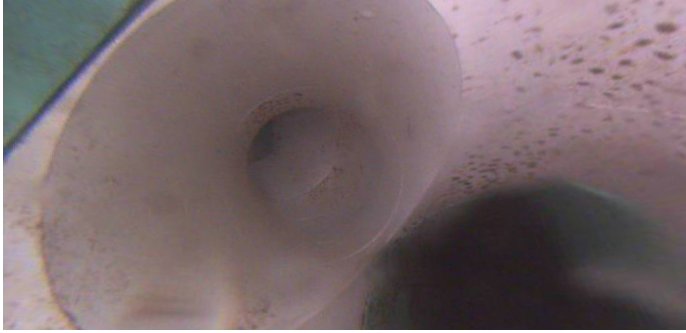
Code: **TF**
Description: **Tap Factory**

Distance (ft): **156.0**
Structural Grade: **0**
O&M Grade: **0**
Clock Start/From: **2**
Clock To:
1st Value: **4.000**
2nd Value:
Value Percent:
Continuous Index:
Within 8" of Joint:
Remarks:

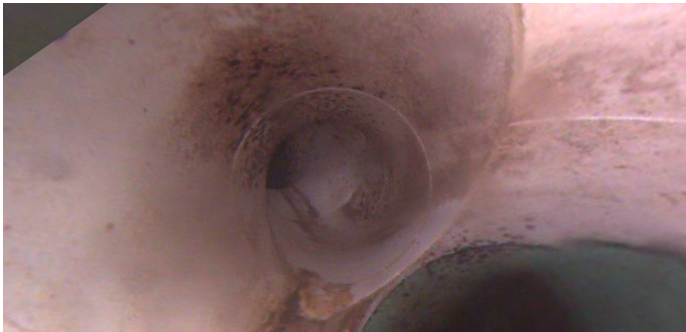
Code: **TF**
Description: **Tap Factory**

Distance (ft): **194.2**
Structural Grade: **0**
O&M Grade: **0**
Clock Start/From: **2**
Clock To:
1st Value: **4.000**
2nd Value:
Value Percent:
Continuous Index:
Within 8" of Joint:
Remarks:

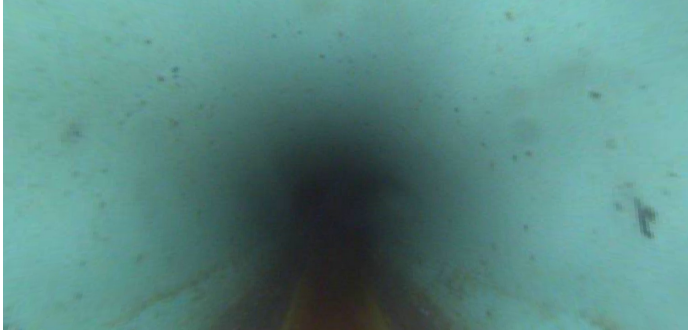
Code:	MSA
Description:	Abandoned Survey
Distance (ft):	202.8
Structural Grade:	0
O&M Grade:	0
Clock Start/From:	
Clock To:	
1st Value:	
2nd Value:	
Value Percent:	
Continuous Index:	
Within 8" of Joint:	NO
Remarks:	camera stopped
