Profile/Photo Observation Report

Street:	Norris	Flow Control:	Not Controlled
City:	Hobart, IN	Year Renewed:	
Location:	Sidewalk	Tape/Media #:	
Purpose:	Maintenance Related	Dia/Height:	8"
Use:	Sanitary	Material:	PVC
Drain Area:	NA	Lining:	
Category:	NA		
Comment:	Unknown reason for stop.

Location Details:		Direction of Survey:	Upstream
US MH:	M-910-014	DS MH:	M-910-015
		Total Length Surveyed (ft):	202.8

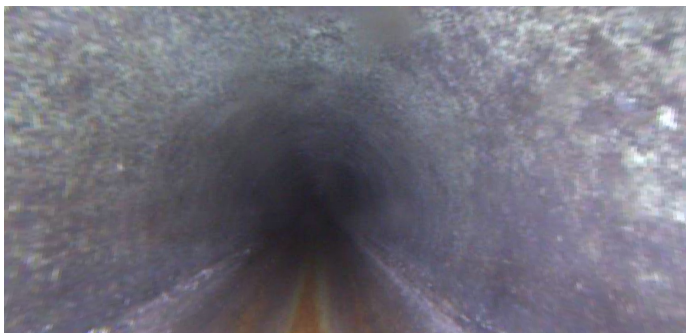
Code: **AMH**
Description: **Manhole**

Distance (ft): **.0**
Structural Grade: **0**
O&M Grade: **0**
Clock Start/From:
Clock To:
1st Value:
2nd Value:
Value Percent:
Continuous Index:
Within 8" of Joint: **NO**
Remarks: **M-910-015**

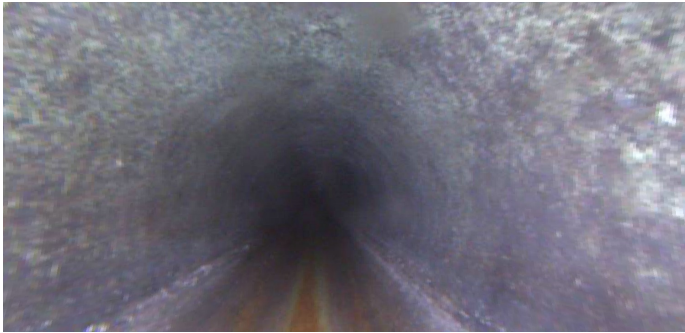
Code:	MWL
Description:	Water Level

Distance (ft):	.0
Structural Grade:	0
O&M Grade:	0
Clock Start/From:	
Clock To:	
1st Value:	
2nd Value:	
Value Percent:	5.000
Continuous Index:	
Within 8" of Joint:	NO
Remarks:

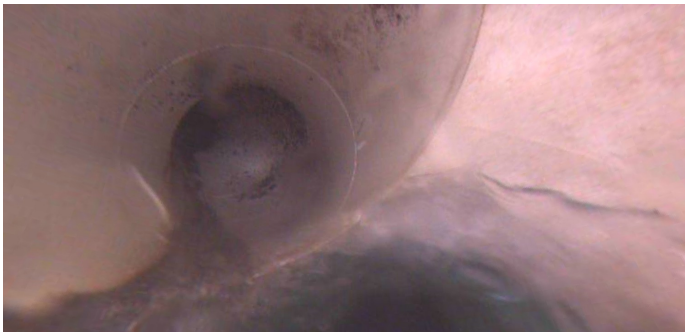
Code:	TFA
Description:	Tap Factory Active

Distance (ft):	99.1
Structural Grade:	0
O&M Grade:	0
Clock Start/From:	1
Clock To:	
1st Value:	4.000
2nd Value:	
Value Percent:	
Continuous Index:	
Within 8" of Joint:	
Remarks:

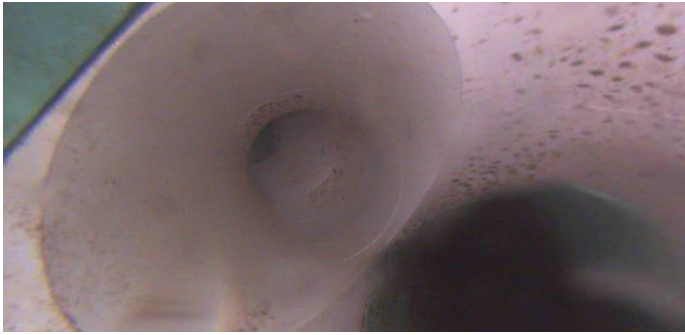
Code: **TF**
Description: **Tap Factory**

Distance (ft): **156.0**
Structural Grade: **0**
O&M Grade: **0**
Clock Start/From: **2**
Clock To:
1st Value: **4.000**
2nd Value:
Value Percent:
Continuous Index:
Within 8" of Joint:
Remarks:

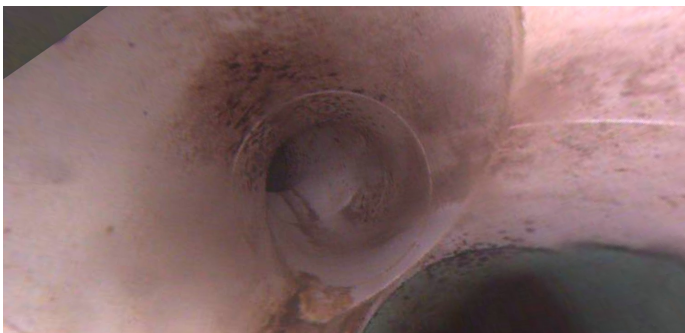
Code: **TF**
Description: **Tap Factory**

Distance (ft): **194.2**
Structural Grade: **0**
O&M Grade: **0**
Clock Start/From: **2**
Clock To:
1st Value: **4.000**
2nd Value:
Value Percent:
Continuous Index:
Within 8" of Joint:
Remarks:

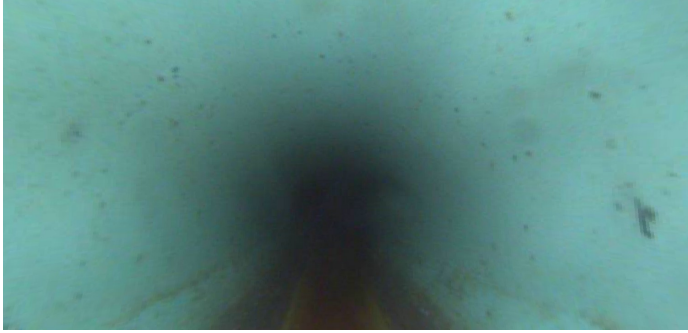
Code:	MSA
Description:	Abandoned Survey
Distance (ft):	202.8
Structural Grade:	0
O&M Grade:	0
Clock Start/From:	
Clock To:	
1st Value:	
2nd Value:	
Value Percent:	
Continuous Index:	
Within 8" of Joint:	NO
Remarks:	camera stopped
