Profile/Photo Observation Report

Street:	NORRIS DR	Flow Control:	Not Controlled
City:	Hobart, IN	Year Renewed:	
Location:	Light Highway	Tape/Media #:	
Purpose:	Routine Assessment	Dia/Height:	8"
Use:	Sanitary	Material:	PVC
Drain Area:	NA	Lining:	
Category:	NA		
Comment:

Location Details:		Direction of Survey:	Upstream
US MH:	M-910-014	DS MH:	M-910-015
		Total Length Surveyed (ft):	361.3

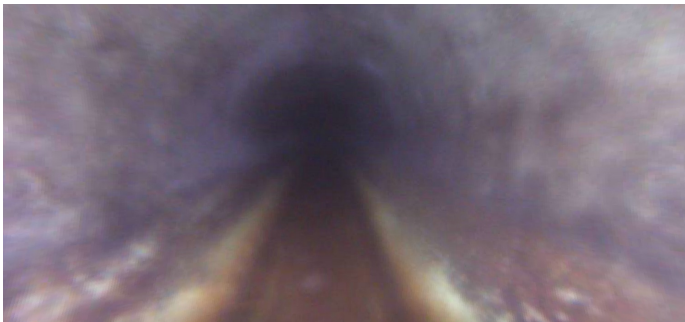
Code: **AMH**
Description: **Manhole**

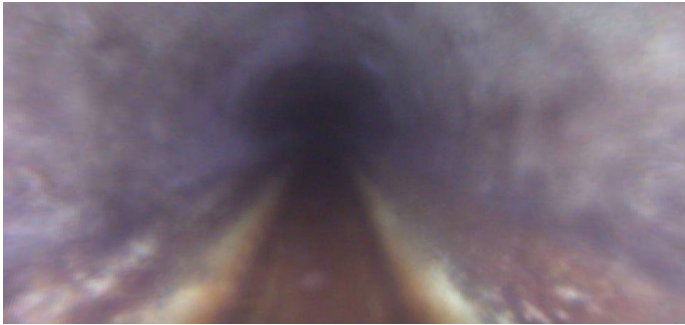
Code:	MWL
Description:	Water Level

Distance (ft):	.0
Structural Grade:	0
O&M Grade:	0
Clock Start/From:	
Clock To:	
1st Value:	
2nd Value:	
Value Percent:	5.000
Continuous Index:	
Within 8" of Joint:	NO
Remarks:

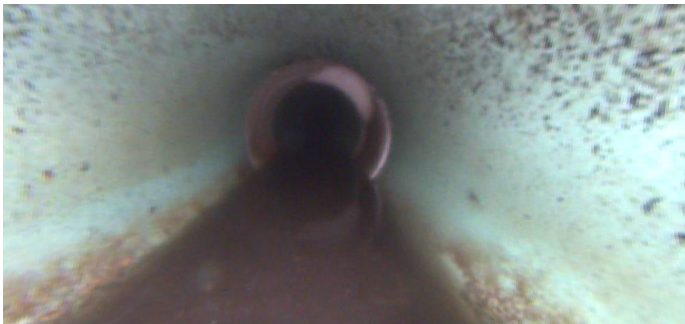
Code:	TF
Description:	Tap Factory

Distance (ft):	101.7
Structural Grade:	0
O&M Grade:	0
Clock Start/From:	1
Clock To:	
1st Value:	4.000
2nd Value:	
Value Percent:	
Continuous Index:	
Within 8" of Joint:	
Remarks:

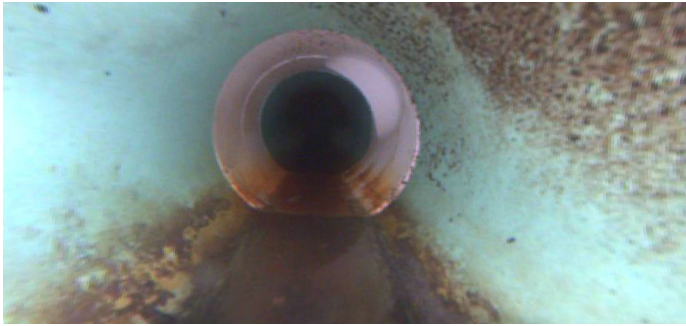
Code: **TF**
Description: **Tap Factory**

Distance (ft): **160.8**
Structural Grade: **0**
O&M Grade: **0**
Clock Start/From: **2**
Clock To:
1st Value: **4.000**
2nd Value:
Value Percent:
Continuous Index:
Within 8" of Joint:
Remarks:

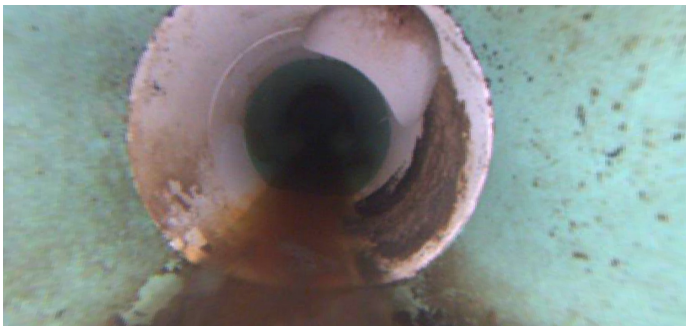
Code: **TF**
Description: **Tap Factory**

Distance (ft): **200.9**
Structural Grade: **0**
O&M Grade: **0**
Clock Start/From: **2**
Clock To:
1st Value: **4.000**
2nd Value:
Value Percent:
Continuous Index:
Within 8" of Joint:
Remarks:

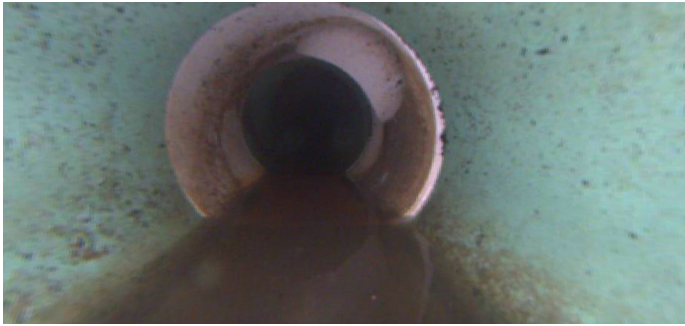
Code: **TF**
Description: **Tap Factory**

Distance (ft): **281.4**
Structural Grade: **0**
O&M Grade: **0**
Clock Start/From: **2**
Clock To:
1st Value: **4.000**
2nd Value:
Value Percent:
Continuous Index:
Within 8" of Joint:
Remarks:

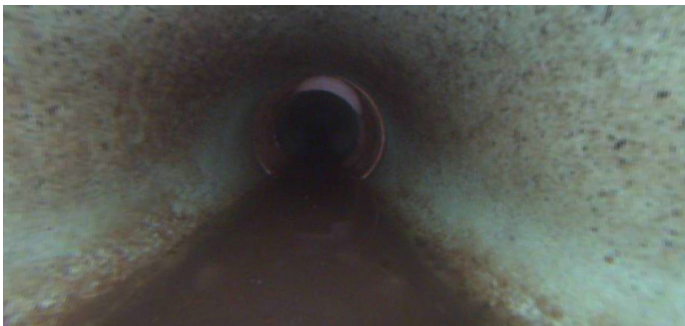
Code: **TF**
Description: **Tap Factory**

Distance (ft): **332.1**
Structural Grade: **0**
O&M Grade: **0**
Clock Start/From: **12**
Clock To:
1st Value: **4.000**
2nd Value:
Value Percent:
Continuous Index:
Within 8" of Joint:
Remarks:

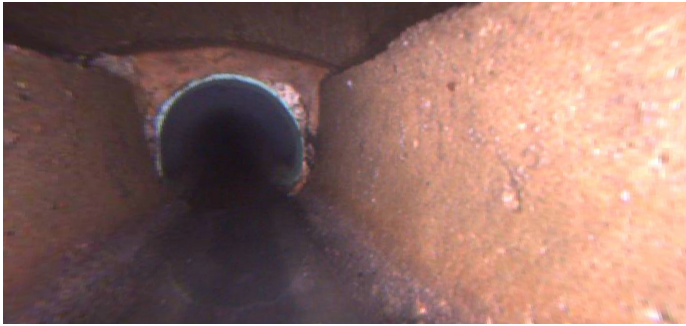
Code:	AMH
Description:	Manhole
Distance (ft):	361.3
Structural Grade:	0
O&M Grade:	0
Clock Start/From:	
Clock To:	
1st Value:	
2nd Value:	
Value Percent:	
Continuous Index:	
Within 8" of Joint:	NO
Remarks:	M-910-014
