Profile/Photo Observation Report

Street:	Norris Dr.	Flow Control:	Not Controlled
City:	Hobart, IN	Year Renewed:	
Location:	Light Highway	Tape/Media #:	
Purpose:	Routine Assessment	Dia/Height:	8"
Use:	Sanitary	Material:	PVC
Drain Area:	NA	Lining:	
Category:	NA		
Comment:

Location Details:		Direction of Survey:	Upstream
US MH:	M-910-014	DS MH:	M-910-015
		Total Length Surveyed (ft):	361.3

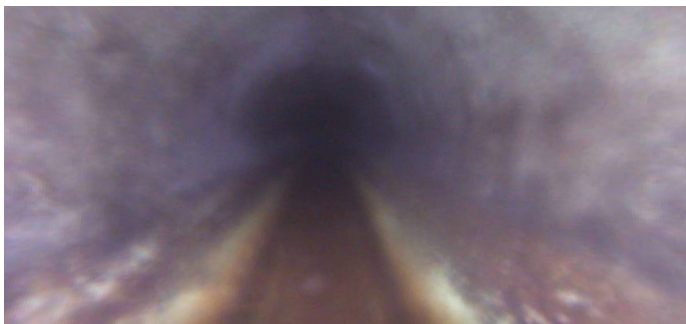
Code: **AMH**
Description: **Manhole**

Distance (ft): **.0**
Structural Grade: **0**
O&M Grade: **0**
Clock Start/From:
Clock To:
1st Value:
2nd Value:
Value Percent:
Continuous Index:
Within 8" of Joint: **NO**
Remarks: **M-910-015**

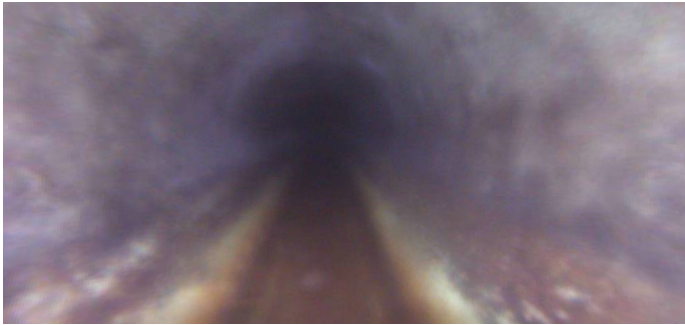
Code:	MWL
Description:	Water Level

Distance (ft):	.0
Structural Grade:	0
O&M Grade:	0
Clock Start/From:	
Clock To:	
1st Value:	
2nd Value:	
Value Percent:	5.000
Continuous Index:	
Within 8" of Joint:	NO
Remarks:

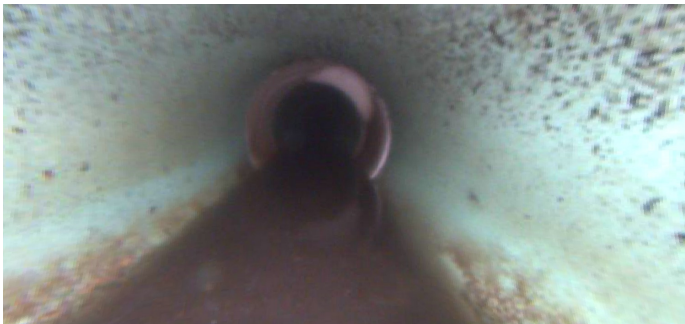
Code:	TF
Description:	Tap Factory

Distance (ft):	101.7
Structural Grade:	0
O&M Grade:	0
Clock Start/From:	1
Clock To:	
1st Value:	4.000
2nd Value:	
Value Percent:	
Continuous Index:	
Within 8" of Joint:	
Remarks:

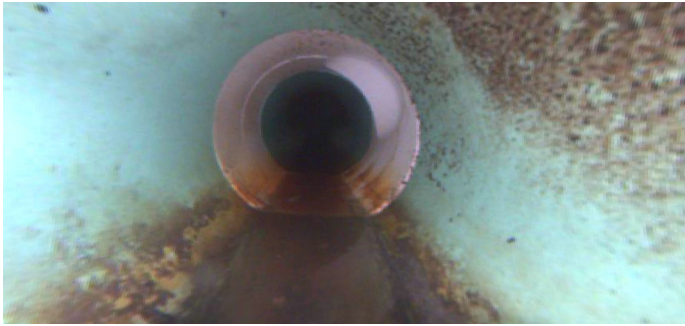
Code: **TF**
Description: **Tap Factory**

Distance (ft): **160.8**
Structural Grade: **0**
O&M Grade: **0**
Clock Start/From: **2**
Clock To:
1st Value: **4.000**
2nd Value:
Value Percent:
Continuous Index:
Within 8" of Joint:
Remarks:

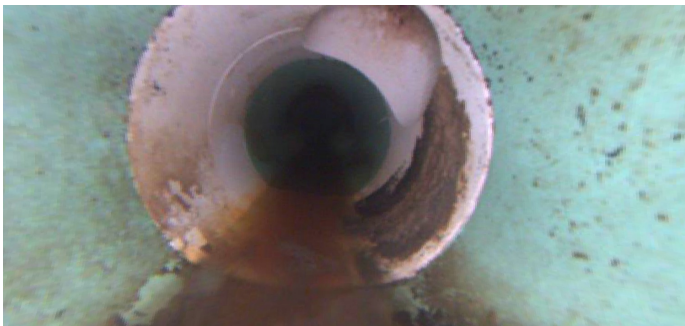
Code: **TF**
Description: **Tap Factory**

Distance (ft): **200.9**
Structural Grade: **0**
O&M Grade: **0**
Clock Start/From: **2**
Clock To:
1st Value: **4.000**
2nd Value:
Value Percent:
Continuous Index:
Within 8" of Joint:
Remarks:

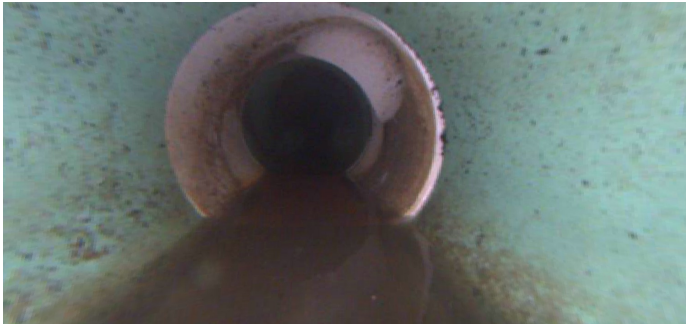
Code: **TF**
Description: **Tap Factory**

Distance (ft): **281.4**
Structural Grade: **0**
O&M Grade: **0**
Clock Start/From: **2**
Clock To:
1st Value: **4.000**
2nd Value:
Value Percent:
Continuous Index:
Within 8" of Joint:
Remarks:

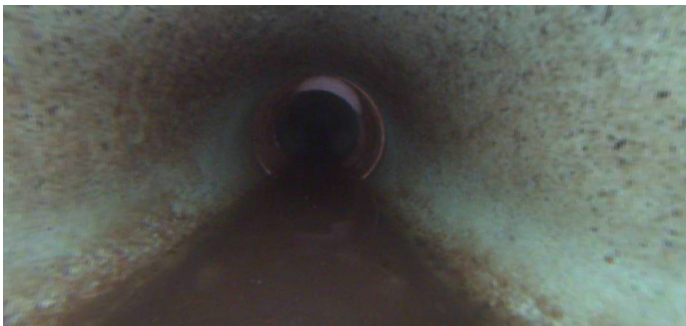
Code: **TF**
Description: **Tap Factory**

Distance (ft): **332.1**
Structural Grade: **0**
O&M Grade: **0**
Clock Start/From: **12**
Clock To:
1st Value: **4.000**
2nd Value:
Value Percent:
Continuous Index:
Within 8" of Joint:
Remarks:

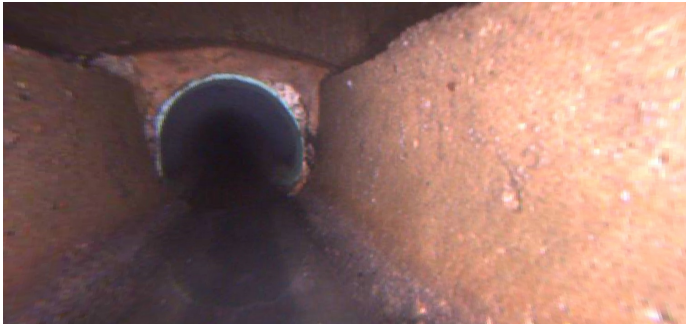
Code:	AMH
Description:	Manhole
Distance (ft):	361.3
Structural Grade:	0
O&M Grade:	0
Clock Start/From:	
Clock To:	
1st Value:	
2nd Value:	
Value Percent:	
Continuous Index:	
Within 8" of Joint:	NO
Remarks:	M-910-014
