Profile/Photo Observation Report

Date:	03/28/2018	Weather:		Coding:	PACP 6.0
Pipe Length (ft):	172.1	Owner:	NA	Pre Clean:	Not Known
P.O.#:		Surveyor:	Selasie Honu	PSR:	P-910-028-018
Customer:		Clean Date:	01/01/1900	Shape:	C

Street:	OFF NORRIS DR	Flow Control:	Not Controlled
City:	Hobart, IN	Year Renewed:	
Location:	Ditch	Tape/Media #:	
Purpose:	Maintenance Related	Dia/Height:	8"
Use:	Sanitary	Material:	PVC
Drain Area:	NA	Lining:	
Category:	NA		
Comment:	Flow direction wrong. Redeployment.		
Location Details:		Direction of Survey:	Upstream
US MH:	M-910-018	DS MH:	M-910-028
		Total Length Surveyed (ft):	170.3

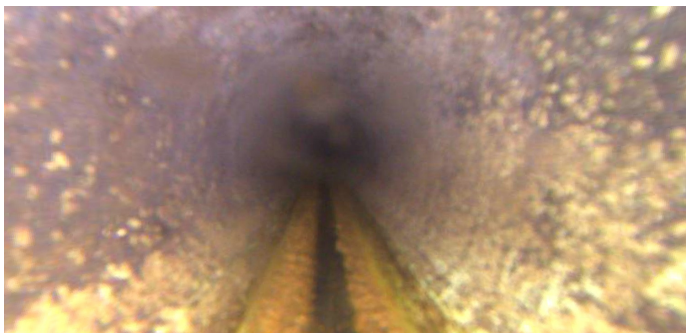
Code: **DAGS**
Description: **Deposits Attached Grease**

Distance (ft): **.0**
Structural Grade: **0**
O&M Grade: **2**
Clock Start/From: **7**
Clock To: **5**
1st Value:
2nd Value:
Value Percent: **5.000**
Continuous Index: **S01**
Within 8" of Joint: **NO**
Remarks:

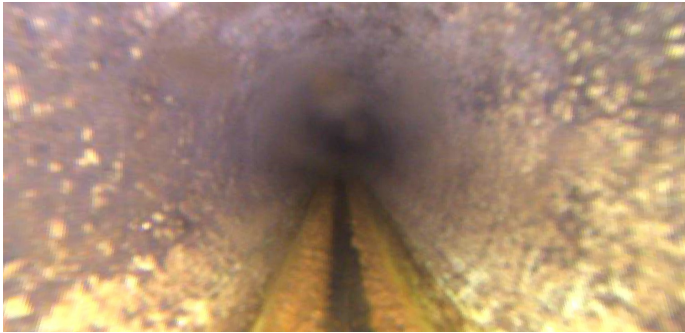
Code:	AMH
Description:	Manhole

Distance (ft):	.0
Structural Grade:	0
O&M Grade:	0
Clock Start/From:	
Clock To:	
1st Value:	
2nd Value:	
Value Percent:	
Continuous Index:	
Within 8" of Joint:	NO
Remarks:	M-910-028

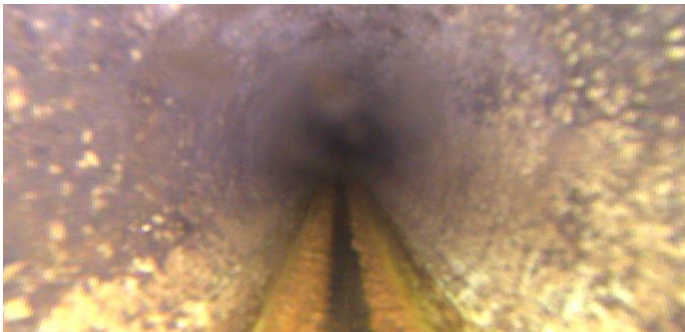
Code:	MWL
Description:	Water Level

Distance (ft):	.0
Structural Grade:	0
O&M Grade:	0
Clock Start/From:	
Clock To:	
1st Value:	
2nd Value:	
Value Percent:	5.000
Continuous Index:	
Within 8" of Joint:	NO
Remarks:

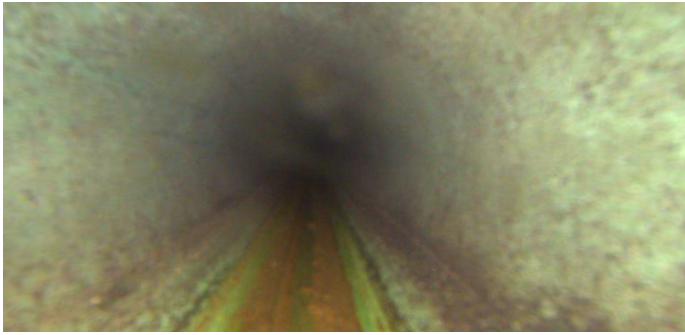
Code: **DAGS**
Description: **Deposits Attached Grease**

Distance (ft): **7.7**
Structural Grade: **0**
O&M Grade: **2**
Clock Start/From: **7**
Clock To: **5**
1st Value:
2nd Value:
Value Percent: **5.000**
Continuous Index: **F01**
Within 8" of Joint: **NO**
Remarks:

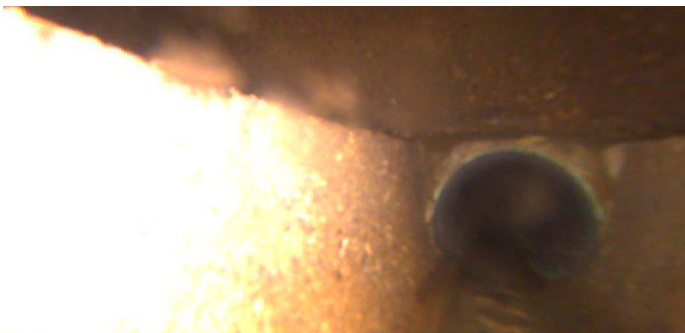
Code: **AMH**
Description: **Manhole**

Distance (ft): **170.3**
Structural Grade: **0**
O&M Grade: **0**
Clock Start/From:
Clock To:
1st Value:
2nd Value:
Value Percent:
Continuous Index:
Within 8" of Joint: **NO**
Remarks: **M-910-018**
