## Profile/Photo Observation Report

Street:	<b>NORRIS DR</b>	Flow Control:	<b>Not Controlled</b>
City:	<b>Hobart, IN</b>	Year Renewed:	
Location:	<b>Sidewalk</b>	Tape/Media #:	
Purpose:	<b>Maintenance Related</b>	Dia/Height:	<b>8"</b>
Use:	<b>Sanitary</b>	Material:	<b>PVC</b>
Drain Area:	<b>NA</b>	Lining:	
Category:	<b>NA</b>		
Comment:

Location Details:		Direction of Survey:	<b>Downstream</b>
US MH:	<b>M-910-019</b>	DS MH:	<b>M-910-025</b>
		Total Length Surveyed (ft):	<b>118.2</b>

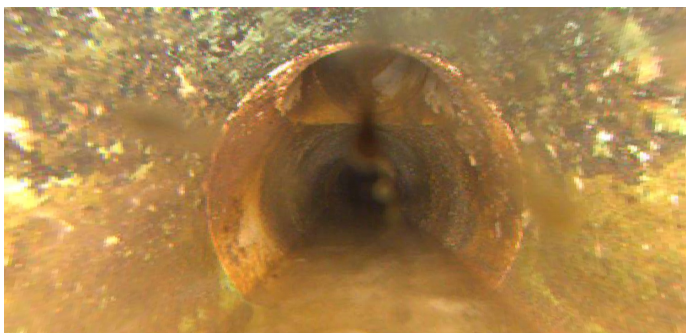
Code: **AMH**  
Description: **Manhole**

Distance (ft): **.0**  
Structural Grade: **0**  
O&M Grade: **0**  
Clock Start/From:  
Clock To:  
1st Value:  
2nd Value:  
Value Percent:  
Continuous Index:  
Within 8" of Joint: **NO**  
Remarks: **M-910-019**

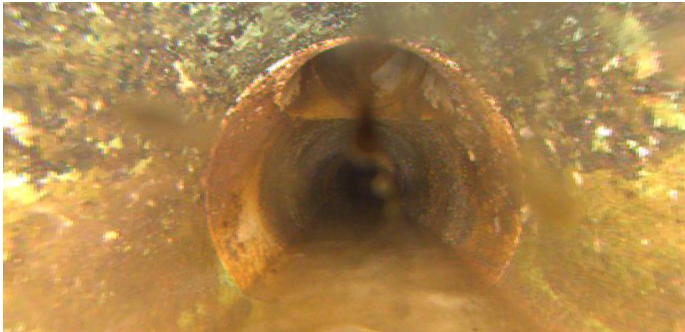
Code:	<b>MWL</b>
Description:	<b>Water Level</b>

Distance (ft):	<b>.0</b>
Structural Grade:	<b>0</b>
O&M Grade:	<b>0</b>
Clock Start/From:	
Clock To:	
1st Value:	
2nd Value:	
Value Percent:	<b>5.000</b>
Continuous Index:	
Within 8" of Joint:	<b>NO</b>
Remarks:

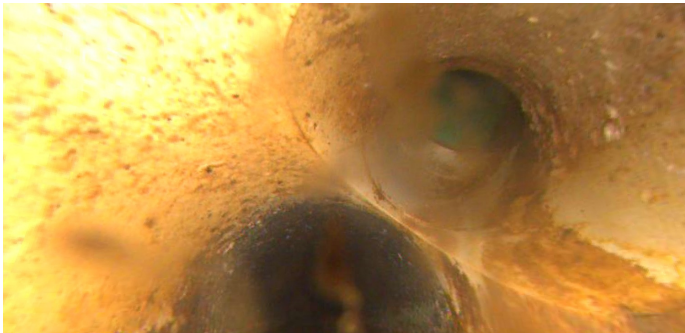
Code:	<b>TF</b>
Description:	<b>Tap Factory</b>

Distance (ft):	<b>3.3</b>
Structural Grade:	<b>0</b>
O&M Grade:	<b>0</b>
Clock Start/From:	<b>1</b>
Clock To:	
1st Value:	<b>4.000</b>
2nd Value:	
Value Percent:	
Continuous Index:	
Within 8" of Joint:	
Remarks:

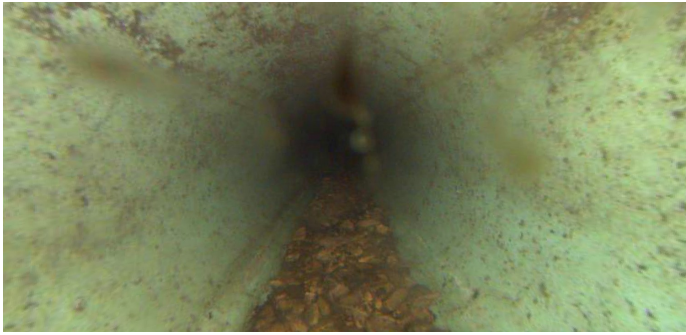
Code: **DSGV**  
Description: **Deposits Settled Gravel**

Distance (ft): **25.8**  
Structural Grade: **0**  
O&M Grade: **2**  
Clock Start/From: **6**  
Clock To:  
1st Value:  
2nd Value:  
Value Percent: **5.000**  
Continuous Index: **S01**  
Within 8" of Joint: **NO**  
Remarks:

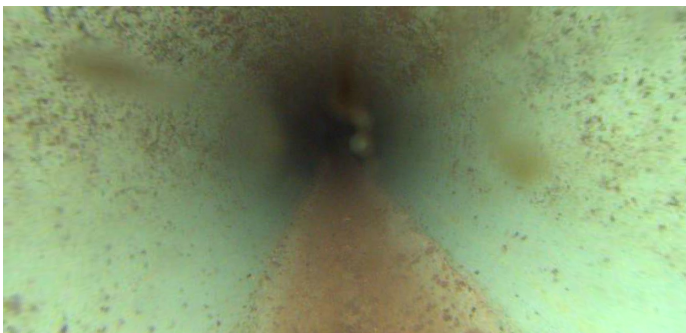
Code: **DSGV**  
Description: **Deposits Settled Gravel**

Distance (ft): **33.4**  
Structural Grade: **0**  
O&M Grade: **2**  
Clock Start/From: **6**  
Clock To:  
1st Value:  
2nd Value:  
Value Percent: **5.000**  
Continuous Index: **F01**  
Within 8" of Joint: **NO**  
Remarks:

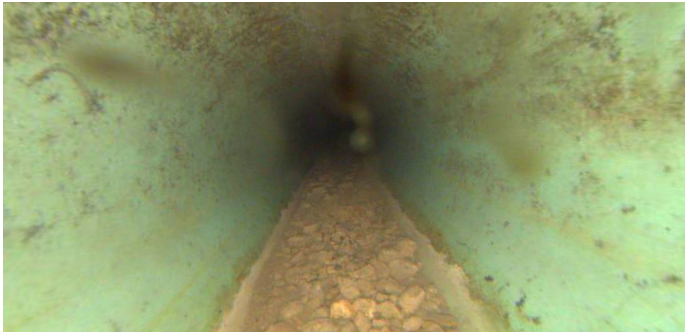
Code: **DSGV**  
Description: **Deposits Settled Gravel**

Distance (ft): **45.1**  
Structural Grade: **0**  
O&M Grade: **2**  
Clock Start/From: **6**  
Clock To:  
1st Value:  
2nd Value:  
Value Percent: **5.000**  
Continuous Index: **S02**  
Within 8" of Joint: **NO**  
Remarks:

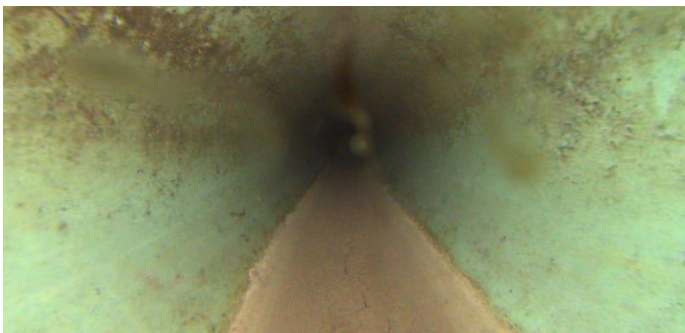
Code: **DSGV**  
Description: **Deposits Settled Gravel**

Distance (ft): **57.7**  
Structural Grade: **0**  
O&M Grade: **2**  
Clock Start/From: **6**  
Clock To:  
1st Value:  
2nd Value:  
Value Percent: **5.000**  
Continuous Index: **F02**  
Within 8" of Joint: **NO**  
Remarks:

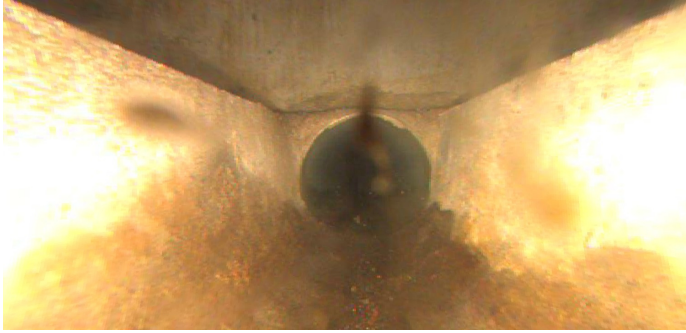
Code:	AMH
Description:	Manhole
Distance (ft):	118.2
Structural Grade:	0
O&M Grade:	0
Clock Start/From:	
Clock To:	
1st Value:	
2nd Value:	
Value Percent:	
Continuous Index:	
Within 8" of Joint:	NO
Remarks:	M-910-025
