Profile/Photo Observation Report

Date:	03/28/2018	Weather:		Coding:	PACP 6.0
Pipe Length (ft):	122.2	Owner:	NA	Pre Clean:	Not Known
P.O.#:		Surveyor:	Selasie Honu	PSR:	P-910-025-019
Customer:		Clean Date:	01/01/1900	Shape:	C

Location Details:		Direction of Survey:	Downstream
US MH:	M-910-019	DS MH:	M-910-025
		Total Length Surveyed (ft):	118.2

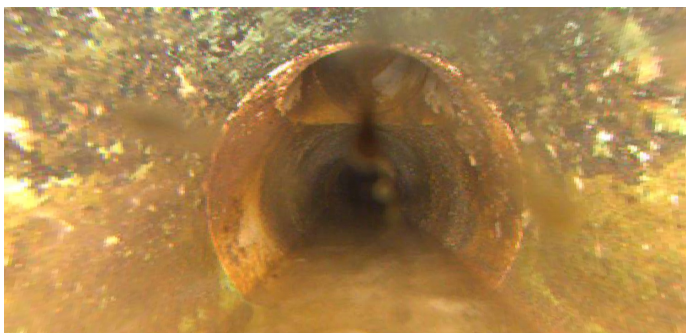
Code: **AMH**
Description: **Manhole**

Distance (ft): **.0**
Structural Grade: **0**
O&M Grade: **0**
Clock Start/From:
Clock To:
1st Value:
2nd Value:
Value Percent:
Continuous Index:
Within 8" of Joint: **NO**
Remarks: **M-910-019**

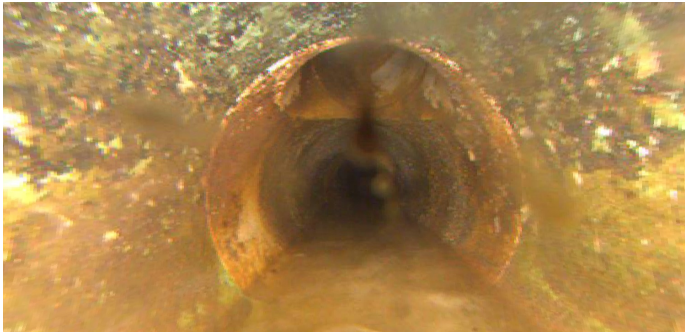
Code:	MWL
Description:	Water Level

Distance (ft):	.0
Structural Grade:	0
O&M Grade:	0
Clock Start/From:	
Clock To:	
1st Value:	
2nd Value:	
Value Percent:	5.000
Continuous Index:	
Within 8" of Joint:	NO
Remarks:

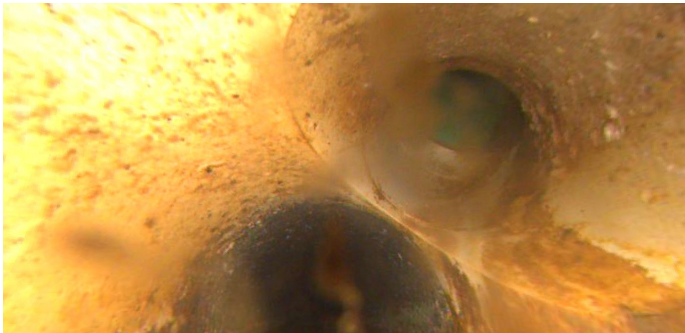
Code:	TF
Description:	Tap Factory

Distance (ft):	3.3
Structural Grade:	0
O&M Grade:	0
Clock Start/From:	1
Clock To:	
1st Value:	4.000
2nd Value:	
Value Percent:	
Continuous Index:	
Within 8" of Joint:	
Remarks:

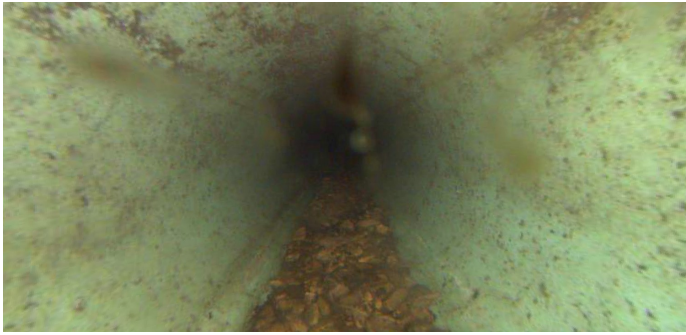
Code: **DSGV**
Description: **Deposits Settled Gravel**

Distance (ft): **25.8**
Structural Grade: **0**
O&M Grade: **2**
Clock Start/From: **6**
Clock To:
1st Value:
2nd Value:
Value Percent: **5.000**
Continuous Index: **S01**
Within 8" of Joint: **NO**
Remarks:

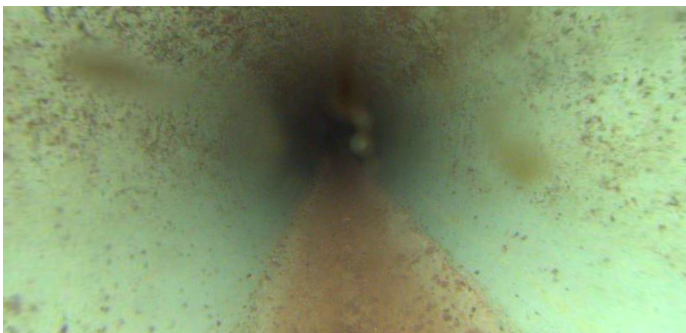
Code: **DSGV**
Description: **Deposits Settled Gravel**

Distance (ft): **33.4**
Structural Grade: **0**
O&M Grade: **2**
Clock Start/From: **6**
Clock To:
1st Value:
2nd Value:
Value Percent: **5.000**
Continuous Index: **F01**
Within 8" of Joint: **NO**
Remarks:

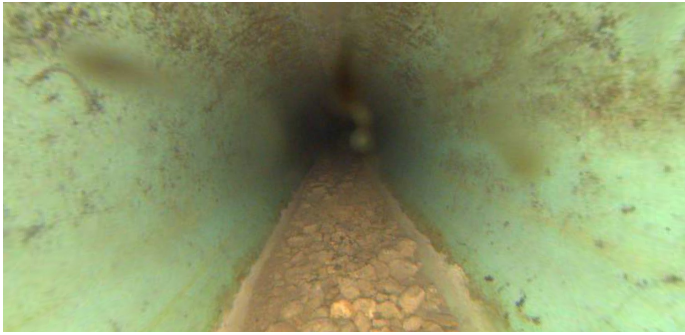
Code: **DSGV**
Description: **Deposits Settled Gravel**

Distance (ft): **45.1**
Structural Grade: **0**
O&M Grade: **2**
Clock Start/From: **6**
Clock To:
1st Value:
2nd Value:
Value Percent: **5.000**
Continuous Index: **S02**
Within 8" of Joint: **NO**
Remarks:

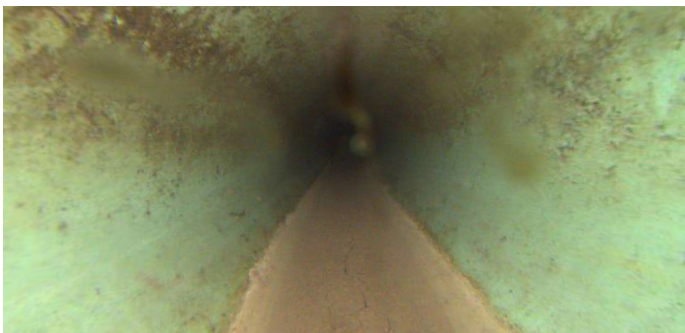
Code: **DSGV**
Description: **Deposits Settled Gravel**

Distance (ft): **57.7**
Structural Grade: **0**
O&M Grade: **2**
Clock Start/From: **6**
Clock To:
1st Value:
2nd Value:
Value Percent: **5.000**
Continuous Index: **F02**
Within 8" of Joint: **NO**
Remarks:

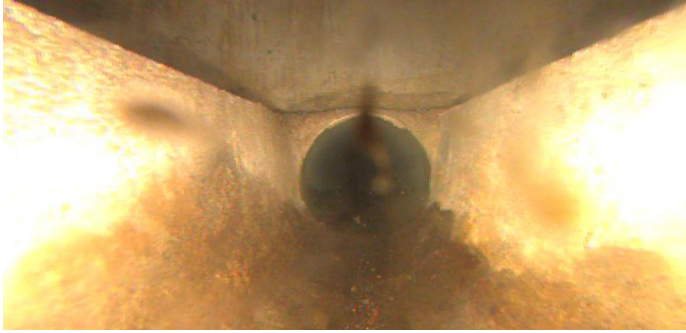
Code:	AMH
Description:	Manhole
Distance (ft):	118.2
Structural Grade:	0
O&M Grade:	0
Clock Start/From:	
Clock To:	
1st Value:	
2nd Value:	
Value Percent:	
Continuous Index:	
Within 8" of Joint:	NO
Remarks:	M-910-025
