## Profile/Photo Observation Report

Street:	<b>NORRIS DR</b>	Flow Control:	<b>Not Controlled</b>
City:	<b>Hobart, IN</b>	Year Renewed:	
Location:	<b>Sidewalk</b>	Tape/Media #:	
Purpose:	<b>Maintenance Related</b>	Dia/Height:	<b>8"</b>
Use:	<b>Sanitary</b>	Material:	<b>PVC</b>
Drain Area:	<b>NA</b>	Lining:	
Category:	<b>NA</b>		
Comment:	<b>Flow direction wrong.</b>

Location Details:		Direction of Survey:	<b>Downstream</b>
US MH:	<b>M-910-022</b>	DS MH:	<b>M-910-021</b>
		Total Length Surveyed (ft):	<b>283.9</b>

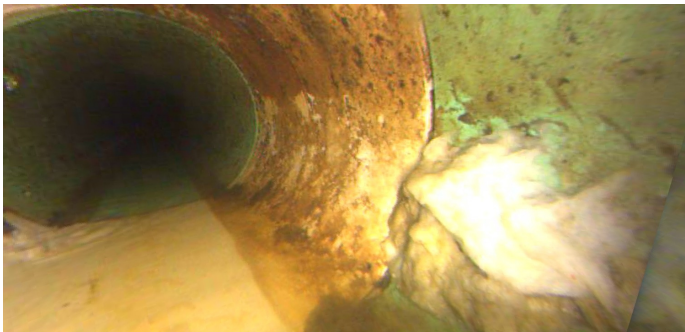
Code:	<b>DAGS</b>
Description:	<b>Deposits Attached Grease</b>

Distance (ft):	<b>12.0</b>
Structural Grade:	<b>0</b>
O&M Grade:	<b>2</b>
Clock Start/From:	<b>3</b>
Clock To:	<b>4</b>
1st Value:	
2nd Value:	
Value Percent:	<b>5.000</b>
Continuous Index:	
Within 8" of Joint:	<b>YES</b>
Remarks:

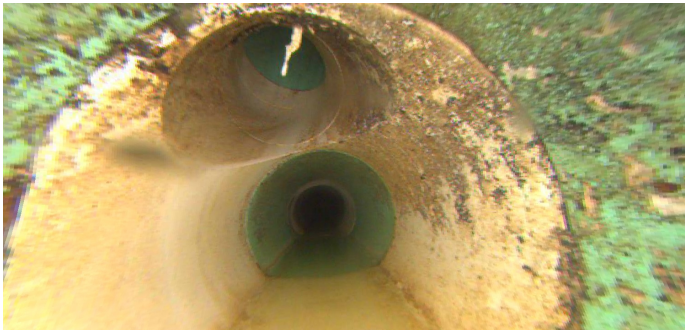
Code: **TF**  
Description: **Tap Factory**

Distance (ft): **35.2**  
Structural Grade: **0**  
O&M Grade: **0**  
Clock Start/From: **12**  
Clock To:  
1st Value: **4.000**  
2nd Value:  
Value Percent:  
Continuous Index:  
Within 8" of Joint: **YES**  
Remarks:

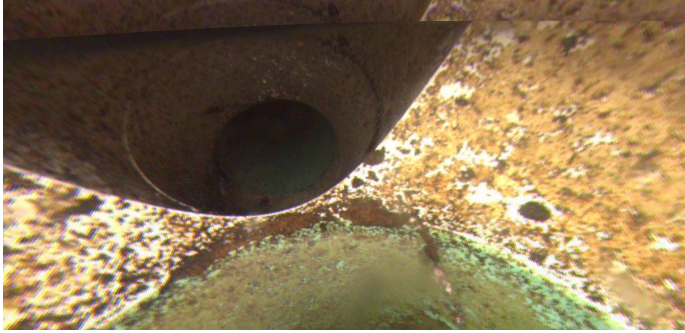
Code: **TF**  
Description: **Tap Factory**

Distance (ft): **77.0**  
Structural Grade: **0**  
O&M Grade: **0**  
Clock Start/From: **11**  
Clock To:  
1st Value: **4.000**  
2nd Value:  
Value Percent:  
Continuous Index:  
Within 8" of Joint: **YES**  
Remarks:

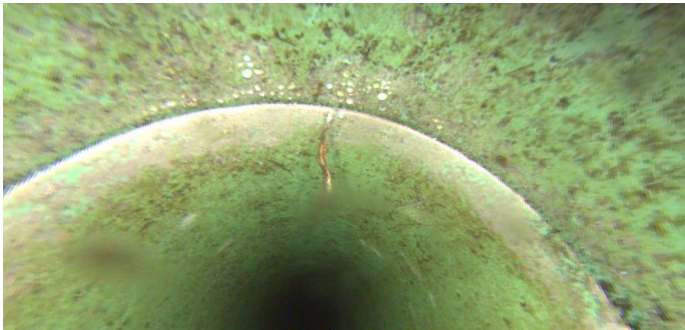
Code: **RFJ**  
Description: **Roots Fine Joint**

Distance (ft): **102.2**  
Structural Grade: **0**  
O&M Grade: **1**  
Clock Start/From: **12**  
Clock To:  
1st Value:  
2nd Value:  
Value Percent:  
Continuous Index:  
Within 8" of Joint: **YES**  
Remarks:

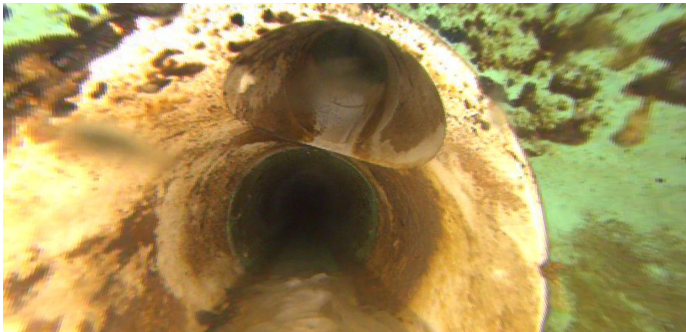
Code: **TF**  
Description: **Tap Factory**

Distance (ft): **116.4**  
Structural Grade: **0**  
O&M Grade: **0**  
Clock Start/From: **1**  
Clock To:  
1st Value: **4.000**  
2nd Value:  
Value Percent:  
Continuous Index:  
Within 8" of Joint: **YES**  
Remarks:

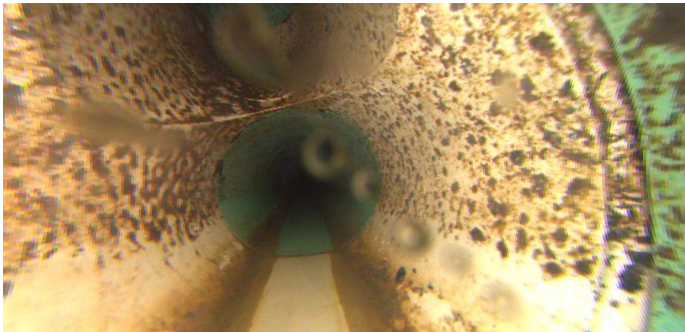
Code: **TF**  
Description: **Tap Factory**

Distance (ft): **213.6**  
Structural Grade: **0**  
O&M Grade: **0**  
Clock Start/From: **11**  
Clock To:  
1st Value: **4.000**  
2nd Value:  
Value Percent:  
Continuous Index:  
Within 8" of Joint: **YES**  
Remarks:

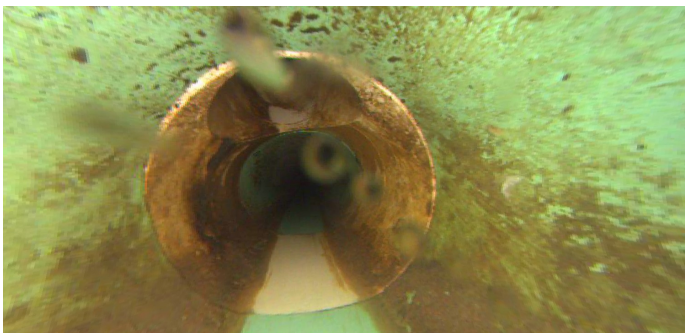
Code: **TF**  
Description: **Tap Factory**

Distance (ft): **228.8**  
Structural Grade: **0**  
O&M Grade: **0**  
Clock Start/From: **12**  
Clock To:  
1st Value: **4.000**  
2nd Value:  
Value Percent:  
Continuous Index:  
Within 8" of Joint: **YES**  
Remarks:

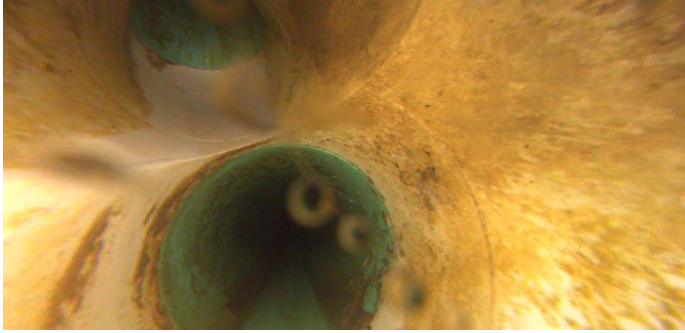
Code: **TF**  
Description: **Tap Factory**

Distance (ft): **271.9**  
Structural Grade: **0**  
O&M Grade: **0**  
Clock Start/From: **11**  
Clock To:  
1st Value: **4.000**  
2nd Value:  
Value Percent:  
Continuous Index:  
Within 8" of Joint: **YES**  
Remarks:

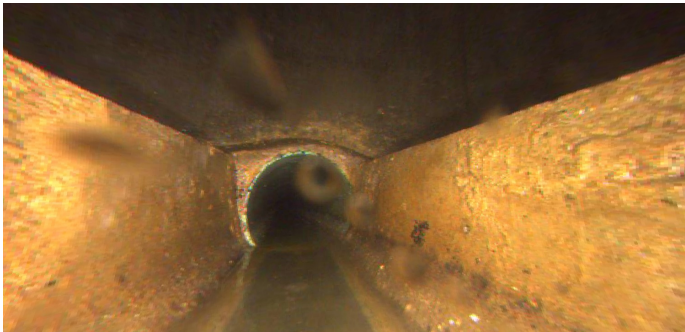
Code: **AMH**  
Description: **Manhole**

Distance (ft): **283.9**  
Structural Grade: **0**  
O&M Grade: **0**  
Clock Start/From:  
Clock To:  
1st Value:  
2nd Value:  
Value Percent:  
Continuous Index:  
Within 8" of Joint: **NO**  
Remarks: **M-910-021**
