Profile/Photo Observation Report

Date:	03/27/2018	Weather:		Coding:	PACP 6.0
Pipe Length (ft):	289.2	Owner:	NA	Pre Clean:	Not Known
P.O.#:		Surveyor:	Byrd Fitzgerald	PSR:	P-910-021-022
Customer:		Clean Date:	01/01/1900	Shape:	C

Street:	Norris	Flow Control:	Not Controlled
City:	Hobart, IN	Year Renewed:	
Location:	Sidewalk	Tape/Media #:	
Purpose:	Maintenance Related	Dia/Height:	8"
Use:	Sanitary	Material:	PVC
Drain Area:	NA	Lining:	
Category:	NA		
Comment:	Flow direction wrong.

Location Details:		Direction of Survey:	Downstream
US MH:	M-910-022	DS MH:	M-910-021
		Total Length Surveyed (ft):	283.9

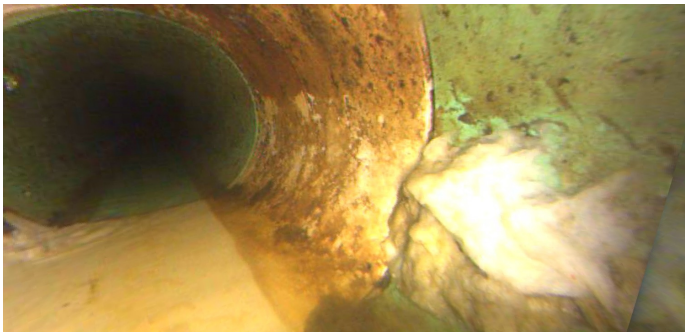
Code:	DAGS
Description:	Deposits Attached Grease

Distance (ft):	12.0
Structural Grade:	0
O&M Grade:	2
Clock Start/From:	3
Clock To:	4
1st Value:	
2nd Value:	
Value Percent:	5.000
Continuous Index:	
Within 8" of Joint:	YES
Remarks:

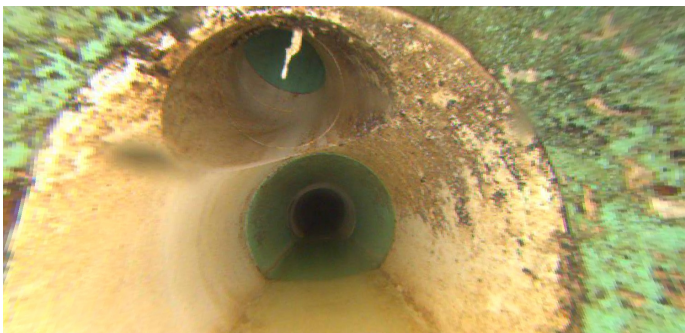
Code: **TF**
Description: **Tap Factory**

Distance (ft): **35.2**
Structural Grade: **0**
O&M Grade: **0**
Clock Start/From: **12**
Clock To:
1st Value: **4.000**
2nd Value:
Value Percent:
Continuous Index:
Within 8" of Joint: **YES**
Remarks:

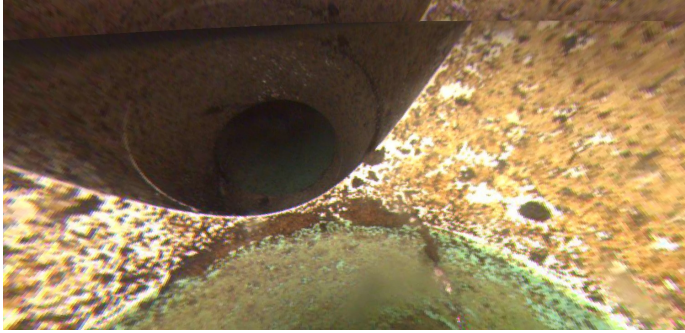
Code: **TF**
Description: **Tap Factory**

Distance (ft): **77.0**
Structural Grade: **0**
O&M Grade: **0**
Clock Start/From: **11**
Clock To:
1st Value: **4.000**
2nd Value:
Value Percent:
Continuous Index:
Within 8" of Joint: **YES**
Remarks:

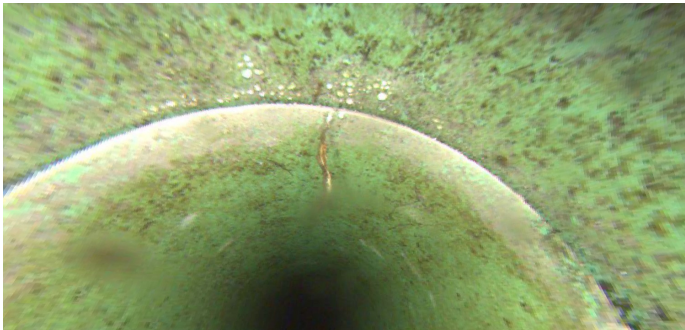
Code: **RFJ**
Description: **Roots Fine Joint**

Distance (ft): **102.2**
Structural Grade: **0**
O&M Grade: **1**
Clock Start/From: **12**
Clock To:
1st Value:
2nd Value:
Value Percent:
Continuous Index:
Within 8" of Joint: **YES**
Remarks:

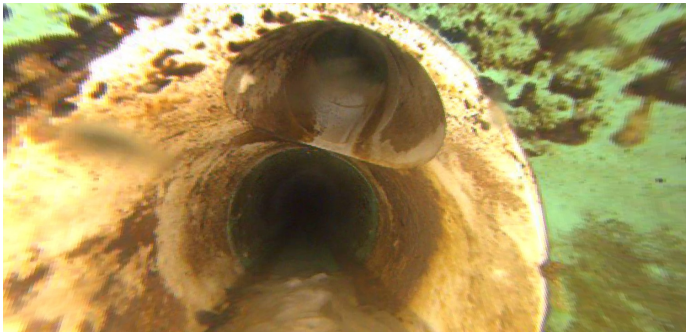
Code: **TF**
Description: **Tap Factory**

Distance (ft): **116.4**
Structural Grade: **0**
O&M Grade: **0**
Clock Start/From: **1**
Clock To:
1st Value: **4.000**
2nd Value:
Value Percent:
Continuous Index:
Within 8" of Joint: **YES**
Remarks:

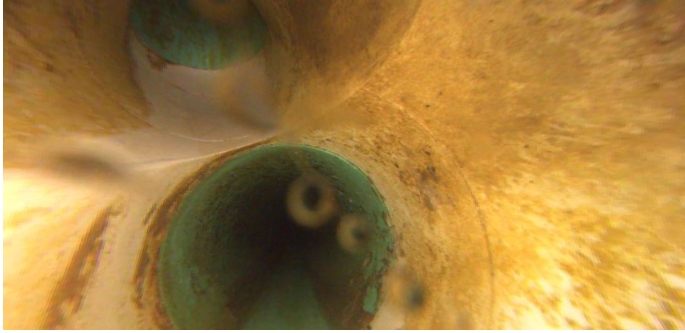
Code: **TF**
Description: **Tap Factory**

Distance (ft): **271.9**
Structural Grade: **0**
O&M Grade: **0**
Clock Start/From: **11**
Clock To:
1st Value: **4.000**
2nd Value:
Value Percent:
Continuous Index:
Within 8" of Joint: **YES**
Remarks:

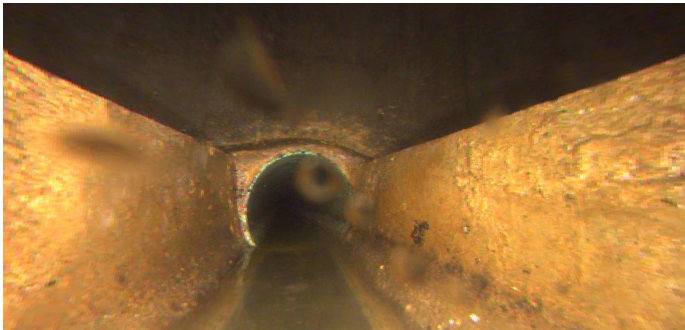
Code: **AMH**
Description: **Manhole**

Distance (ft): **283.9**
Structural Grade: **0**
O&M Grade: **0**
Clock Start/From:
Clock To:
1st Value:
2nd Value:
Value Percent:
Continuous Index:
Within 8" of Joint: **NO**
Remarks: **M-910-021**
