Profile/Photo Observation Report

Street:	NORRIS DR	Flow Control:	Not Controlled
City:	Hobart, IN	Year Renewed:	
Location:	Light Highway	Tape/Media #:	
Purpose:	Routine Assessment	Dia/Height:	8"
Use:	Sanitary	Material:	PVC
Drain Area:	NA	Lining:	
Category:	NA		
Comment:

Location Details:		Direction of Survey:	Upstream
US MH:	M-910-024	DS MH:	M-910-023
		Total Length Surveyed (ft):	173.7

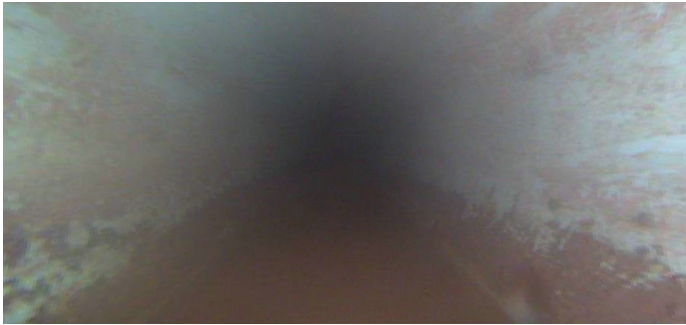
Code:	MWL
Description:	Water Level

Distance (ft):	.0
Structural Grade:	0
O&M Grade:	0
Clock Start/From:	
Clock To:	
1st Value:	
2nd Value:	
Value Percent:	5.000
Continuous Index:	
Within 8" of Joint:	NO
Remarks:

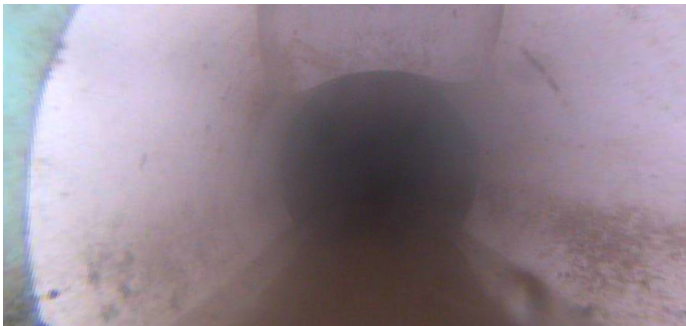
Code:	TF
Description:	Tap Factory

Distance (ft):	4.6
Structural Grade:	0
O&M Grade:	0
Clock Start/From:	12
Clock To:	
1st Value:	4.000
2nd Value:	
Value Percent:	
Continuous Index:	
Within 8" of Joint:	
Remarks:

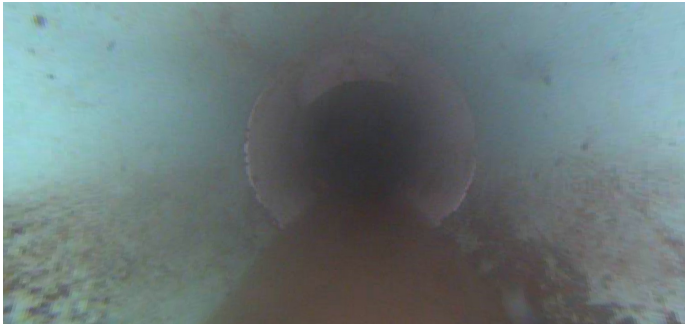
Code: **TF**
Description: **Tap Factory**

Distance (ft): **17.3**
Structural Grade: **0**
O&M Grade: **0**
Clock Start/From: **11**
Clock To:
1st Value: **4.000**
2nd Value:
Value Percent:
Continuous Index:
Within 8" of Joint:
Remarks:

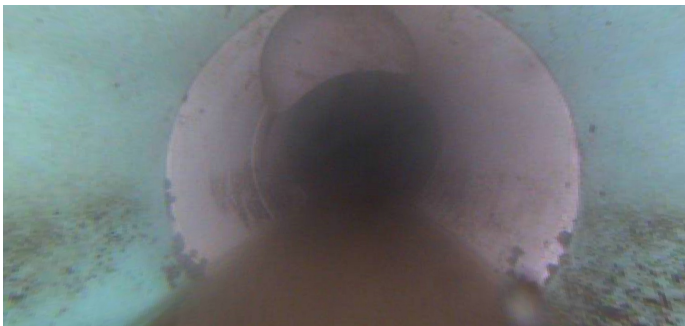
Code: **TF**
Description: **Tap Factory**

Distance (ft): **31.4**
Structural Grade: **0**
O&M Grade: **0**
Clock Start/From: **12**
Clock To:
1st Value: **4.000**
2nd Value:
Value Percent:
Continuous Index:
Within 8" of Joint:
Remarks:

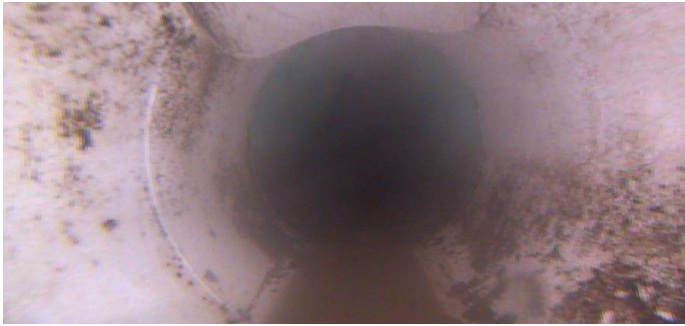
Code: **TF**
Description: **Tap Factory**

Distance (ft): **45.7**
Structural Grade: **0**
O&M Grade: **0**
Clock Start/From: **12**
Clock To:
1st Value: **4.000**
2nd Value:
Value Percent:
Continuous Index:
Within 8" of Joint:
Remarks:

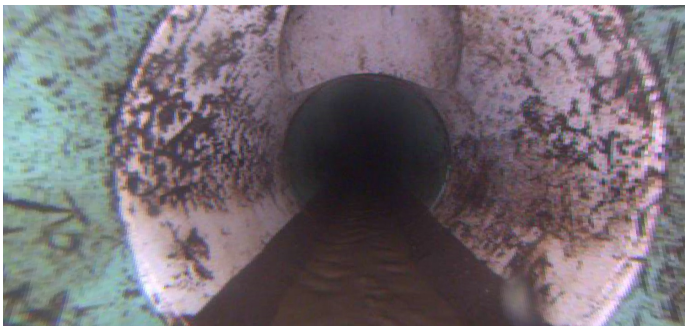
Code: **TF**
Description: **Tap Factory**

Distance (ft): **90.5**
Structural Grade: **0**
O&M Grade: **0**
Clock Start/From: **12**
Clock To:
1st Value: **4.000**
2nd Value:
Value Percent:
Continuous Index:
Within 8" of Joint:
Remarks:

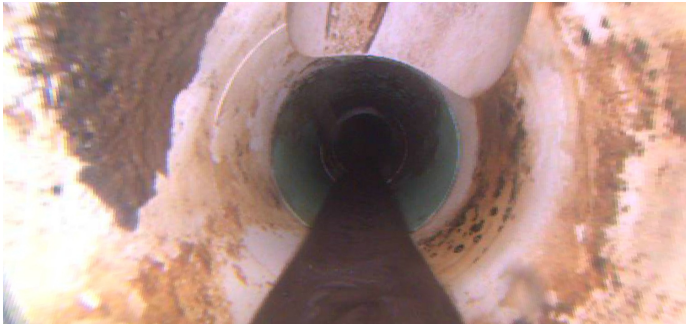
Code: **TF**
Description: **Tap Factory**

Distance (ft): **113.0**
Structural Grade: **0**
O&M Grade: **0**
Clock Start/From: **12**
Clock To:
1st Value: **4.000**
2nd Value:
Value Percent:
Continuous Index:
Within 8" of Joint:
Remarks:

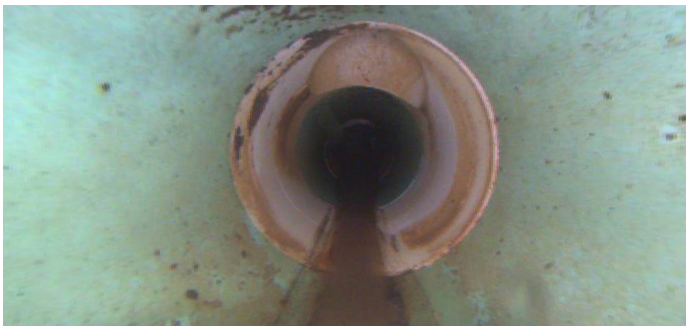
Code: **TF**
Description: **Tap Factory**

Distance (ft): **141.6**
Structural Grade: **0**
O&M Grade: **0**
Clock Start/From: **12**
Clock To:
1st Value: **4.000**
2nd Value:
Value Percent:
Continuous Index:
Within 8" of Joint:
Remarks:

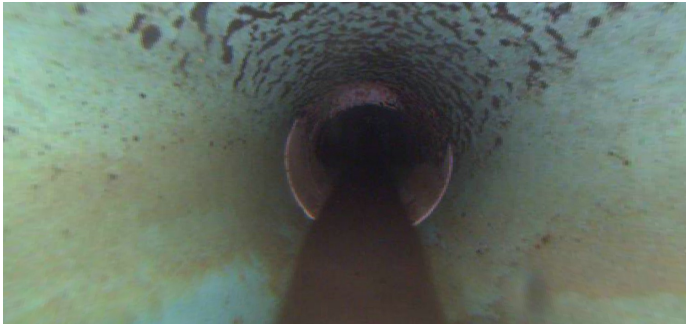
Code: **TF**
Description: **Tap Factory**

Distance (ft): **143.2**
Structural Grade: **0**
O&M Grade: **0**
Clock Start/From: **12**
Clock To:
1st Value: **4.000**
2nd Value:
Value Percent:
Continuous Index:
Within 8" of Joint:
Remarks:

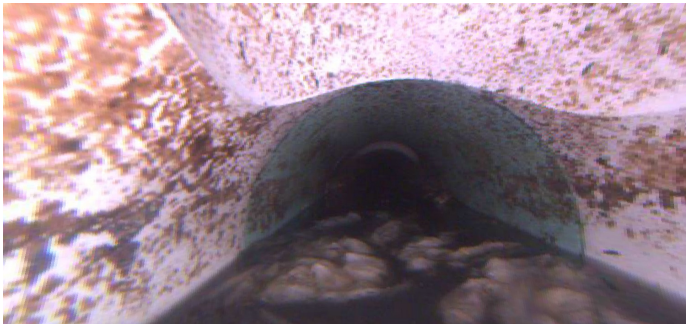
Code: **TF**
Description: **Tap Factory**

Distance (ft): **171.8**
Structural Grade: **0**
O&M Grade: **0**
Clock Start/From: **12**
Clock To:
1st Value: **4.000**
2nd Value:
Value Percent:
Continuous Index:
Within 8" of Joint:
Remarks:

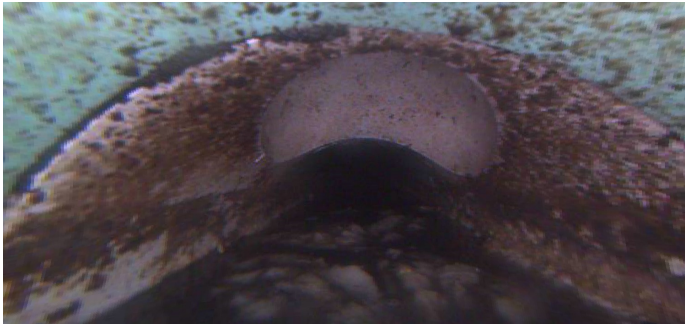
Code: **TF**
Description: **Tap Factory**

Distance (ft): **173.3**
Structural Grade: **0**
O&M Grade: **0**
Clock Start/From: **12**
Clock To:
1st Value: **4.000**
2nd Value:
Value Percent:
Continuous Index:
Within 8" of Joint:
Remarks:

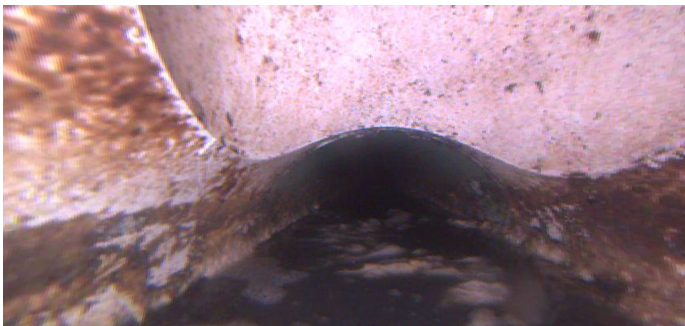
Code: **MSA**
Description: **Abandoned Survey**

Distance (ft): **173.7**
Structural Grade: **0**
O&M Grade: **0**
Clock Start/From:
Clock To:
1st Value:
2nd Value:
Value Percent:
Continuous Index:
Within 8" of Joint: **NO**
Remarks: **camera stopped**
