## Profile/Photo Observation Report

Street:	<b>Norris Dr.</b>	Flow Control:	<b>Not Controlled</b>
City:	<b>Hobart, IN</b>	Year Renewed:	
Location:	<b>Light Highway</b>	Tape/Media #:	
Purpose:	<b>Routine Assessment</b>	Dia/Height:	<b>8"</b>
Use:	<b>Sanitary</b>	Material:	<b>PVC</b>
Drain Area:	<b>NA</b>	Lining:	
Category:	<b>NA</b>		
Comment:

Location Details:		Direction of Survey:	<b>Upstream</b>
US MH:	<b>M-910-024</b>	DS MH:	<b>M-910-023</b>
		Total Length Surveyed (ft):	<b>173.7</b>

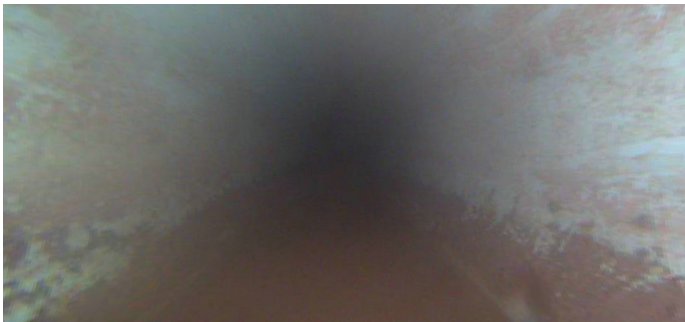
Code: **AMH**  
Description: **Manhole**

Distance (ft):	.0
Structural Grade:	0
O&M Grade:	0
Clock Start/From:	
Clock To:	
1st Value:	
2nd Value:	
Value Percent:	
Continuous Index:	
Within 8" of Joint:	NO
Remarks:	M-910-023

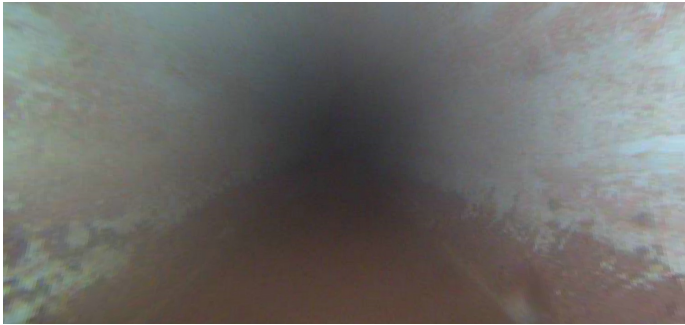
Code:	<b>MWL</b>
Description:	<b>Water Level</b>

Distance (ft):	<b>.0</b>
Structural Grade:	<b>0</b>
O&M Grade:	<b>0</b>
Clock Start/From:	
Clock To:	
1st Value:	
2nd Value:	
Value Percent:	<b>5.000</b>
Continuous Index:	
Within 8" of Joint:	<b>NO</b>
Remarks:

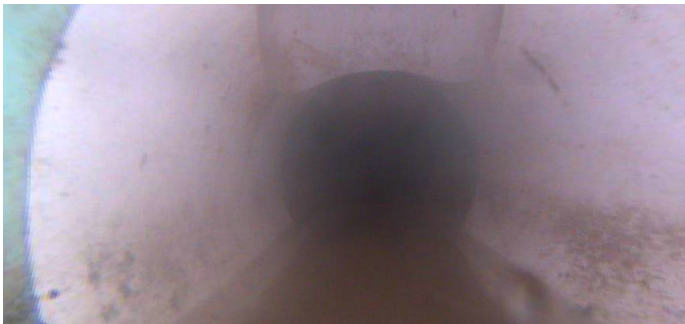
Code:	<b>TF</b>
Description:	<b>Tap Factory</b>

Distance (ft):	<b>4.6</b>
Structural Grade:	<b>0</b>
O&M Grade:	<b>0</b>
Clock Start/From:	<b>12</b>
Clock To:	
1st Value:	<b>4.000</b>
2nd Value:	
Value Percent:	
Continuous Index:	
Within 8" of Joint:	
Remarks:

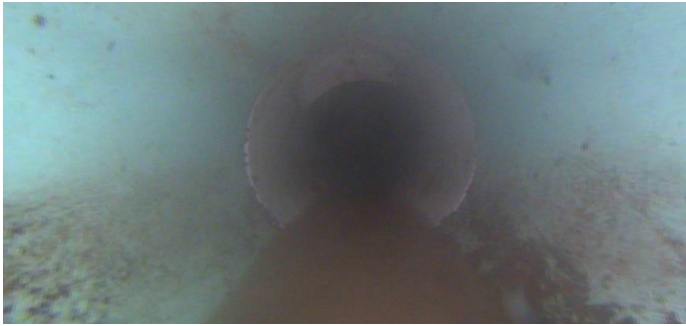
Code: **TF**  
Description: **Tap Factory**

Distance (ft): **17.3**  
Structural Grade: **0**  
O&M Grade: **0**  
Clock Start/From: **11**  
Clock To:  
1st Value: **4.000**  
2nd Value:  
Value Percent:  
Continuous Index:  
Within 8" of Joint:  
Remarks:

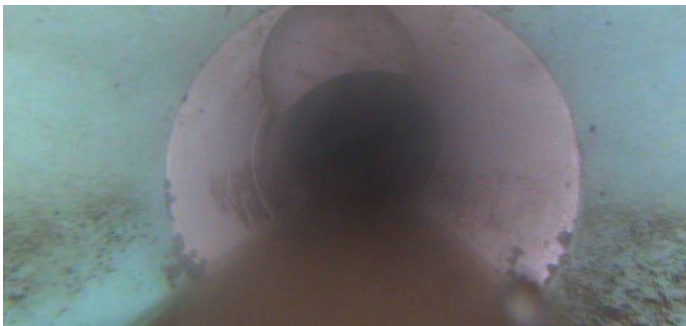
Code: **TF**  
Description: **Tap Factory**

Distance (ft): **31.4**  
Structural Grade: **0**  
O&M Grade: **0**  
Clock Start/From: **12**  
Clock To:  
1st Value: **4.000**  
2nd Value:  
Value Percent:  
Continuous Index:  
Within 8" of Joint:  
Remarks:

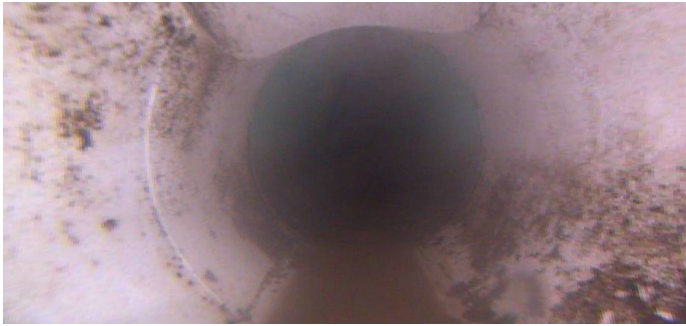
Code: **TF**  
Description: **Tap Factory**

Distance (ft): **45.7**  
Structural Grade: **0**  
O&M Grade: **0**  
Clock Start/From: **12**  
Clock To:  
1st Value: **4.000**  
2nd Value:  
Value Percent:  
Continuous Index:  
Within 8" of Joint:  
Remarks:

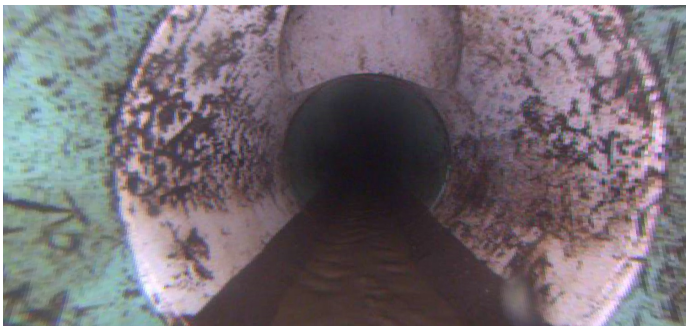
Code: **TF**  
Description: **Tap Factory**

Distance (ft): **90.5**  
Structural Grade: **0**  
O&M Grade: **0**  
Clock Start/From: **12**  
Clock To:  
1st Value: **4.000**  
2nd Value:  
Value Percent:  
Continuous Index:  
Within 8" of Joint:  
Remarks:

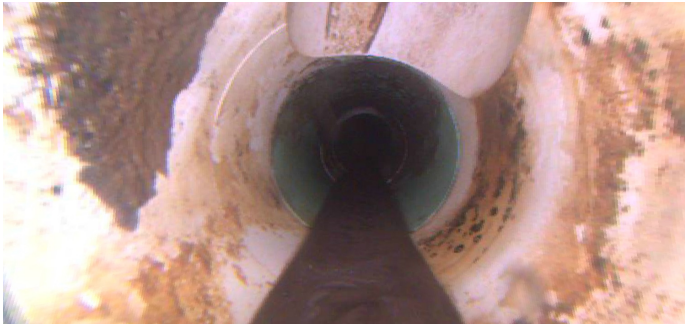
Code: **TF**  
Description: **Tap Factory**

Distance (ft): **113.0**  
Structural Grade: **0**  
O&M Grade: **0**  
Clock Start/From: **12**  
Clock To:  
1st Value: **4.000**  
2nd Value:  
Value Percent:  
Continuous Index:  
Within 8" of Joint:  
Remarks:

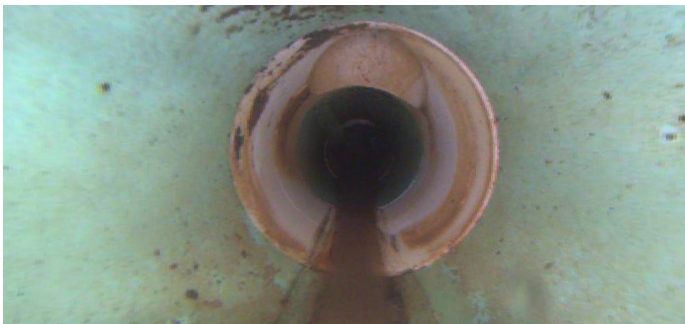
Code: **TF**  
Description: **Tap Factory**

Distance (ft): **141.6**  
Structural Grade: **0**  
O&M Grade: **0**  
Clock Start/From: **12**  
Clock To:  
1st Value: **4.000**  
2nd Value:  
Value Percent:  
Continuous Index:  
Within 8" of Joint:  
Remarks:

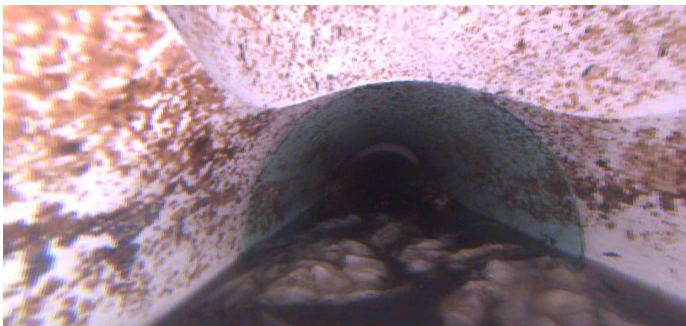
Code: **TF**  
Description: **Tap Factory**

Distance (ft): **171.8**  
Structural Grade: **0**  
O&M Grade: **0**  
Clock Start/From: **12**  
Clock To:  
1st Value: **4.000**  
2nd Value:  
Value Percent:  
Continuous Index:  
Within 8" of Joint:  
Remarks:
