Profile/Photo Observation Report

Street:	OFF NORRIS DR	Flow Control:	Not Controlled
City:	Hobart, IN	Year Renewed:	
Location:	Ditch	Tape/Media #:	
Purpose:	Maintenance Related	Dia/Height:	8"
Use:	Sanitary	Material:	PVC
Drain Area:	NA	Lining:	
Category:	NA		
Comment:	Flow direction wrong.

Location Details:		Direction of Survey:	Upstream
US MH:	M-910-025	DS MH:	M-910-027
		Total Length Surveyed (ft):	206.0

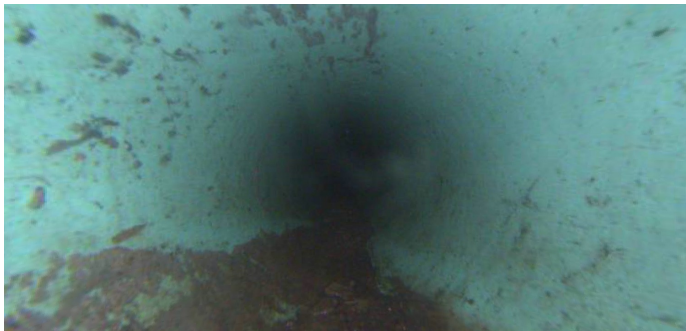
Code: **DSF**
Description: **Deposits Settled Fine**

Distance (ft): **.0**
Structural Grade: **0**
O&M Grade: **2**
Clock Start/From: **6**
Clock To:
1st Value:
2nd Value:
Value Percent: **5.000**
Continuous Index:
Within 8" of Joint: **NO**
Remarks:

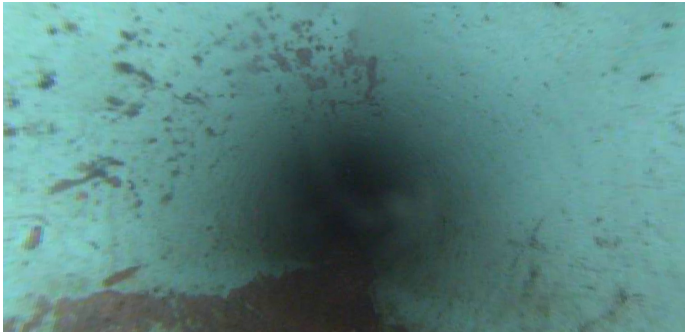
Code:	AMH
Description:	Manhole

Distance (ft):	.0
Structural Grade:	0
O&M Grade:	0
Clock Start/From:	
Clock To:	
1st Value:	
2nd Value:	
Value Percent:	
Continuous Index:	
Within 8" of Joint:	NO
Remarks:	M-910-027

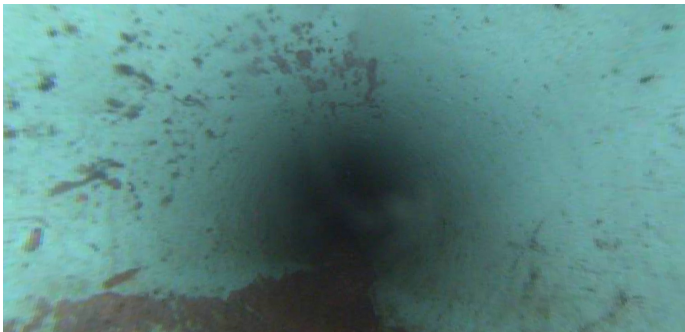
Code:	MWL
Description:	Water Level

Distance (ft):	.0
Structural Grade:	0
O&M Grade:	0
Clock Start/From:	
Clock To:	
1st Value:	
2nd Value:	
Value Percent:	5.000
Continuous Index:	
Within 8" of Joint:	NO
Remarks:

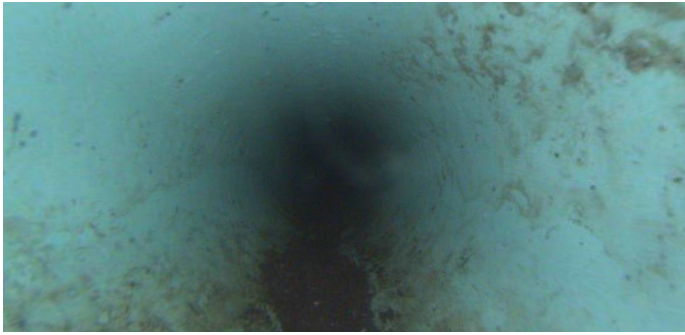
Code: **DSF**
Description: **Deposits Settled Fine**

Distance (ft): **62.2**
Structural Grade: **0**
O&M Grade: **2**
Clock Start/From: **6**
Clock To:
1st Value:
2nd Value:
Value Percent: **5.000**
Continuous Index:
Within 8" of Joint: **NO**
Remarks:

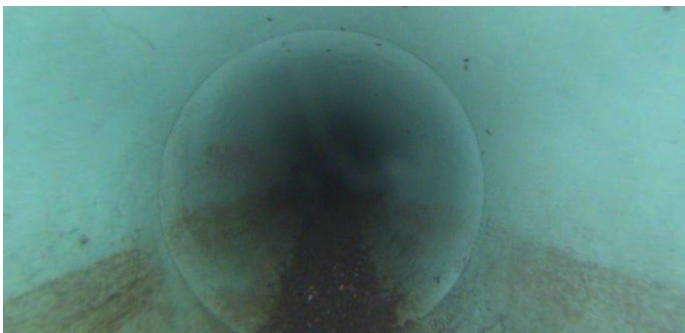
Code: **DSF**
Description: **Deposits Settled Fine**

Distance (ft): **141.8**
Structural Grade: **0**
O&M Grade: **2**
Clock Start/From: **6**
Clock To:
1st Value:
2nd Value:
Value Percent: **5.000**
Continuous Index:
Within 8" of Joint: **NO**
Remarks:

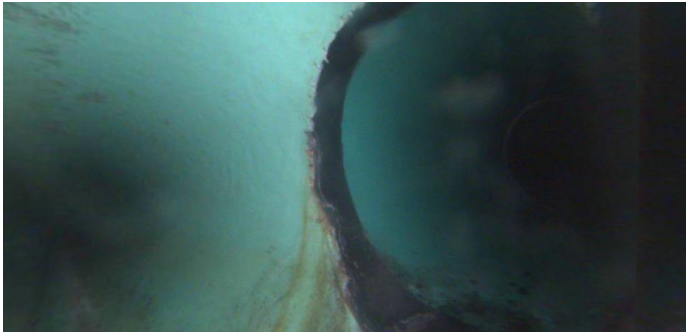
Code: **TB**
Description: **Tap Break-in**

Distance (ft): **145.2**
Structural Grade: **0**
O&M Grade: **0**
Clock Start/From: **3**
Clock To:
1st Value: **4.000**
2nd Value:
Value Percent:
Continuous Index:
Within 8" of Joint:
Remarks:

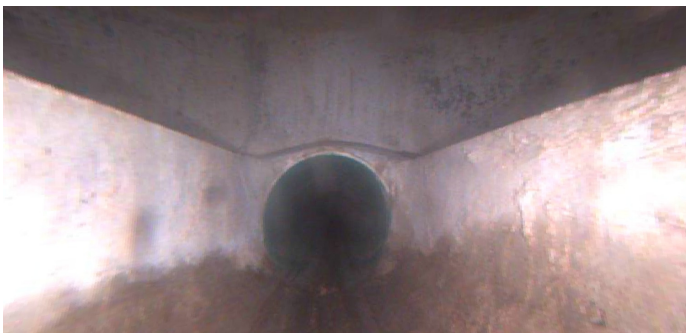
Code: **AMH**
Description: **Manhole**

Distance (ft): **206.0**
Structural Grade: **0**
O&M Grade: **0**
Clock Start/From:
Clock To:
1st Value:
2nd Value:
Value Percent:
Continuous Index:
Within 8" of Joint: **NO**
Remarks: **M-910-025**
