Profile/Photo Observation Report

| Street: | McAfee Dr. | Flow Control: | Not Controlled |
| City: | Hobart, IN | Year Renewed: | |

| US MH: | M-1004-015 | DS MH: | M-1004-097 |

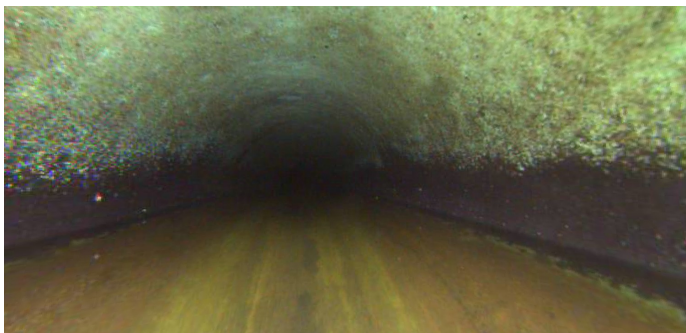
Code: **AMH**
Description: **Manhole**

Distance (ft): **.0**
Structural Grade: **0**
O&M Grade: **0**
Clock Start/From:
Clock To:
1st Value:
2nd Value:
Value Percent:
Continuous Index:
Within 8" of Joint: **NO**
Remarks: **M-1004-015**

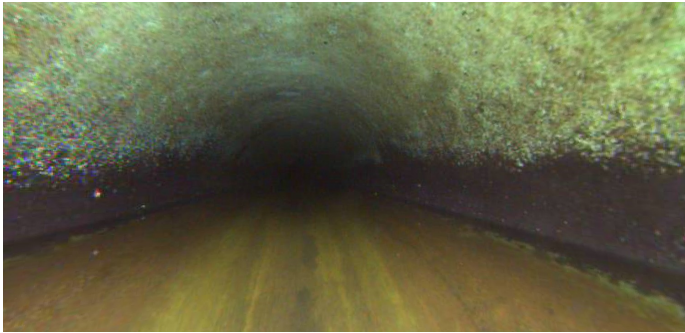
| Code: | MWL |
| Description: | Water Level |

| Distance (ft): | .0 |
| Value Percent: | 10.000 |

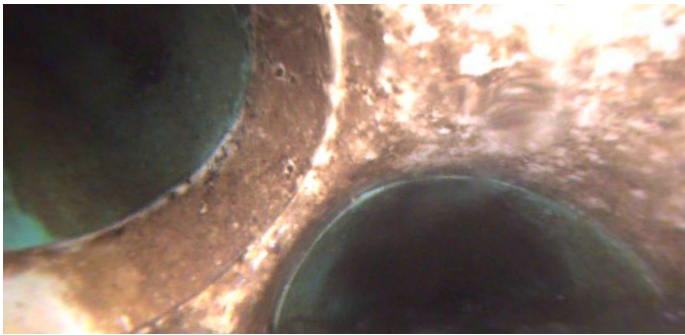
| Code: | TF |
| Description: | Tap Factory |

| Distance (ft): | 120.6 |
| Clock Start/From: | 2 |
| 1st Value: | 4.000 |

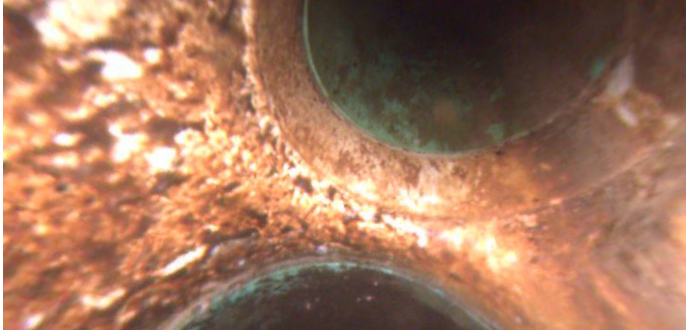
Code: **TF**
Description: **Tap Factory**

Distance (ft): **136.9**
Structural Grade: **0**
O&M Grade: **0**
Clock Start/From: **11**
Clock To:
1st Value: **4.000**
2nd Value:
Value Percent:
Continuous Index:
Within 8" of Joint:
Remarks: **Photo taken from rear camera.**

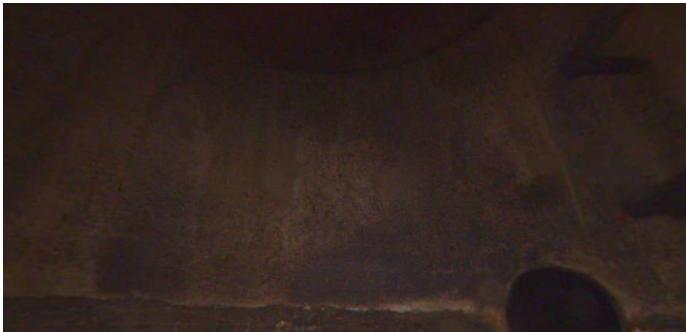
Code: **AMH**
Description: **Manhole**

Distance (ft): **143.5**
Structural Grade: **0**
O&M Grade: **0**
Clock Start/From:
Clock To:
1st Value:
2nd Value:
Value Percent:
Continuous Index:
Within 8" of Joint: **NO**
Remarks: **M-1004-097**
