Profile/Photo Observation Report

Street:	W 40th ave	Flow Control:	Not Controlled
City:	Hobart, IN	Year Renewed:	
Location:	Other	Tape/Media #:	
Purpose:	Not Known	Dia/Height:	10"
Use:	Sanitary	Material:	VCP
Drain Area:	NA	Lining:	
Category:	NA		
Comment:

Location Details:		Direction of Survey:	Downstream
US MH:	M-503-062	DS MH:	M-503-045
		Total Length Surveyed (ft):	308.3

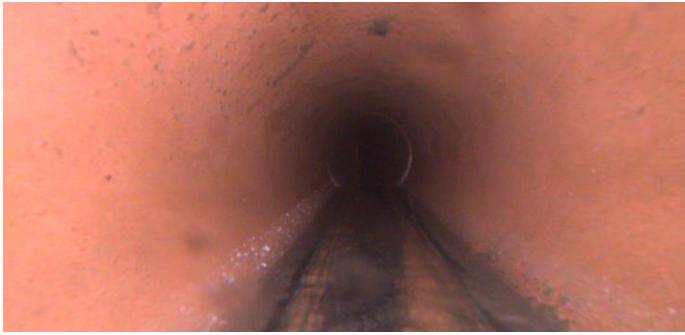
Code: **AMH**
Description: **Manhole**

Distance (ft): **.0**
Structural Grade: **0**
O&M Grade: **0**
Clock Start/From:
Clock To:
1st Value:
2nd Value:
Value Percent:
Continuous Index:
Within 8" of Joint: **NO**
Remarks: **M-503-062**

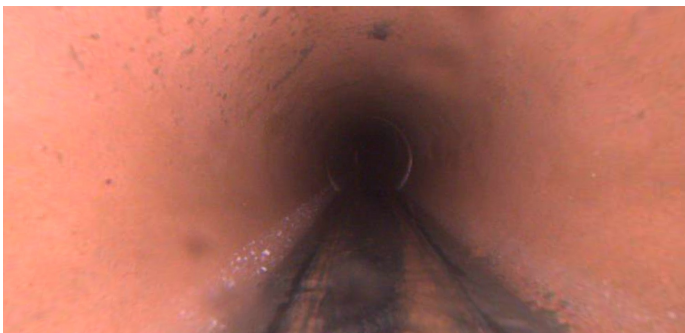
Code: **MWL**
Description: **Water Level**

Distance (ft): **.0**
Structural Grade: **0**
O&M Grade: **0**
Clock Start/From:
Clock To:
1st Value:
2nd Value:
Value Percent: **5.000**
Continuous Index:
Within 8" of Joint: **NO**
Remarks:

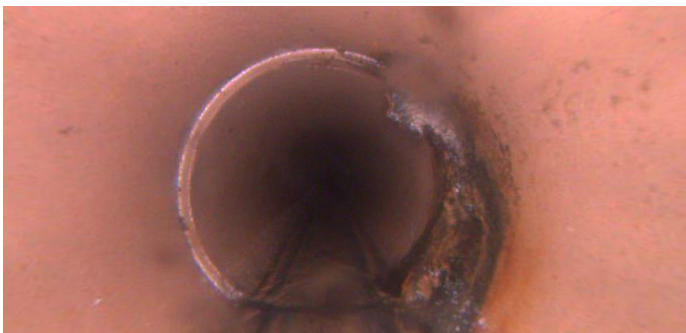
Code: **ID**
Description: **Infil Dripper**

Distance (ft): **18.6**
Structural Grade: **0**
O&M Grade: **3**
Clock Start/From: **1**
Clock To:
1st Value:
2nd Value:
Value Percent:
Continuous Index:
Within 8" of Joint: **YES**
Remarks:

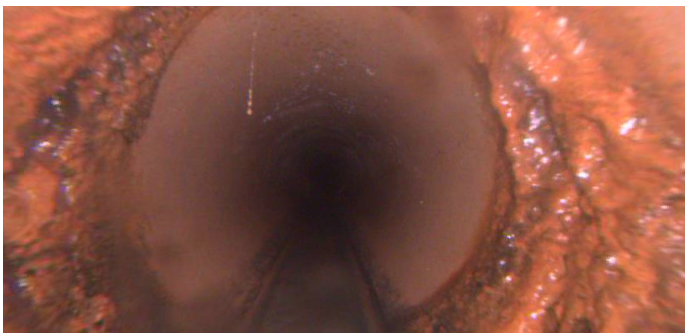
Code: **DAE**
Description: **Deposits Attached Encrustation**

Distance (ft): **97.3**
Structural Grade: **0**
O&M Grade: **2**
Clock Start/From: **8**
Clock To: **4**
1st Value:
2nd Value:
Value Percent: **5.000**
Continuous Index:
Within 8" of Joint: **YES**
Remarks:

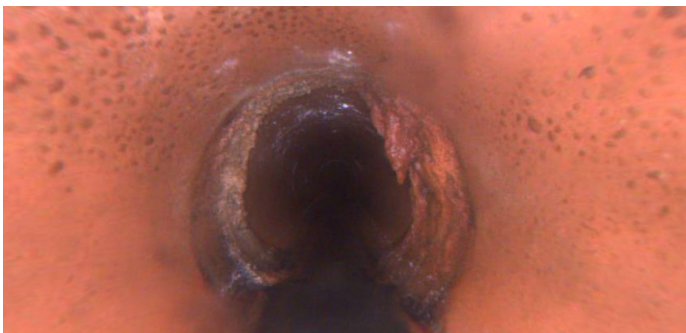
Code: **DAE**
Description: **Deposits Attached Encrustation**

Distance (ft): **122.9**
Structural Grade: **0**
O&M Grade: **2**
Clock Start/From: **8**
Clock To: **4**
1st Value:
2nd Value:
Value Percent: **10.000**
Continuous Index:
Within 8" of Joint: **YES**
Remarks:

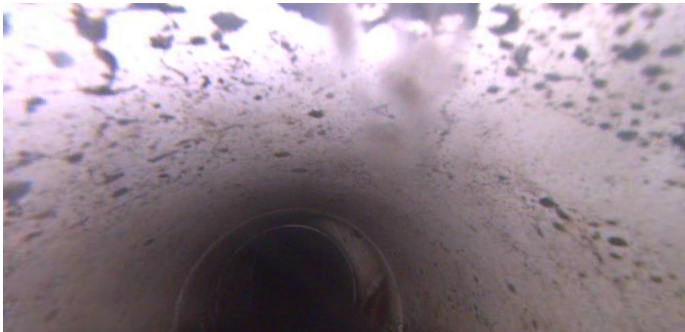
Code: MMC
Description: Material Change

Distance (ft): 298.5
Structural Grade: 0
O&M Grade: 0
Clock Start/From:
Clock To:
1st Value:
2nd Value:
Value Percent:
Continuous Index:
Within 8" of Joint: NO
Remarks: PVC

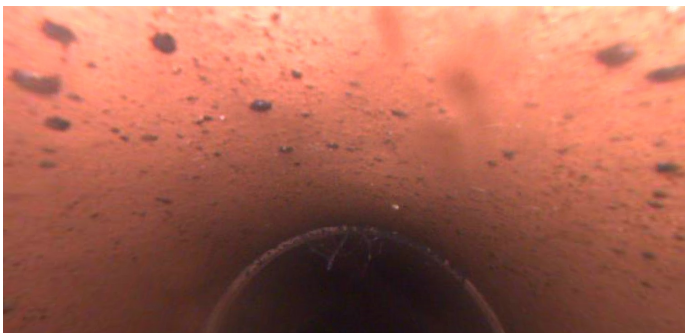
Code: **IW**
Description: **Infil Weeper**

Distance (ft): **308.3**
Structural Grade: **0**
O&M Grade: **2**
Clock Start/From: **8**
Clock To: **4**
1st Value:
2nd Value:
Value Percent:
Continuous Index: **F01**
Within 8" of Joint: **YES**
Remarks:
