Profile/Photo Observation Report

Date:	08/20/2024	Weather:		Coding:	PACP 7.0
Pipe Length (ft):		Owner:	City of Hobart	Pre Clean:	Heavy Cleaning
P.O.#:		Surveyor:	S. Bucklin	PSR:	M-804-081.1-M-804-081
Customer:	City of Hobart	Clean Date:	08/20/2024	Shape:	C

Street:	Hobart Road, State Road 130	Flow Control:	Not Controlled
City:	Hobart, IN	Year Renewed:	
Location:	Local rural streets with light traffic, t	Tape/Media #:	
Purpose:	Sewer System Evaluation Survey (SS	Dia/Height:	8"
Use:	Sanitary Sewage Pipe	Material:	PVC
Drain Area:		Lining:	
Category:	NA		
Comment:			
Location Details:		Direction of Survey:	Upstream
US MH:	M-804-081.1	DS MH:	M-804-081
		Total Length Surveyed (ft):	160.8

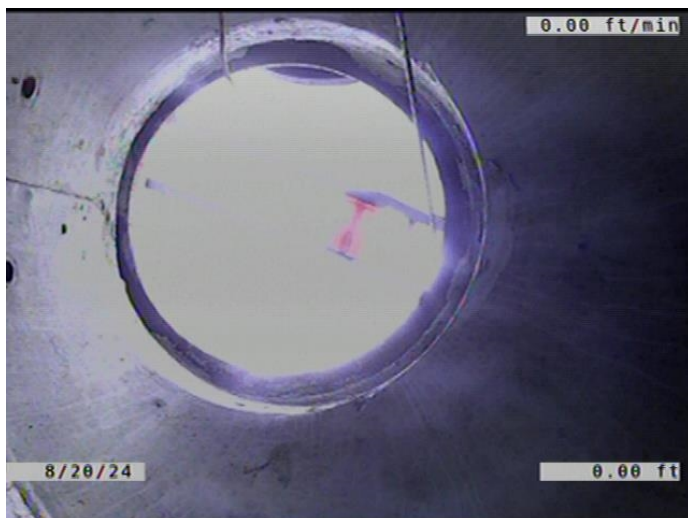
Code: **AMH**
Description: **Manhole**

Distance (ft): **.0**
Structural Grade: **0**
O&M Grade: **0**
Clock Start/From:
Clock To:
1st Value:
2nd Value:
Value Percent:
Continuous Index:
Within 8" of Joint: **NO**
Remarks: **M-804-081**

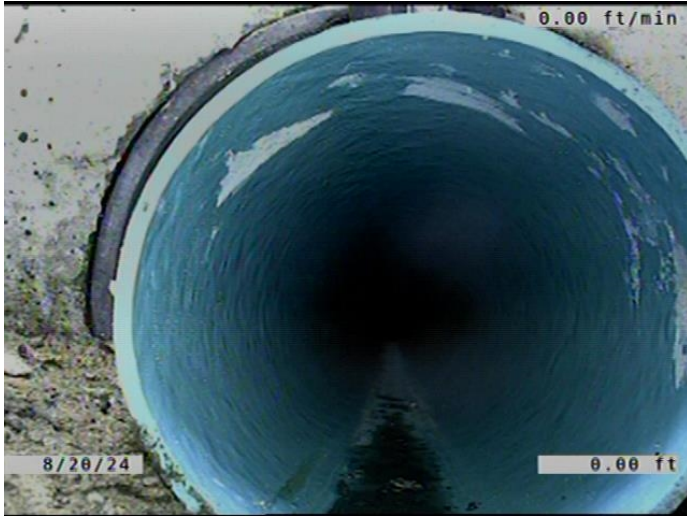
Code: **MWL**
Description: **Miscellaneous Water Level**

Distance (ft): **.0**
Structural Grade: **0**
O&M Grade: **0**
Clock Start/From:
Clock To:
1st Value:
2nd Value:
Value Percent: **5.000**
Continuous Index:
Within 8" of Joint: **NO**
Remarks:

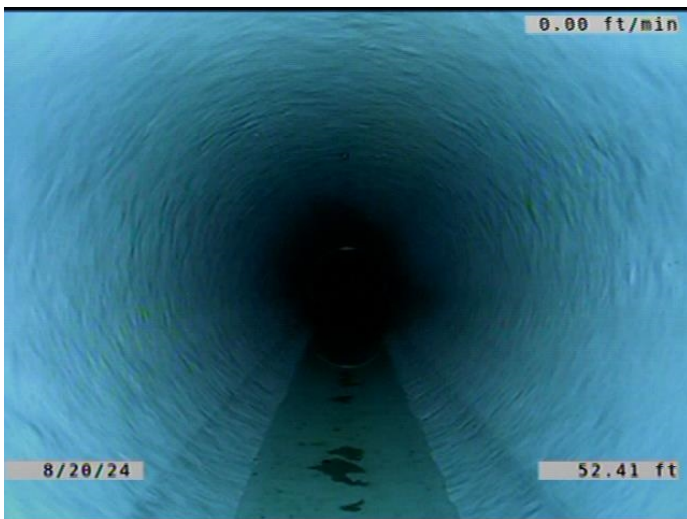
Code: **MWLS**
Description: **Miscellaneous Water Level Sag**

Distance (ft): **52.4**
Structural Grade: **2**
O&M Grade: **0**
Clock Start/From:
Clock To:
1st Value:
2nd Value:
Value Percent: **15.000**
Continuous Index: **S01**
Within 8" of Joint: **NO**
Remarks:

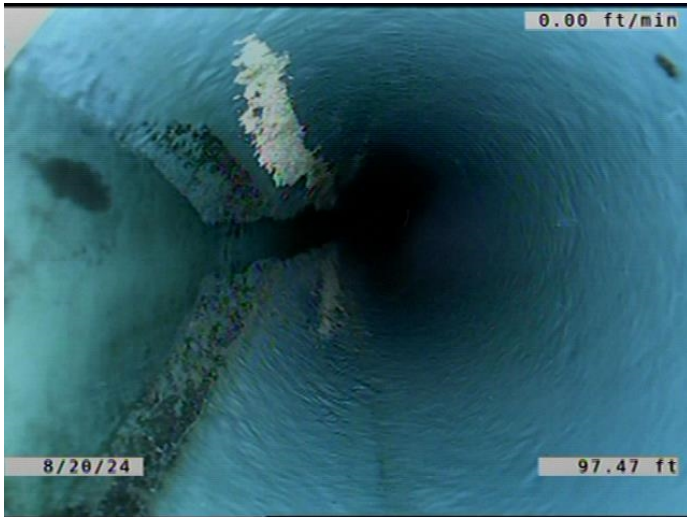
Code: **TF**
Description: **Tap Factory**

Distance (ft): **97.5**
Structural Grade: **0**
O&M Grade: **0**
Clock Start/From: **9**
Clock To:
1st Value: **6.000**
2nd Value:
Value Percent:
Continuous Index:
Within 8" of Joint: **YES**
Remarks:

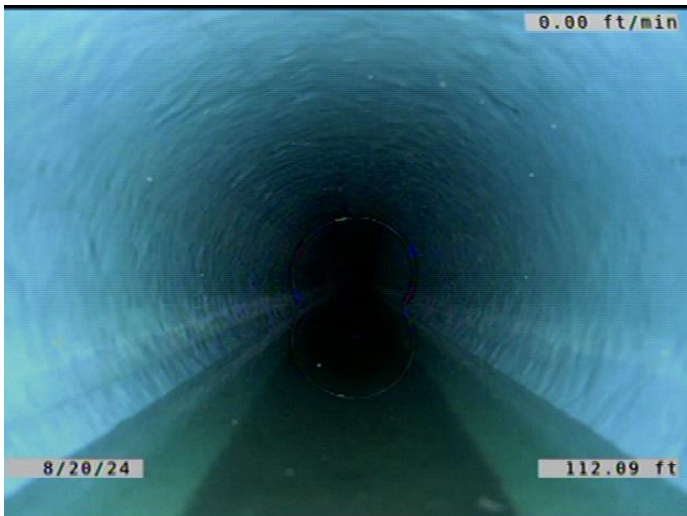
Code: **DSF**
Description: **Deposits Settled Fine**

Distance (ft): **112.1**
Structural Grade: **0**
O&M Grade: **2**
Clock Start/From: **5**
Clock To: **7**
1st Value:
2nd Value:
Value Percent: **5.000**
Continuous Index: **S02**
Within 8" of Joint: **YES**
Remarks:

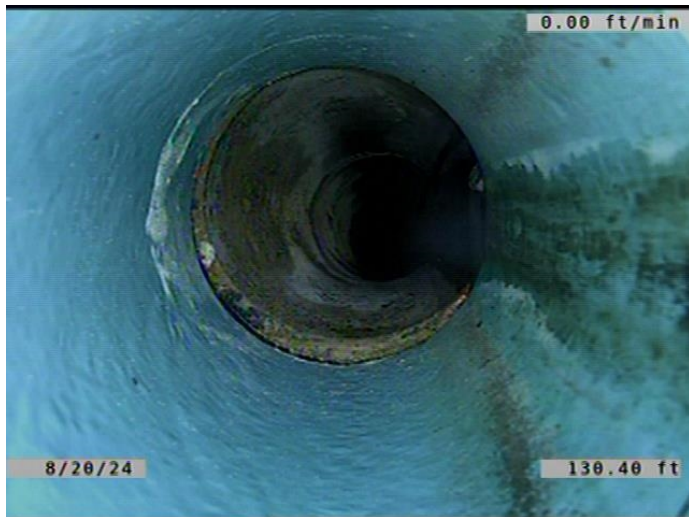
Code: **TF**
Description: **Tap Factory**

Distance (ft): **130.4**
Structural Grade: **0**
O&M Grade: **0**
Clock Start/From: **3**
Clock To:
1st Value: **6.000**
2nd Value:
Value Percent:
Continuous Index:
Within 8" of Joint: **YES**
Remarks: **TAP IS PVC. SERVICE IS VCP.**

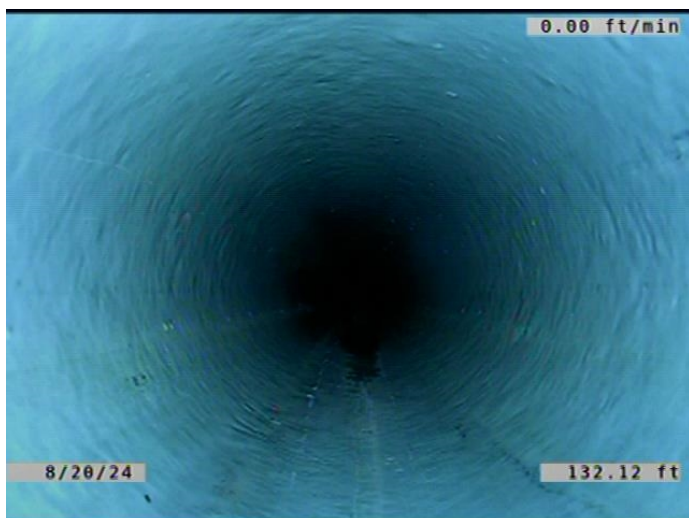
Code: **MWLS**
Description: **Miscellaneous Water Level Sag**

Distance (ft): **132.1**
Structural Grade: **2**
O&M Grade: **0**
Clock Start/From:
Clock To:
1st Value:
2nd Value:
Value Percent: **15.000**
Continuous Index: **F01**
Within 8" of Joint: **NO**
Remarks:

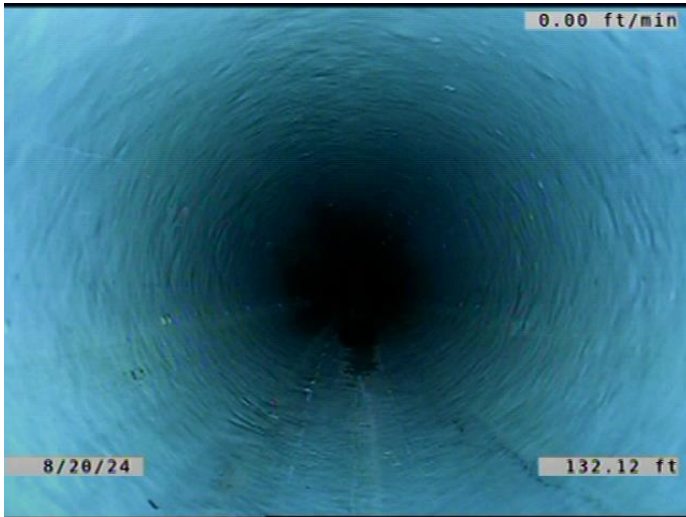
Code: **DSF**
Description: **Deposits Settled Fine**

Distance (ft): **132.1**
Structural Grade: **0**
O&M Grade: **2**
Clock Start/From: **5**
Clock To: **7**
1st Value:
2nd Value:
Value Percent: **5.000**
Continuous Index: **F02**
Within 8" of Joint: **YES**
Remarks:

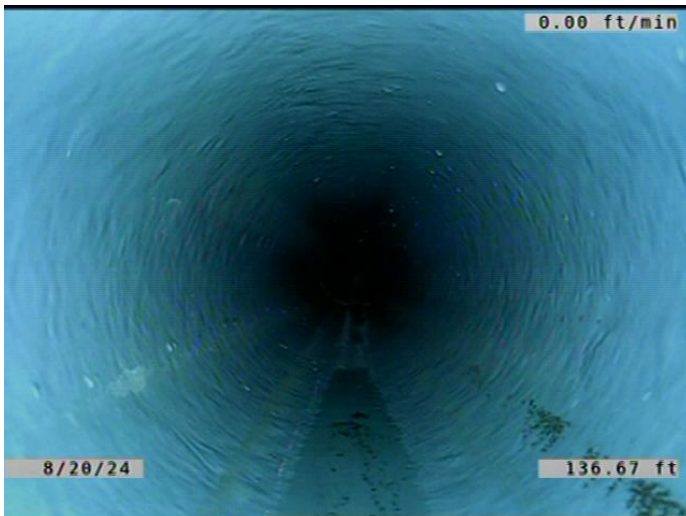
Code: **MWLS**
Description: **Miscellaneous Water Level Sag**

Distance (ft): **136.7**
Structural Grade: **2**
O&M Grade: **0**
Clock Start/From:
Clock To:
1st Value:
2nd Value:
Value Percent: **5.000**
Continuous Index:
Within 8" of Joint: **NO**
Remarks:

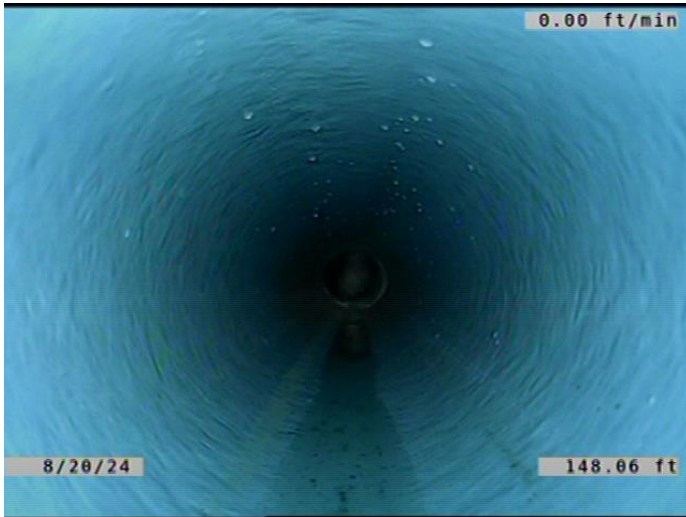
Code: **MWLS**
Description: **Miscellaneous Water Level Sag**

Distance (ft): **148.1**
Structural Grade: **2**
O&M Grade: **0**
Clock Start/From:
Clock To:
1st Value:
2nd Value:
Value Percent: **5.000**
Continuous Index: **S03**
Within 8" of Joint: **NO**
Remarks:

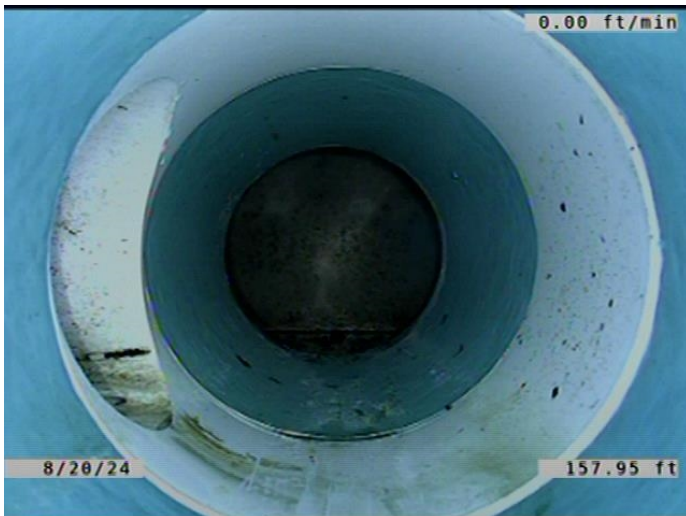
Code: **MWLS**
Description: **Miscellaneous Water Level Sag**

Distance (ft): **158.0**
Structural Grade: **2**
O&M Grade: **0**
Clock Start/From:
Clock To:
1st Value:
2nd Value:
Value Percent: **5.000**
Continuous Index: **F03**
Within 8" of Joint: **NO**
Remarks:

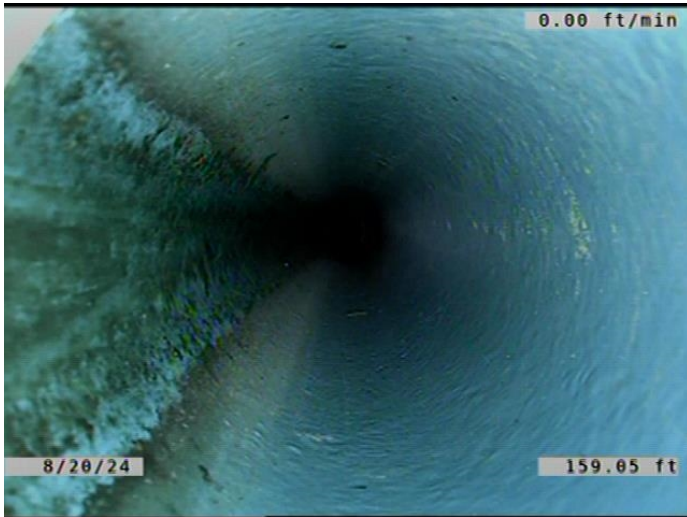
Code: **TF**
Description: **Tap Factory**

Distance (ft): **159.0**
Structural Grade: **0**
O&M Grade: **0**
Clock Start/From: **9**
Clock To:
1st Value: **6.000**
2nd Value:
Value Percent:
Continuous Index:
Within 8" of Joint: **YES**
Remarks:

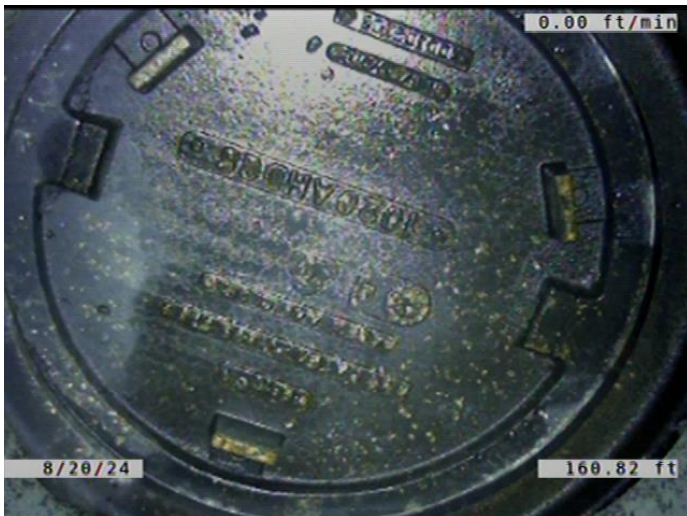
Code: **AMH**
Description: **Manhole**

Distance (ft): **160.8**
Structural Grade: **0**
O&M Grade: **0**
Clock Start/From:
Clock To:
1st Value:
2nd Value:
Value Percent:
Continuous Index:
Within 8" of Joint: **NO**
Remarks: **M-804-081.1**
