## Profile/Photo Observation Report

Street:	<b>East 10th Street</b>	Flow Control:	<b>Not Controlled</b>
City:	<b>Hobart, IN</b>	Year Renewed:	
Location:	<b>Sidewalk</b>	Tape/Media #:	<b>DEP254</b>
Purpose:	<b>Routine Assessment</b>	Dia/Height:	<b>15"</b>
Use:	<b>Sanitary</b>	Material:	<b>PVC</b>
Drain Area:		Lining:	
Category:	<b>NA</b>		
Comment:	<b>YES501824 Submittal 2</b>		
Location Details:		Direction of Survey:	<b>Upstream</b>
US MH:	<b>M-806-047</b>	DS MH:	<b>M-806-062</b>
		Total Length Surveyed (ft):	<b>188.0</b>

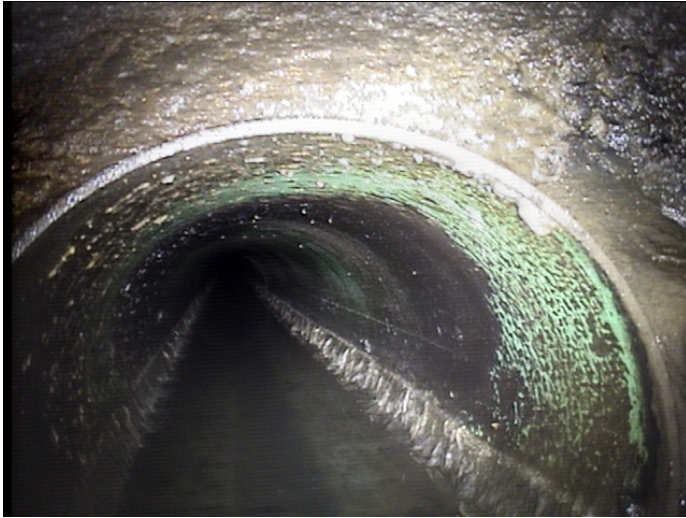
Code: **MWL**  
Description: **Water Level**

Distance (ft): **.0**  
Structural Grade: **0**  
O&M Grade: **0**  
Clock Start/From:  
Clock To:  
1st Value:  
2nd Value:  
Value Percent: **10.000**  
Continuous Index:  
Within 8" of Joint: **NO**  
Remarks:

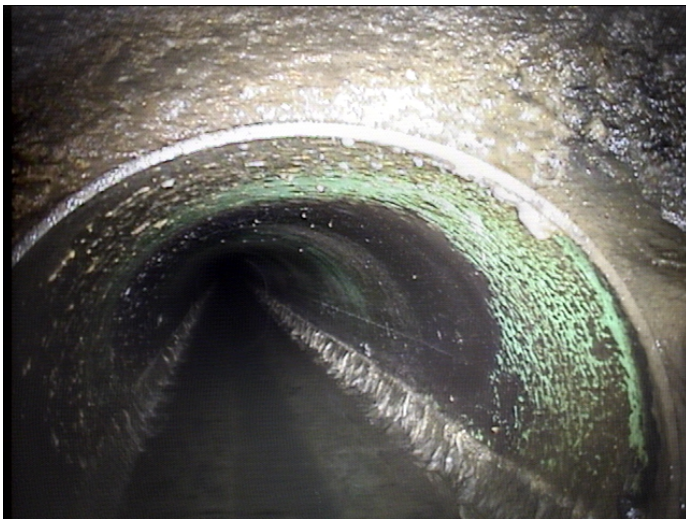
Code: **DSF**  
Description: **Deposits Settled Fine**

Distance (ft): **.0**  
Structural Grade: **0**  
O&M Grade: **2**  
Clock Start/From: **5**  
Clock To: **7**  
1st Value:  
2nd Value:  
Value Percent: **10.000**  
Continuous Index: **S01**  
Within 8" of Joint: **NO**  
Remarks:

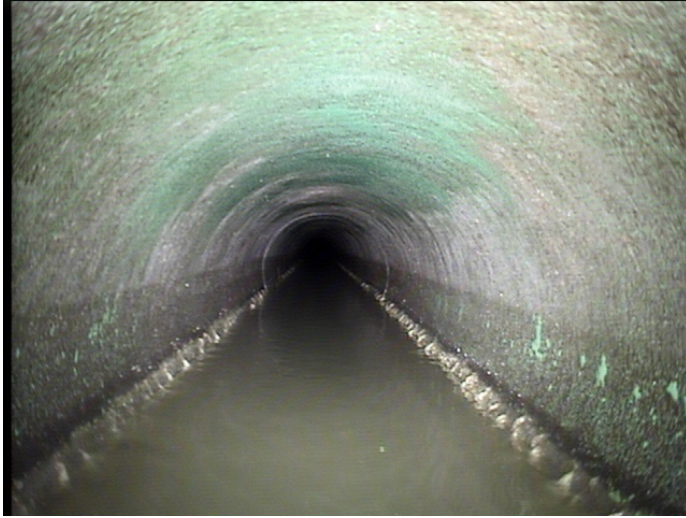
Code: **DSF**  
Description: **Deposits Settled Fine**

Distance (ft): **188.0**  
Structural Grade: **0**  
O&M Grade: **2**  
Clock Start/From: **5**  
Clock To: **7**  
1st Value:  
2nd Value:  
Value Percent: **10.000**  
Continuous Index: **F01**  
Within 8" of Joint: **NO**  
Remarks:

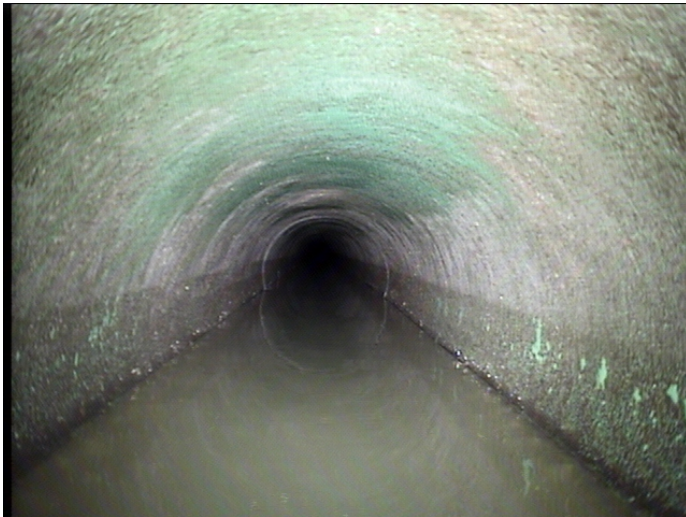
Code: **MSA**  
Description: **Abandoned Survey**

Distance (ft): **188.0**  
Structural Grade: **0**  
O&M Grade: **0**  
Clock Start/From:  
Clock To:  
1st Value:  
2nd Value:  
Value Percent:  
Continuous Index:  
Within 8" of Joint: **NO**  
Remarks: **Traction. M-806-048 DNE**
