Profile/Photo Observation Report

Date:	08/01/2023	Weather:		Coding:	PACP 7.0
Pipe Length (ft):	210.9	Owner:	City of Hobart	Pre Clean:	Heavy Cleaning
P.O.#:	YES502259	Surveyor:	S. Bucklin	PSR:	M-902-011-M-902-015
Customer:	City of Hobart	Clean Date:	07/18/2023	Shape:	C

Street:	East 34th Court	Flow Control:	Not Controlled
City:	Hobart, IN	Year Renewed:	
Location:	Easement/Right of Way	Tape/Media #:	
Purpose:	Routine Assessment	Dia/Height:	8"
Use:	Sanitary Sewage Pipe	Material:	VCP
Drain Area:		Lining:	None
Category:	NA

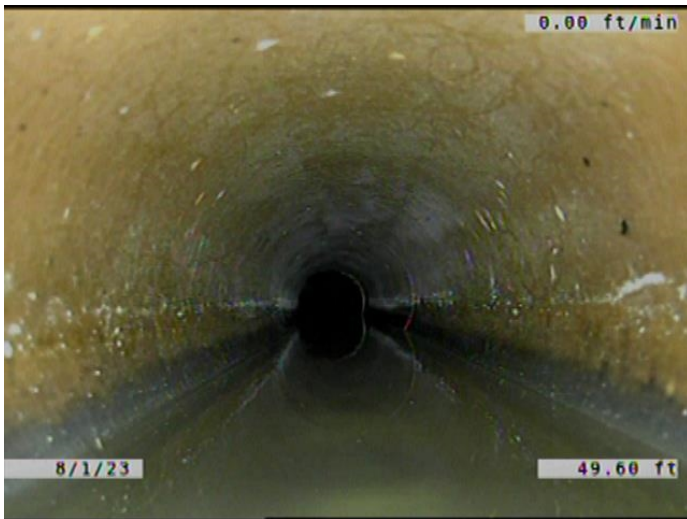
Code: **MWLS**
Description: **Miscellaneous Water Level Sag**

Distance (ft): **49.6**
Structural Grade: **3**
O&M Grade: **0**
Clock Start/From:
Clock To:
1st Value:
2nd Value:
Value Percent: **35.000**
Continuous Index: **F03**
Within 8" of Joint: **NO**
Remarks:

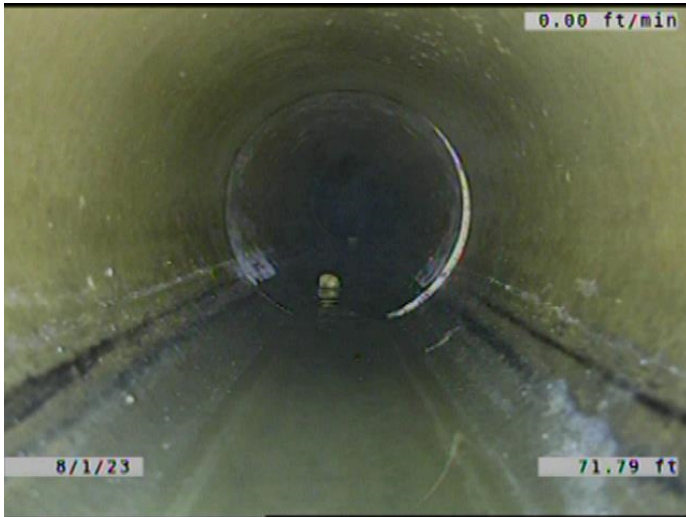
Code: **MWL**
Description: **Miscellaneous Water Level**

Distance (ft): **71.8**
Structural Grade: **0**
O&M Grade: **0**
Clock Start/From:
Clock To:
1st Value:
2nd Value:
Value Percent: **5.000**
Continuous Index:
Within 8" of Joint: **NO**
Remarks:

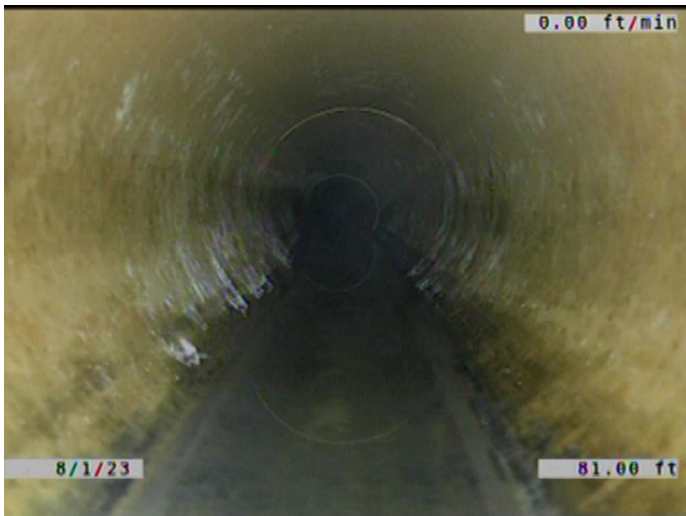
Code: **MWLS**
Description: **Miscellaneous Water Level Sag**

Distance (ft): **81.0**
Structural Grade: **2**
O&M Grade: **0**
Clock Start/From:
Clock To:
1st Value:
2nd Value:
Value Percent: **10.000**
Continuous Index: **S04**
Within 8" of Joint: **NO**
Remarks:

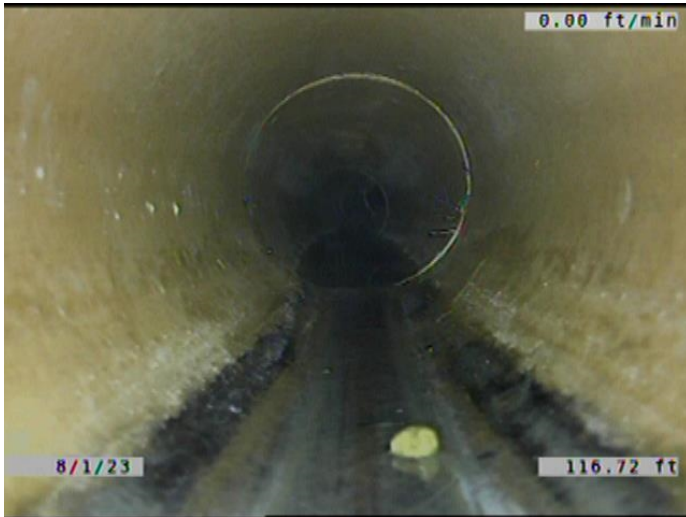
Code: **MWLS**
Description: **Miscellaneous Water Level Sag**

Distance (ft): **116.7**
Structural Grade: **2**
O&M Grade: **0**
Clock Start/From:
Clock To:
1st Value:
2nd Value:
Value Percent: **10.000**
Continuous Index: **F04**
Within 8" of Joint: **NO**
Remarks:

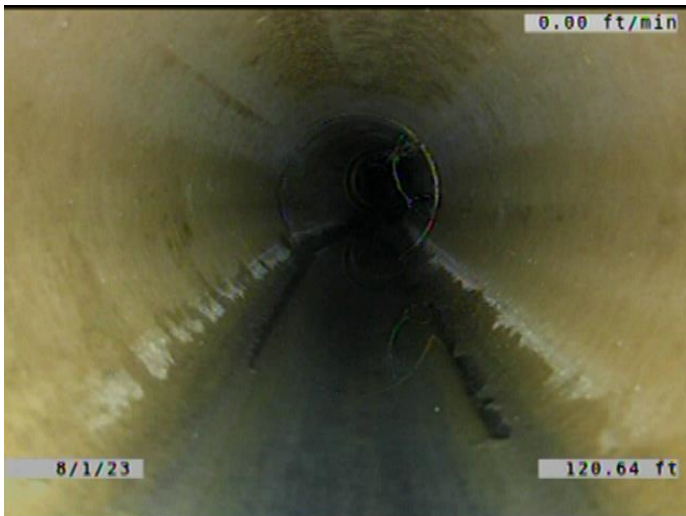
Code: **MWLS**
Description: **Miscellaneous Water Level Sag**

Distance (ft): **120.6**
Structural Grade: **2**
O&M Grade: **0**
Clock Start/From:
Clock To:
1st Value:
2nd Value:
Value Percent: **5.000**
Continuous Index: **S05**
Within 8" of Joint: **NO**
Remarks:

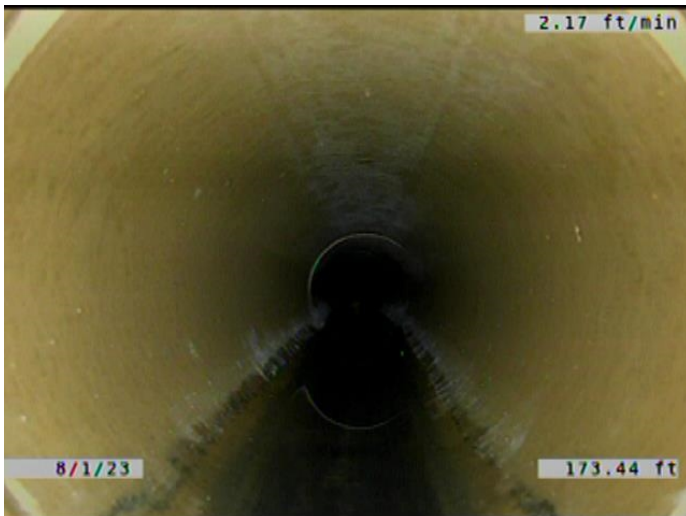
Code: **MWLS**
Description: **Miscellaneous Water Level Sag**

Distance (ft): **173.4**
Structural Grade: **2**
O&M Grade: **0**
Clock Start/From:
Clock To:
1st Value:
2nd Value:
Value Percent: **5.000**
Continuous Index: **S08**
Within 8" of Joint: **NO**
Remarks:

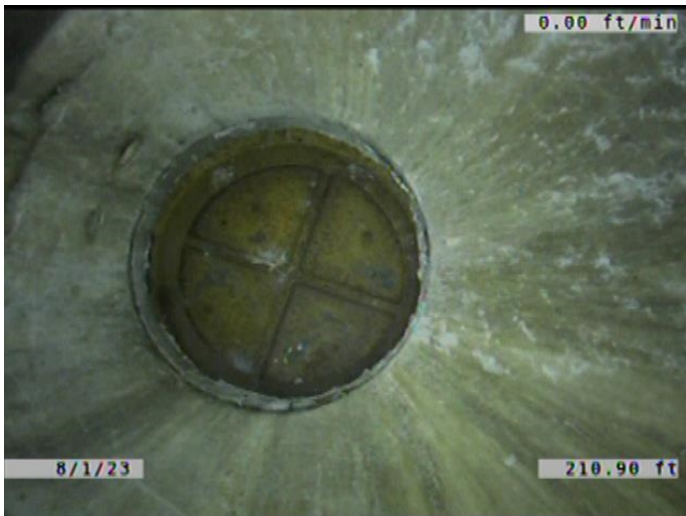
Code: **AMH**
 Description: **Manhole**

Distance (ft): **210.9**
 Structural Grade: **0**
 O&M Grade: **0**
 Clock Start/From:
 Clock To:
 1st Value:
 2nd Value:
 Value Percent:
 Continuous Index:
 Within 8" of Joint: **NO**
 Remarks: **M-902-011**
