## Profile/Photo Observation Report

Date:	<b>03/08/2024</b>	Weather:		Coding:	<b>PACP 7.0</b>
Pipe Length (ft):	<b>99.0</b>	Owner:	<b>City of Hobart</b>	Pre Clean:	<b>Light Cleaning</b>
P.O.#:		Surveyor:	<b>S. Bucklin</b>	PSR:	<b>P-704-071-072</b>
Customer:	<b>City of Hobart</b>	Clean Date:	<b>03/08/2024</b>	Shape:	<b>C</b>

Street:	<b>LAKEWOOD DR</b>	Flow Control:	<b>Not Controlled</b>
City:	<b>Hobart, IN</b>	Year Renewed:	
Location:	<b>Easement/Right of Way</b>	Tape/Media #:	
Purpose:	<b>Sewer System Evaluation Survey (SS</b>	Dia/Height:	<b>8"</b>
Use:	<b>Sanitary Sewage Pipe</b>	Material:	<b>PVC</b>
Drain Area:		Lining:	<b>None</b>
Category:	<b>NA</b>		
Comment:			
Location Details:		Direction of Survey:	<b>Upstream</b>
US MH:	<b>M-704-071</b>	DS MH:	<b>M-704-072</b>
		Total Length Surveyed (ft):	<b>67.1</b>

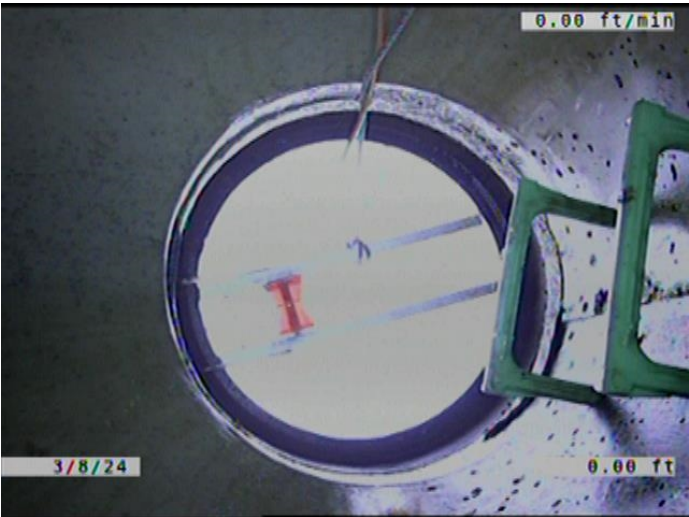
AMH

Manhole

M-704-072

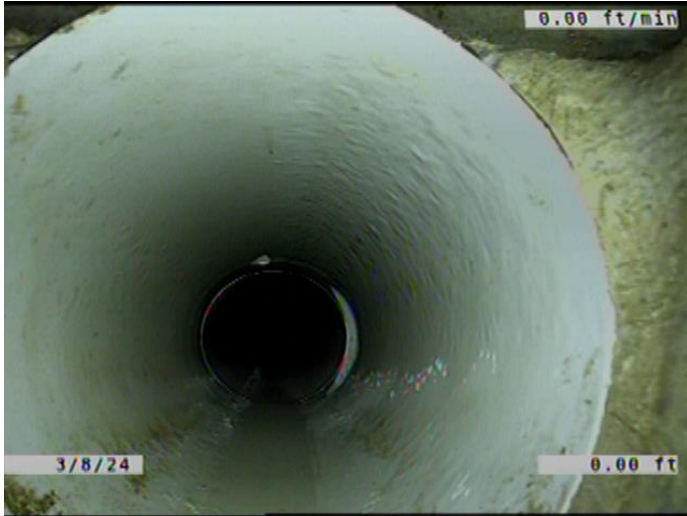
Code:	<b>MWL</b>
Description:	<b>Miscellaneous Water Level</b>
Distance (ft):	<b>.0</b>
Structural Grade:	<b>0</b>
O&M Grade:	<b>0</b>
Clock Start/From:	
Clock To:	
1st Value:	
2nd Value:	
Value Percent:	<b>5.000</b>
Continuous Index:	
Within 8" of Joint:	<b>NO</b>
Remarks:

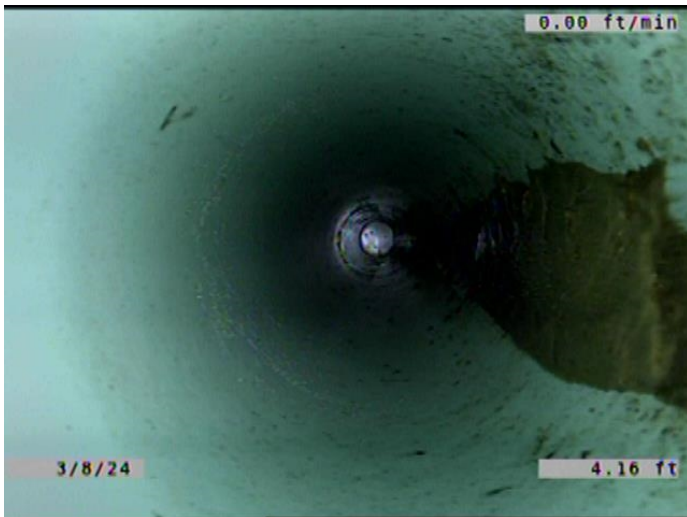
Code:	<b>TFC</b>
Description:	<b>Tap Factory Capped</b>
Distance (ft):	<b>4.2</b>
Structural Grade:	<b>0</b>
O&M Grade:	<b>0</b>
Clock Start/From:	<b>3</b>
Clock To:	
1st Value:	<b>6.000</b>
2nd Value:	
Value Percent:	
Continuous Index:	
Within 8" of Joint:	<b>YES</b>
Remarks:

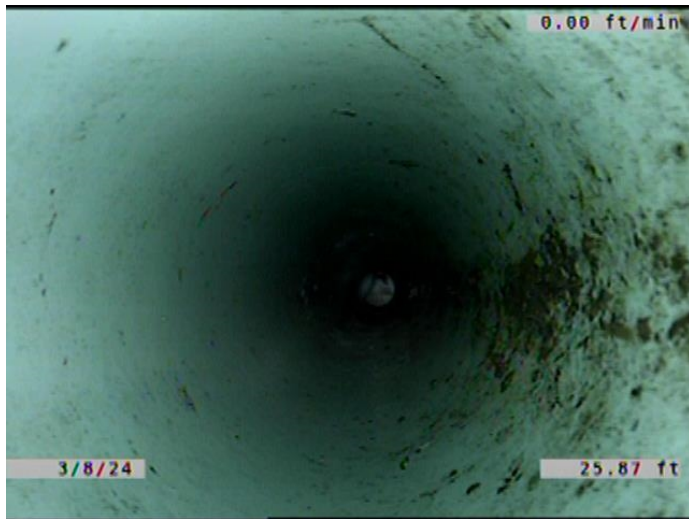
Code:	<b>TFC</b>
Description:	<b>Tap Factory Capped</b>
Distance (ft):	<b>25.9</b>
Structural Grade:	<b>0</b>
O&M Grade:	<b>0</b>
Clock Start/From:	<b>3</b>
Clock To:	
1st Value:	<b>6.000</b>
2nd Value:	
Value Percent:	
Continuous Index:	
Within 8" of Joint:	<b>YES</b>
Remarks:	<b>SERVICE IS OUT OF ROUND.</b>

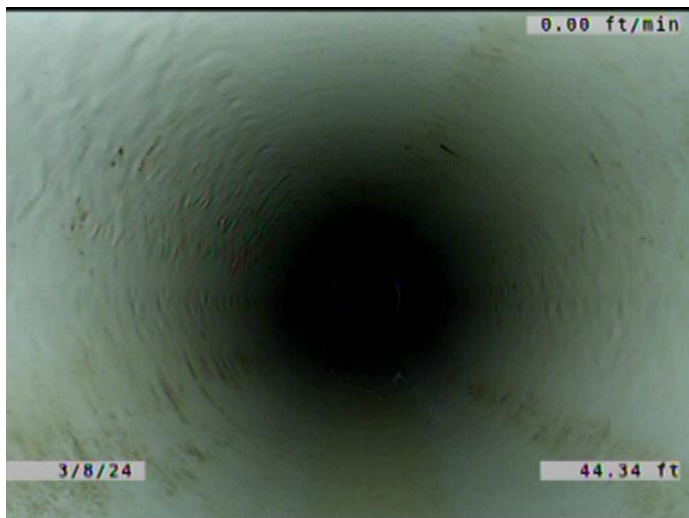
Code:	<b>MWLS</b>
Description:	<b>Miscellaneous Water Level Sag</b>
Distance (ft):	<b>44.3</b>
Structural Grade:	<b>2</b>
O&M Grade:	<b>0</b>
Clock Start/From:	
Clock To:	
1st Value:	
2nd Value:	
Value Percent:	<b>5.000</b>
Continuous Index:	<b>S01</b>
Within 8" of Joint:	<b>NO</b>
Remarks:

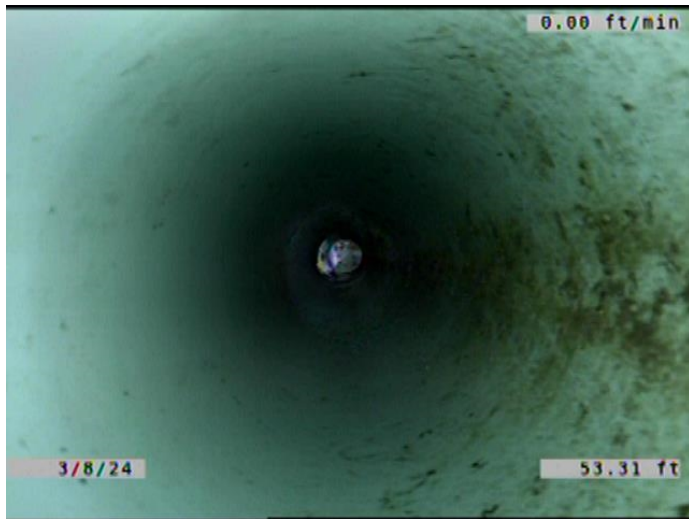
Code: **TFC**  
Description: **Tap Factory Capped**

Distance (ft): **53.3**  
Structural Grade: **0**  
O&M Grade: **0**  
Clock Start/From: **3**  
Clock To:  
1st Value: **6.000**  
2nd Value:  
Value Percent:  
Continuous Index:  
Within 8" of Joint: **YES**  
Remarks:

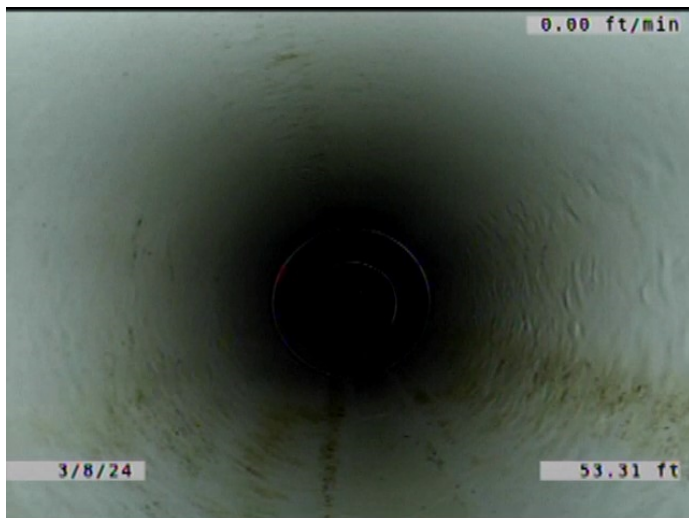
Code: **MWLS**  
Description: **Miscellaneous Water Level Sag**

Distance (ft): **53.3**  
Structural Grade: **2**  
O&M Grade: **0**  
Clock Start/From:  
Clock To:  
1st Value:  
2nd Value:  
Value Percent: **5.000**  
Continuous Index: **F01**  
Within 8" of Joint: **NO**  
Remarks:

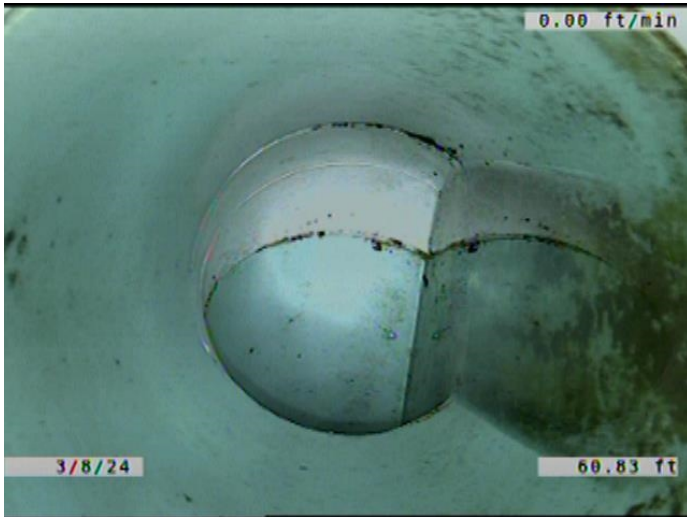
Code: **TF**  
 Description: **Tap Factory**

Distance (ft): **60.8**  
 Structural Grade: **0**  
 O&M Grade: **0**  
 Clock Start/From: **3**  
 Clock To:  
 1st Value: **6.000**  
 2nd Value:  
 Value Percent:  
 Continuous Index:  
 Within 8" of Joint: **YES**  
 Remarks:

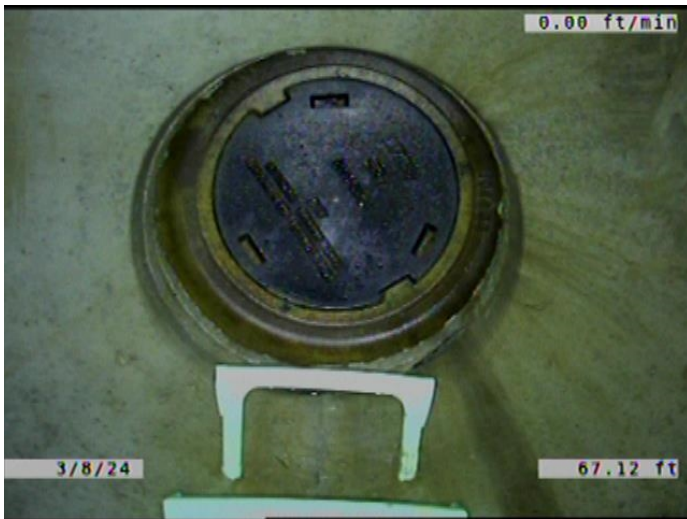
Code: **AMH**  
 Description: **Manhole**

Distance (ft): **67.1**  
 Structural Grade: **0**  
 O&M Grade: **0**  
 Clock Start/From:  
 Clock To:  
 1st Value:  
 2nd Value:  
 Value Percent:  
 Continuous Index:  
 Within 8" of Joint: **NO**  
 Remarks: **M-704-071**
