## Profile/Photo Observation Report

Date:	<b>03/11/2024</b>	Weather:		Coding:	<b>PACP 7.0</b>
Pipe Length (ft):	<b>99.0</b>	Owner:	<b>City of Hobart</b>	Pre Clean:	<b>Heavy Cleaning</b>
P.O.#:		Surveyor:	<b>S. Bucklin</b>	PSR:	<b>P-705-075.1-075</b>
Customer:	<b>City of Hobart</b>	Clean Date:	<b>03/09/2024</b>	Shape:	<b>C</b>

Street:	<b>HARBOR CLUB DR</b>	Flow Control:	<b>Not Controlled</b>
City:	<b>Hobart, IN</b>	Year Renewed:	
Location:	<b>Easement/Right of Way</b>	Tape/Media #:	
Purpose:	<b>Sewer System Evaluation Survey (SS</b>	Dia/Height:	<b>8"</b>
Use:	<b>Sanitary Sewage Pipe</b>	Material:	<b>PVC</b>
Drain Area:		Lining:	<b>None</b>
Category:	<b>NA</b>		
Comment:			
Location Details:		Direction of Survey:	<b>Downstream</b>
US MH:	<b>M-704-075.1</b>	DS MH:	<b>M-705-075</b>
		Total Length Surveyed (ft):	<b>99.1</b>

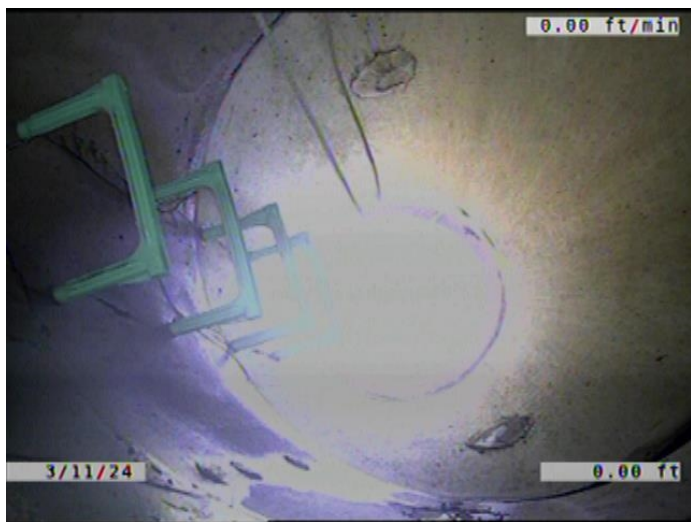
Code: **AMH**  
Description: **Manhole**

Distance (ft): **.0**  
Structural Grade: **0**  
O&M Grade: **0**  
Clock Start/From:  
Clock To:  
1st Value:  
2nd Value:  
Value Percent:  
Continuous Index:  
Within 8" of Joint: **NO**  
Remarks: **M-704-075.1**

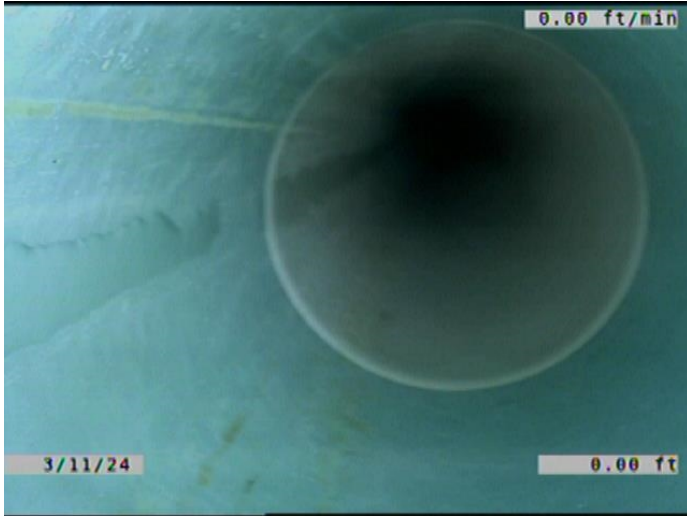
Code:	<b>MWL</b>
Description:	<b>Miscellaneous Water Level</b>
Distance (ft):	<b>.0</b>
Structural Grade:	<b>0</b>
O&M Grade:	<b>0</b>
Clock Start/From:	
Clock To:	
1st Value:	
2nd Value:	
Value Percent:	<b>5.000</b>
Continuous Index:	
Within 8" of Joint:	<b>NO</b>
Remarks:

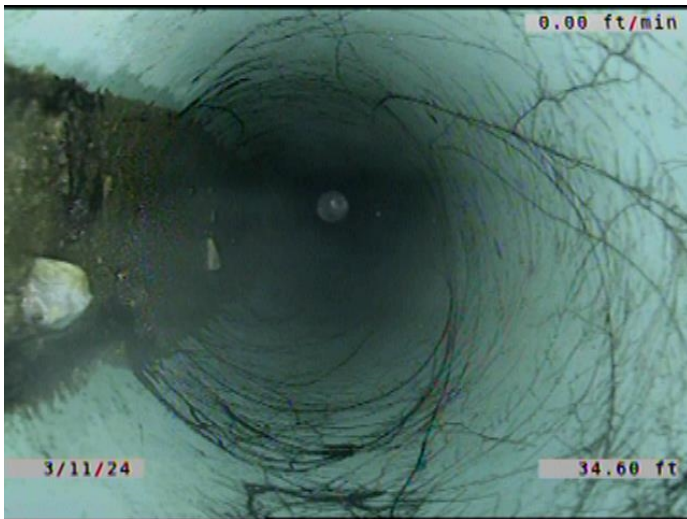
Code:	<b>TFC</b>
Description:	<b>Tap Factory Capped</b>
Distance (ft):	<b>34.6</b>
Structural Grade:	<b>0</b>
O&M Grade:	<b>0</b>
Clock Start/From:	<b>9</b>
Clock To:	
1st Value:	<b>6.000</b>
2nd Value:	
Value Percent:	
Continuous Index:	
Within 8" of Joint:	<b>YES</b>
Remarks:

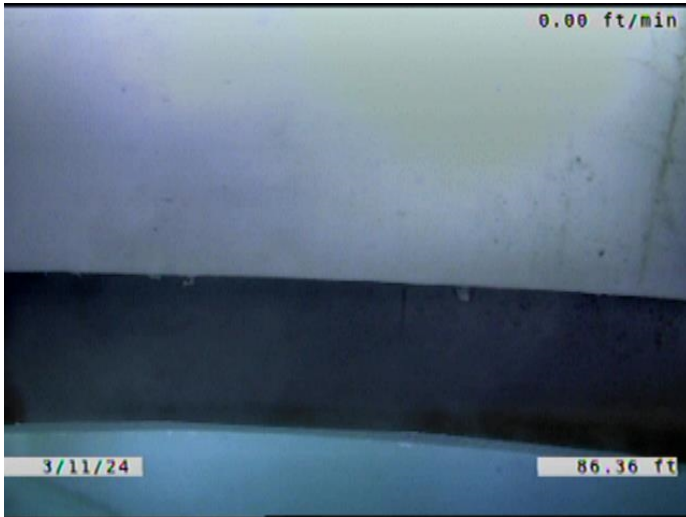
Code: **MGO**  
Description: **Miscellaneous General Observation**

Distance (ft): **86.4**  
Structural Grade: **0**  
O&M Grade: **0**  
Clock Start/From:  
Clock To:  
1st Value:  
2nd Value:  
Value Percent:  
Continuous Index:  
Within 8" of Joint: **NO**  
Remarks: **WHERE BOWEN CONNECTED TO THE EXISTING SEWER IN 2018.**

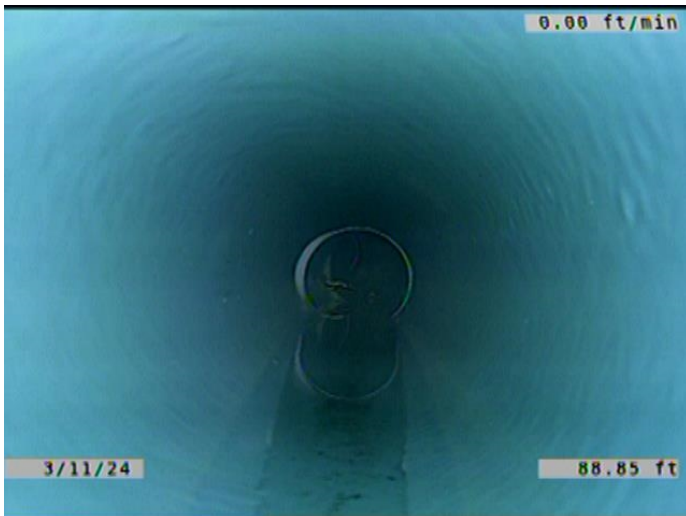
Code: **MWLS**  
Description: **Miscellaneous Water Level Sag**

Distance (ft): **88.9**  
Structural Grade: **2**  
O&M Grade: **0**  
Clock Start/From:  
Clock To:  
1st Value:  
2nd Value:  
Value Percent: **10.000**  
Continuous Index: **S01**  
Within 8" of Joint: **NO**  
Remarks:

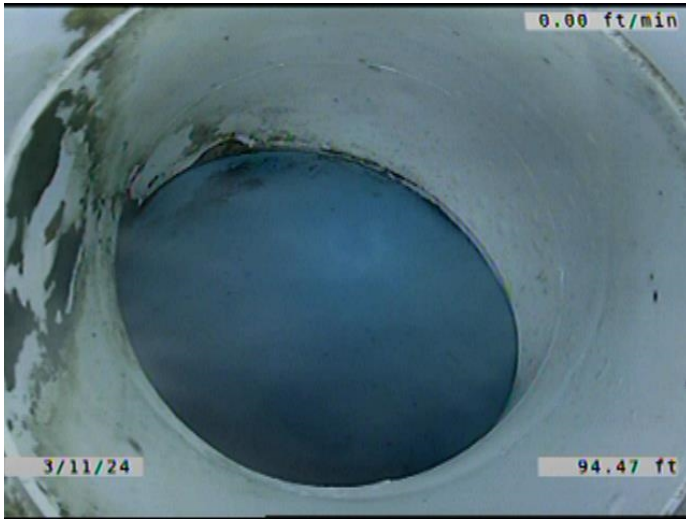
Code: **TF**  
Description: **Tap Factory**

Distance (ft): **94.5**  
Structural Grade: **0**  
O&M Grade: **0**  
Clock Start/From: **9**  
Clock To:  
1st Value: **6.000**  
2nd Value:  
Value Percent:  
Continuous Index:  
Within 8" of Joint: **YES**  
Remarks:

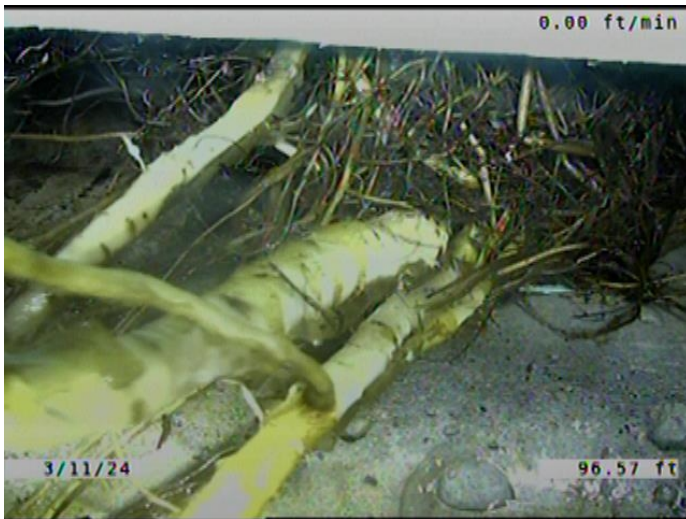
Code: **RTJ**  
Description: **Roots Tap Joint**

Distance (ft): **96.6**  
Structural Grade: **0**  
O&M Grade: **2**  
Clock Start/From: **7**  
Clock To: **9**  
1st Value:  
2nd Value:  
Value Percent: **5.000**  
Continuous Index:  
Within 8" of Joint: **YES**  
Remarks:

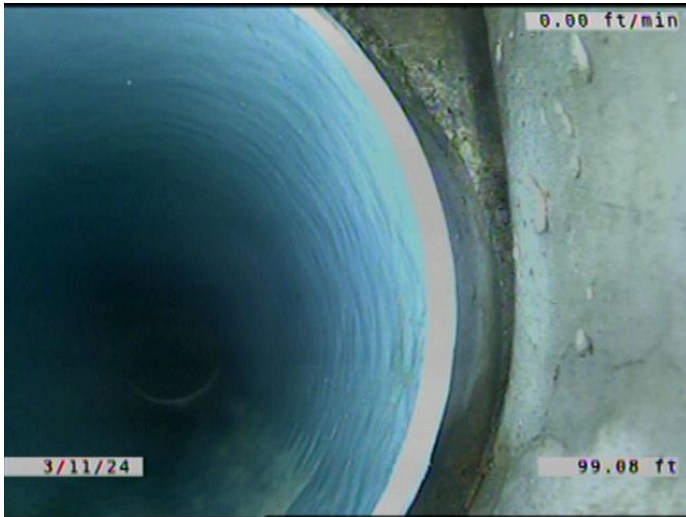
Code: **MWLS**  
 Description: **Miscellaneous Water Level Sag**

Distance (ft): **99.1**  
 Structural Grade: **2**  
 O&M Grade: **0**  
 Clock Start/From:  
 Clock To:  
 1st Value:  
 2nd Value:  
 Value Percent: **10.000**  
 Continuous Index: **F01**  
 Within 8" of Joint: **NO**  
 Remarks:

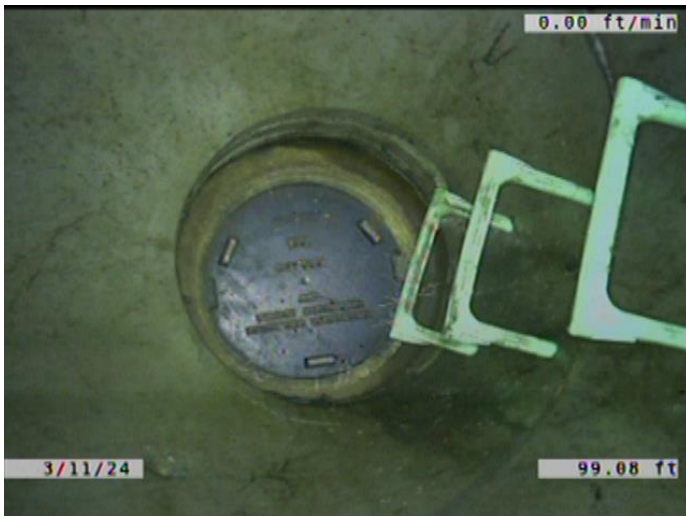
Code: **AMH**  
 Description: **Manhole**

Distance (ft): **99.1**  
 Structural Grade: **0**  
 O&M Grade: **0**  
 Clock Start/From:  
 Clock To:  
 1st Value:  
 2nd Value:  
 Value Percent:  
 Continuous Index:  
 Within 8" of Joint: **NO**  
 Remarks: **M-705-075**
