Profile/Photo Observation Report

Date:	03/09/2024	Weather:		Coding:	PACP 7.0
Pipe Length (ft):	68.0	Owner:	City of Hobart	Pre Clean:	Light Cleaning
P.O.#:		Surveyor:	S. Bucklin	PSR:	P-705-075.2-075.1
Customer:	City of Hobart	Clean Date:	03/08/2024	Shape:	C

Street:	HARBOR CLUB DR	Flow Control:	Not Controlled
City:	Hobart, IN	Year Renewed:	
Location:	Easement/Right of Way	Tape/Media #:	
Purpose:	Sewer System Evaluation Survey (SS)	Dia/Height:	8"
Use:	Sanitary Sewage Pipe	Material:	PVC
Drain Area:		Lining:	None
Category:	NA		
Comment:			
Location Details:		Direction of Survey:	Upstream
US MH:	M-705-075.2	DS MH:	M-704-075.1
		Total Length Surveyed (ft):	70.6

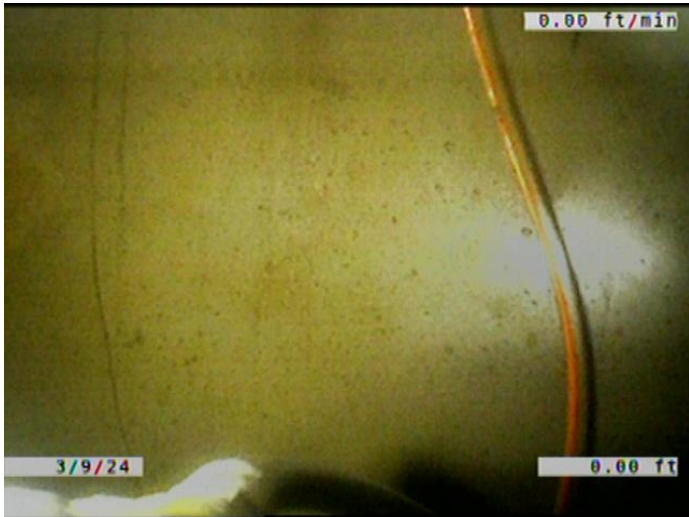
Code: **AMH**
 Description: **Manhole**
 Distance (ft): **.0**
 Structural Grade: **0**
 O&M Grade: **0**
 Clock Start/From:
 Clock To:
 1st Value:
 2nd Value:
 Value Percent:
 Continuous Index:
 Within 8" of Joint: **NO**
 Remarks: **M-704-075.1**

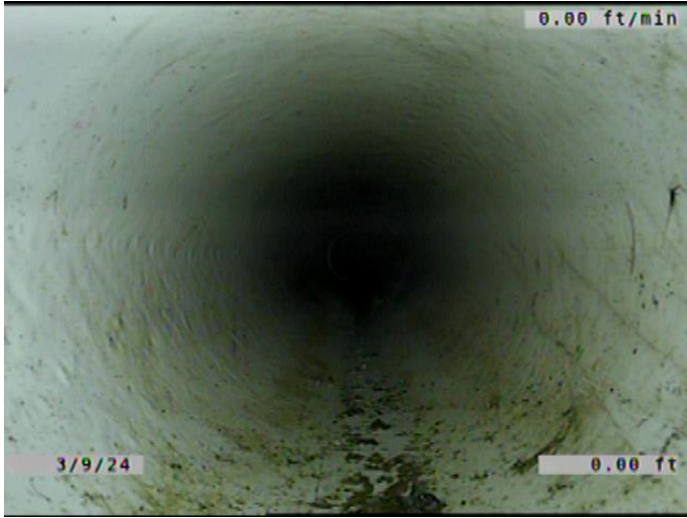
Code: **MWL**
Description: **Miscellaneous Water Level**

Distance (ft): **.0**
Structural Grade: **0**
O&M Grade: **0**
Clock Start/From:
Clock To:
1st Value:
2nd Value:
Value Percent: **5.000**
Continuous Index:
Within 8" of Joint: **NO**
Remarks:

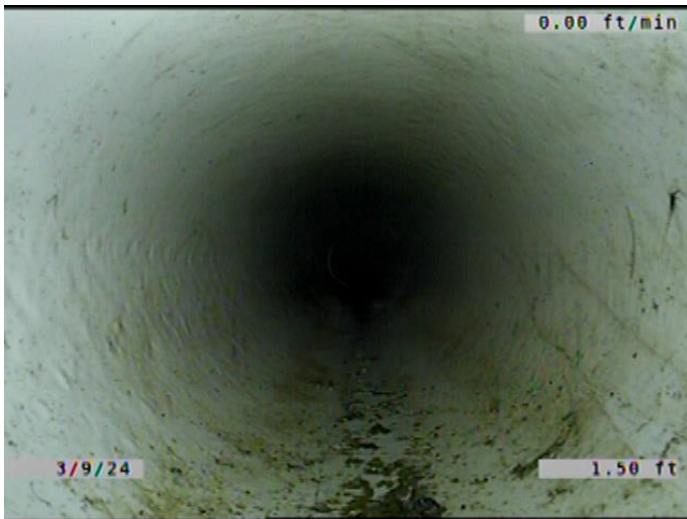
Code: **MGO**
Description: **Miscellaneous General Observation**

Distance (ft): **1.5**
Structural Grade: **0**
O&M Grade: **0**
Clock Start/From:
Clock To:
1st Value:
2nd Value:
Value Percent:
Continuous Index:
Within 8" of Joint: **NO**
Remarks: **DROP INTO THE MANHOLE. HAD TO START IN THE PIPE.**

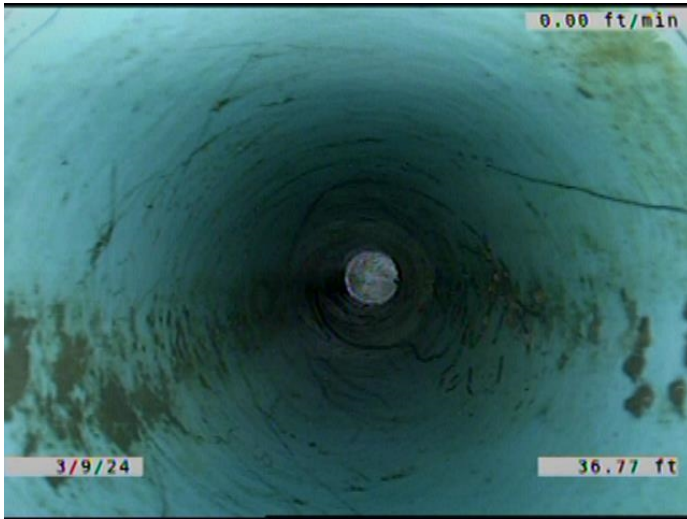
Code: **TFC**
Description: **Tap Factory Capped**

Distance (ft): **36.8**
Structural Grade: **0**
O&M Grade: **0**
Clock Start/From: **3**
Clock To:
1st Value: **6.000**
2nd Value:
Value Percent:
Continuous Index:
Within 8" of Joint: **YES**
Remarks:

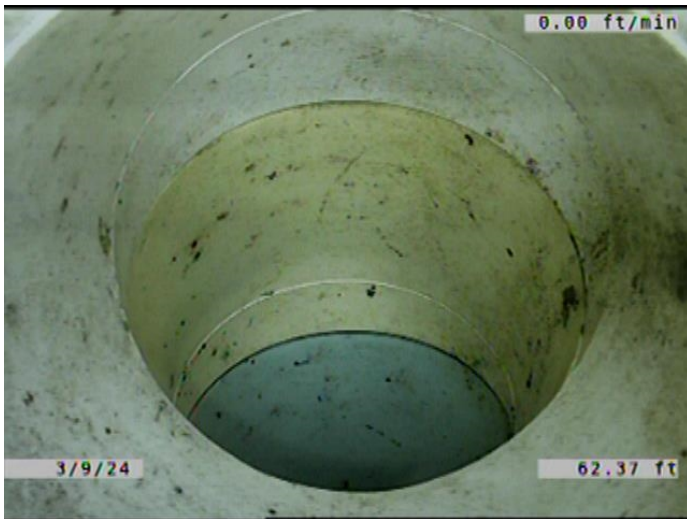
Code: **TF**
Description: **Tap Factory**

Distance (ft): **62.4**
Structural Grade: **0**
O&M Grade: **0**
Clock Start/From: **3**
Clock To:
1st Value: **6.000**
2nd Value:
Value Percent:
Continuous Index:
Within 8" of Joint: **YES**
Remarks:

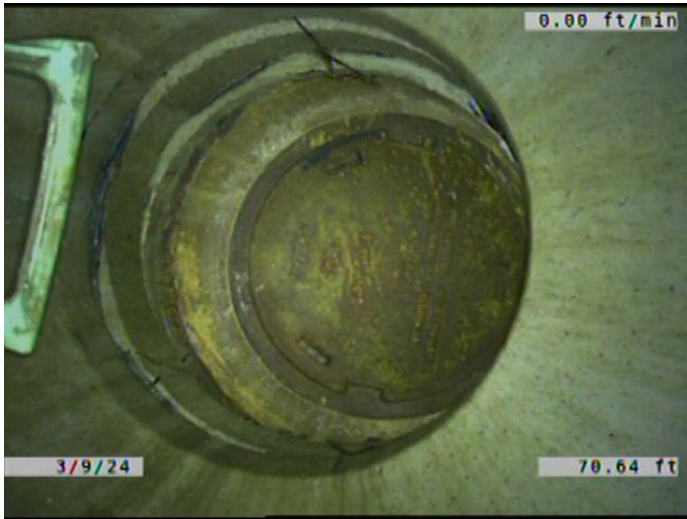
Code: **AMH**
Description: **Manhole**

Distance (ft): **70.6**

Remarks: **M-705-075.2**
