## Profile/Photo Observation Report

Street:	<b>e 34th ct</b>	Flow Control:	<b>Not Controlled</b>
City:	<b>Hobart, IN</b>	Year Renewed:	
Location:	<b>Other</b>	Tape/Media #:	
Purpose:	<b>Not Known</b>	Dia/Height:	<b>10"</b>
Use:	<b>Sanitary</b>	Material:	<b>VCP</b>
Drain Area:	<b>NA</b>	Lining:	
Category:	<b>NA</b>		
Comment:

Location Details:		Direction of Survey:	<b>Upstream</b>
US MH:	<b>M-902-015</b>	DS MH:	<b>M-902-014</b>
		Total Length Surveyed (ft):	<b>9.3</b>

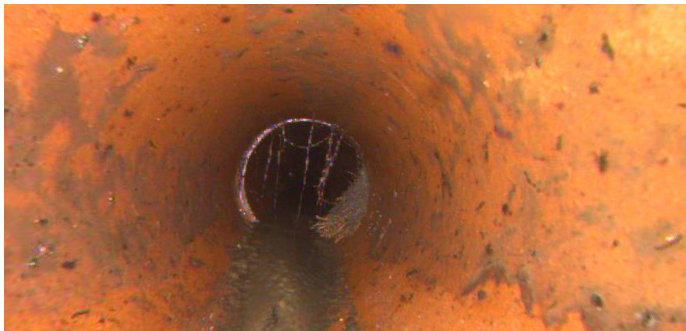
Code: **AMH**  
Description: **Manhole**

Distance (ft): **.0**  
Structural Grade: **0**  
O&M Grade: **0**  
Clock Start/From:  
Clock To:  
1st Value:  
2nd Value:  
Value Percent:  
Continuous Index:  
Within 8" of Joint: **NO**  
Remarks: **M-902-014**

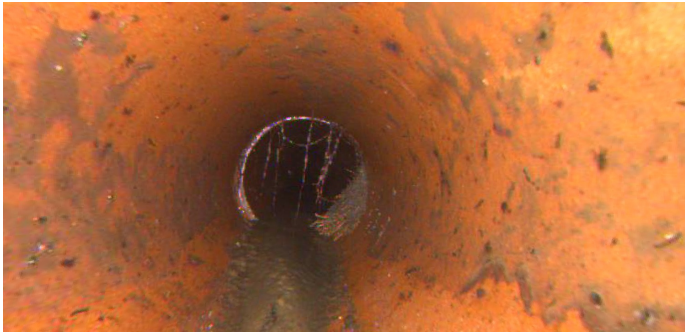
Code:	<b>MWL</b>
Description:	<b>Water Level</b>

Distance (ft):	<b>.0</b>
Structural Grade:	<b>0</b>
O&M Grade:	<b>0</b>
Clock Start/From:	
Clock To:	
1st Value:	
2nd Value:	
Value Percent:	<b>5.000</b>
Continuous Index:	
Within 8" of Joint:	<b>NO</b>
Remarks:

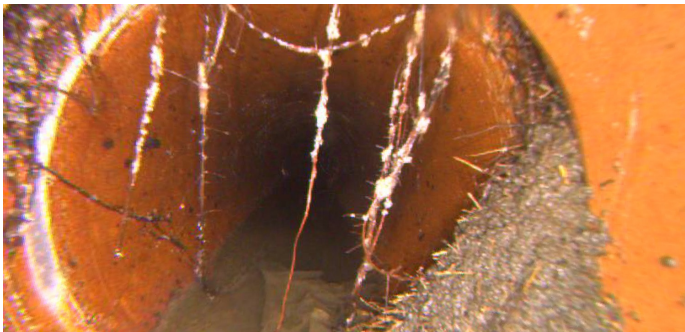
Code:	<b>RMJ</b>
Description:	<b>Roots Medium Joint</b>

Distance (ft):	<b>2.4</b>
Structural Grade:	<b>0</b>
O&M Grade:	<b>3</b>
Clock Start/From:	<b>8</b>
Clock To:	<b>4</b>
1st Value:	
2nd Value:	
Value Percent:	<b>10.000</b>
Continuous Index:	
Within 8" of Joint:	<b>YES</b>
Remarks:

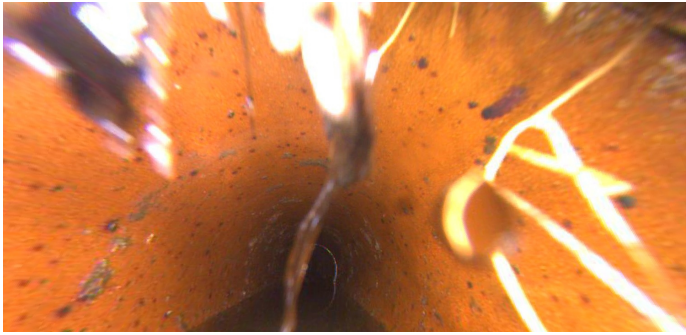
Code: **RFJ**  
Description: **Roots Fine Joint**

Distance (ft): **5.7**  
Structural Grade: **0**  
O&M Grade: **1**  
Clock Start/From: **8**  
Clock To: **4**  
1st Value:  
2nd Value:  
Value Percent:  
Continuous Index:  
Within 8" of Joint: **YES**  
Remarks:

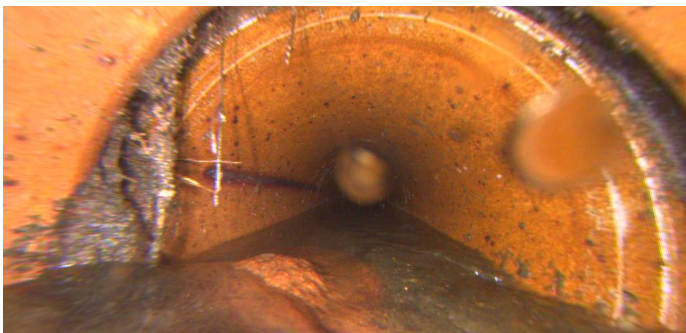
Code: **RMJ**  
Description: **Roots Medium Joint**

Distance (ft): **8.4**  
Structural Grade: **0**  
O&M Grade: **3**  
Clock Start/From: **9**  
Clock To: **11**  
1st Value:  
2nd Value:  
Value Percent: **5.000**  
Continuous Index:  
Within 8" of Joint: **YES**  
Remarks:

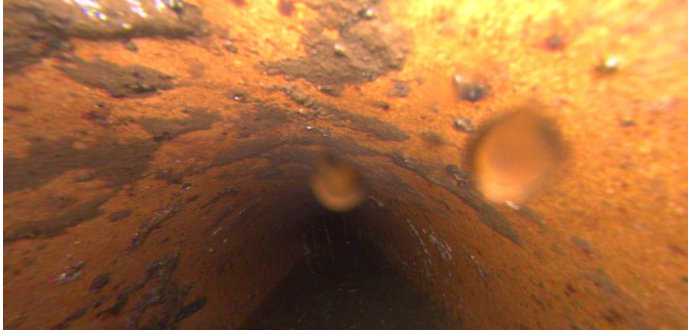
Code:	<b>MSA</b>
Description:	<b>Abandoned Survey</b>
Distance (ft):	<b>9.3</b>
Structural Grade:	<b>0</b>
O&M Grade:	<b>0</b>
Clock Start/From:	
Clock To:	
1st Value:	
2nd Value:	
Value Percent:	
Continuous Index:	
Within 8" of Joint:	<b>NO</b>
Remarks:	<b>OVERTURNED</b>
