Profile/Photo Observation Report

Date:	12/12/2024	Weather:		Coding:	PACP 7.0
Pipe Length (ft):	166.0	Owner:	City of Hobart	Pre Clean:	Heavy Cleaning
P.O.#:	YES502259	Surveyor:	S. Bucklin	PSR:	P-507-051-050
Customer:	City of Hobart	Clean Date:	12/04/2024	Shape:	C

Street:	South Virginia Street	Flow Control:	Not Controlled
City:	Hobart, IN	Year Renewed:	
Location:	Sidewalk	Tape/Media #:	
Purpose:	Sewer System Evaluation Survey (SS	Dia/Height:	8"
Use:	Sanitary Sewage Pipe	Material:	PVC
Drain Area:		Lining:	None
Category:	NA		
Comment:			
Location Details:		Direction of Survey:	Downstream
US MH:	M-507-050	DS MH:	M-507-051
		Total Length Surveyed (ft):	164.9

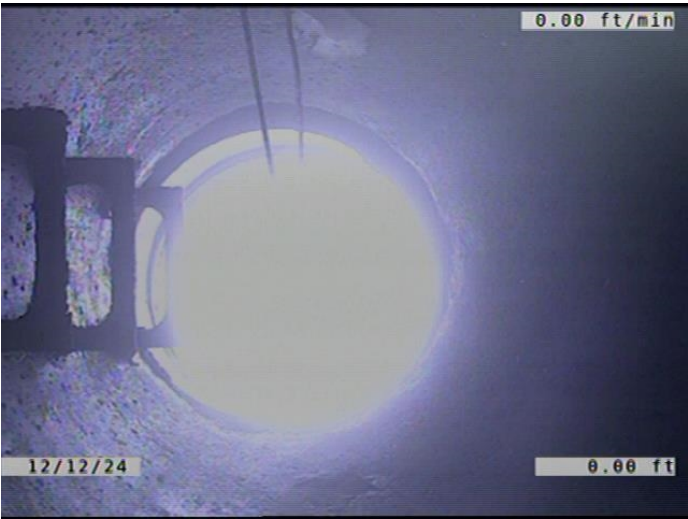
AMH

Manhole

.0

M-507-050

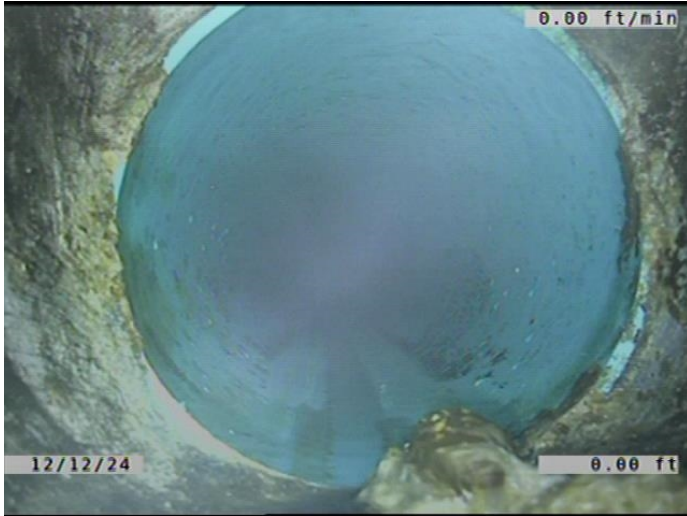
Code: **MWL**
Description: **Miscellaneous Water Level**

Distance (ft): **.0**
Structural Grade: **0**
O&M Grade: **0**
Clock Start/From:
Clock To:
1st Value:
2nd Value:
Value Percent: **5.000**
Continuous Index:
Within 8" of Joint: **NO**
Remarks:

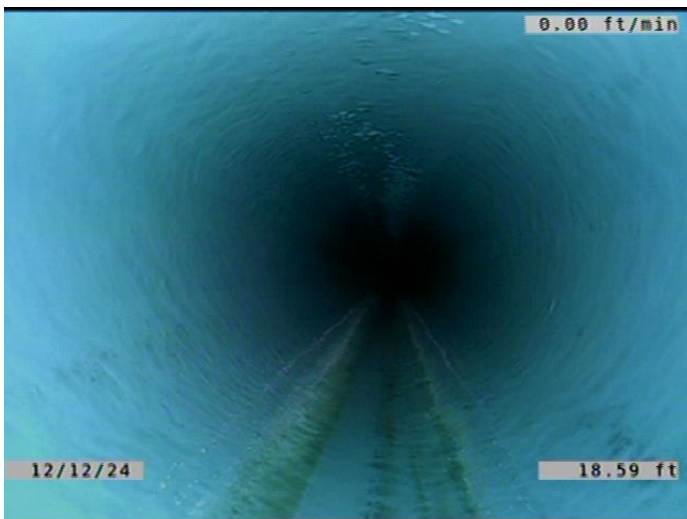
Code: **LR**
Description: **Line Right**

Distance (ft): **18.6**
Structural Grade: **0**
O&M Grade: **1**
Clock Start/From:
Clock To:
1st Value:
2nd Value:
Value Percent: **5.000**
Continuous Index:
Within 8" of Joint: **NO**
Remarks:

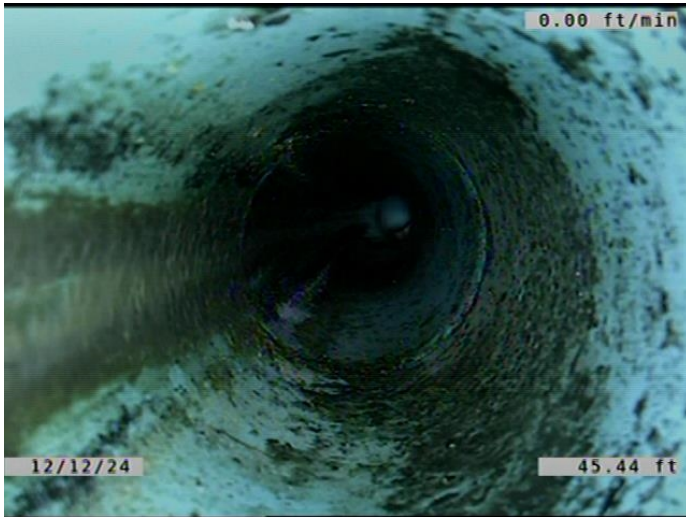
Code: **TF**
Description: **Tap Factory**

Distance (ft): **45.4**
Structural Grade: **0**
O&M Grade: **0**
Clock Start/From: **10**
Clock To:
1st Value: **6.000**
2nd Value:
Value Percent:
Continuous Index:
Within 8" of Joint: **YES**
Remarks: **CONSTANTLY RUNNING WATER.**

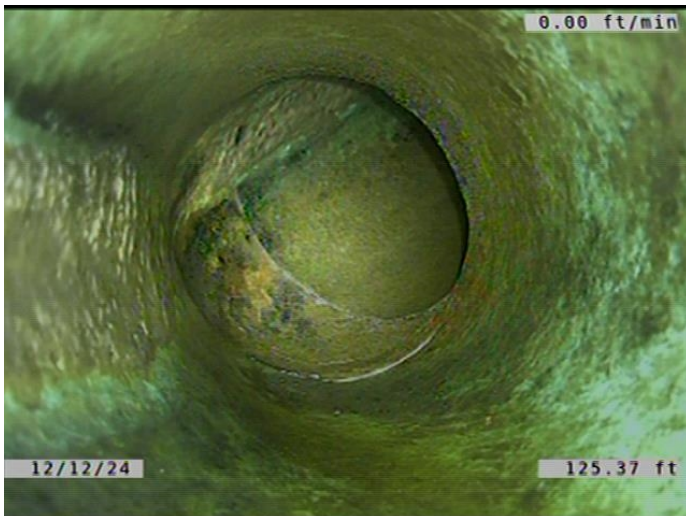
Code: **TF**
Description: **Tap Factory**

Distance (ft): **125.4**
Structural Grade: **0**
O&M Grade: **0**
Clock Start/From: **10**
Clock To:
1st Value: **6.000**
2nd Value:
Value Percent:
Continuous Index:
Within 8" of Joint: **YES**
Remarks:

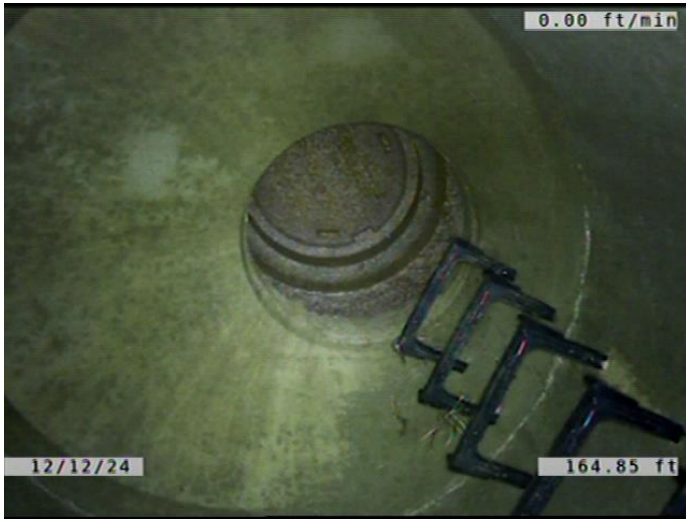
Code:	AMH
Description:	Manhole
Distance (ft):	164.8
Structural Grade:	0
O&M Grade:	0
Clock Start/From:	
Clock To:	
1st Value:	
2nd Value:	
Value Percent:	
Continuous Index:	
Within 8" of Joint:	NO
Remarks:	M-507-051
