## Profile/Photo Observation Report

Date:	<b>12/06/2024</b>	Weather:		Coding:	<b>PACP 7.0</b>
Pipe Length (ft):	<b>175.0</b>	Owner:	<b>City of Hobart</b>	Pre Clean:	<b>Heavy Cleaning</b>
P.O.#:	<b>YES502259</b>	Surveyor:	<b>S. Bucklin</b>	PSR:	<b>P-507-078.1-078</b>
Customer:	<b>City of Hobart</b>	Clean Date:	<b>08/26/2024</b>	Shape:	<b>C</b>

Street:	<b>West 10th Street</b>	Flow Control:	<b>Not Controlled</b>
City:	<b>Hobart, IN</b>	Year Renewed:	
Location:	<b>Easement/Right of Way</b>	Tape/Media #:	
Purpose:	<b>Sewer System Evaluation Survey (SS</b>	Dia/Height:	<b>10"</b>
Use:	<b>Sanitary Sewage Pipe</b>	Material:	<b>PVC</b>
Drain Area:		Lining:	<b>None</b>
Category:	<b>NA</b>		
Comment:			
Location Details:		Direction of Survey:	<b>Upstream</b>
US MH:	<b>M-507-078.1</b>	DS MH:	<b>M-507-078</b>
		Total Length Surveyed (ft):	<b>178.0</b>

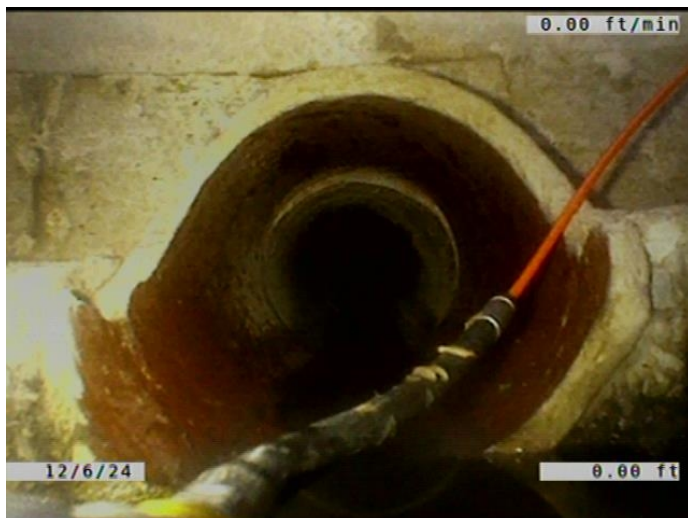
Code: **AMH**  
Description: **Manhole**

Distance (ft): **.0**  
Structural Grade: **0**  
O&M Grade: **0**  
Clock Start/From:  
Clock To:  
1st Value:  
2nd Value:  
Value Percent:  
Continuous Index:  
Within 8" of Joint: **NO**  
Remarks: **M-507-078**

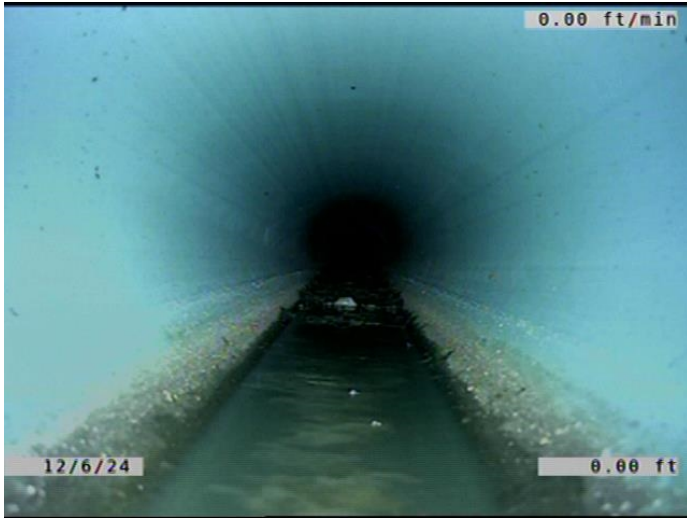
Code:	<b>MWL</b>
Description:	<b>Miscellaneous Water Level</b>
Distance (ft):	<b>.0</b>
Structural Grade:	<b>0</b>
O&M Grade:	<b>0</b>
Clock Start/From:	
Clock To:	
1st Value:	
2nd Value:	
Value Percent:	<b>5.000</b>
Continuous Index:	
Within 8" of Joint:	<b>NO</b>
Remarks:

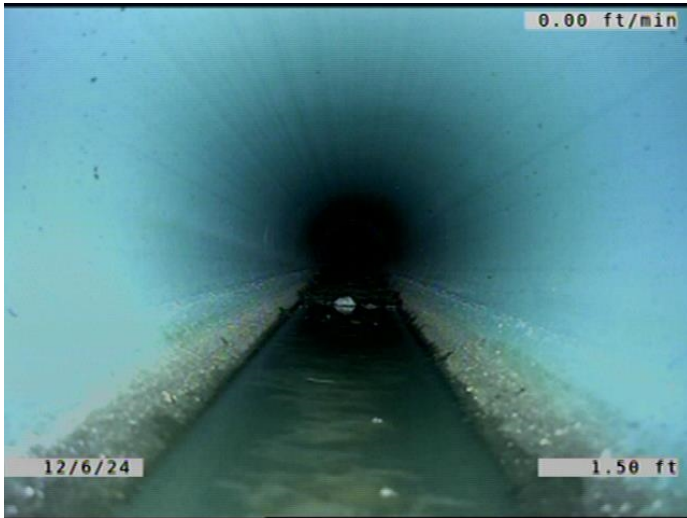
Code:	<b>MGO</b>
Description:	<b>Miscellaneous General Observation</b>
Distance (ft):	<b>1.5</b>
Structural Grade:	<b>0</b>
O&M Grade:	<b>0</b>
Clock Start/From:	
Clock To:	
1st Value:	
2nd Value:	
Value Percent:	
Continuous Index:	
Within 8" of Joint:	<b>NO</b>
Remarks:	<b>MANHOLE DOESNT HAVE A CHANNEL. HAD TO START IN THE PIP</b>

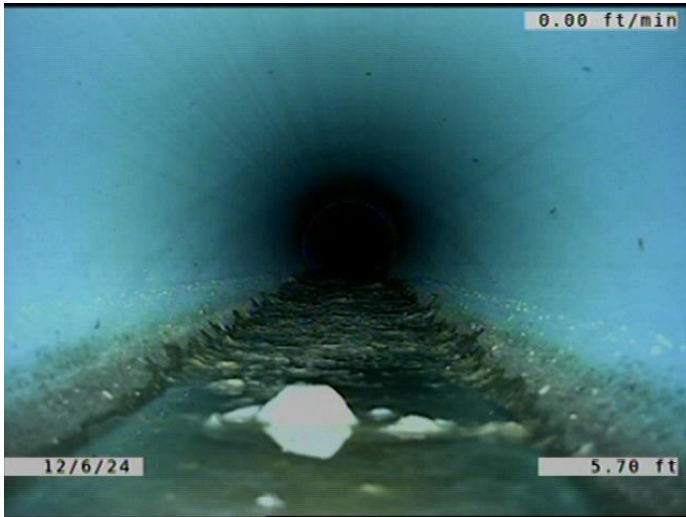
Code: **DSZ**  
Description: **Deposits Settled Other**

Distance (ft): **5.7**  
Structural Grade: **0**  
O&M Grade: **2**  
Clock Start/From: **5**  
Clock To: **7**  
1st Value:  
2nd Value:  
Value Percent: **5.000**  
Continuous Index: **S01**  
Within 8" of Joint: **YES**  
Remarks: **TP AND SOLIDS**

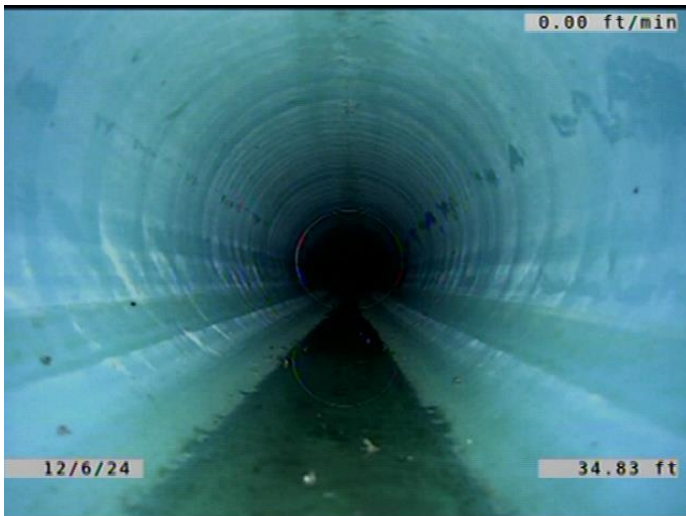
Code: **DSZ**  
Description: **Deposits Settled Other**

Distance (ft): **34.8**  
Structural Grade: **0**  
O&M Grade: **2**  
Clock Start/From: **5**  
Clock To: **7**  
1st Value:  
2nd Value:  
Value Percent: **5.000**  
Continuous Index: **F01**  
Within 8" of Joint: **YES**  
Remarks: **TP AND SOLIDS**

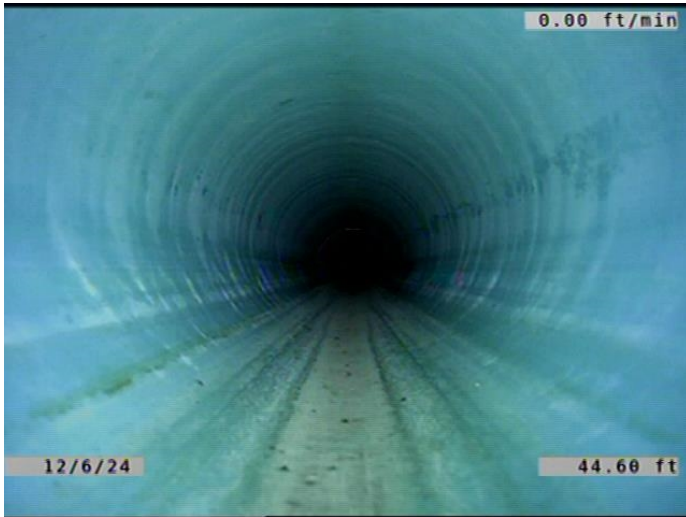
Code: **MWL**  
Description: **Miscellaneous Water Level**

Distance (ft): **44.6**  
Structural Grade: **0**  
O&M Grade: **0**  
Clock Start/From:  
Clock To:  
1st Value:  
2nd Value:  
Value Percent: **0.000**  
Continuous Index:  
Within 8" of Joint: **NO**  
Remarks:

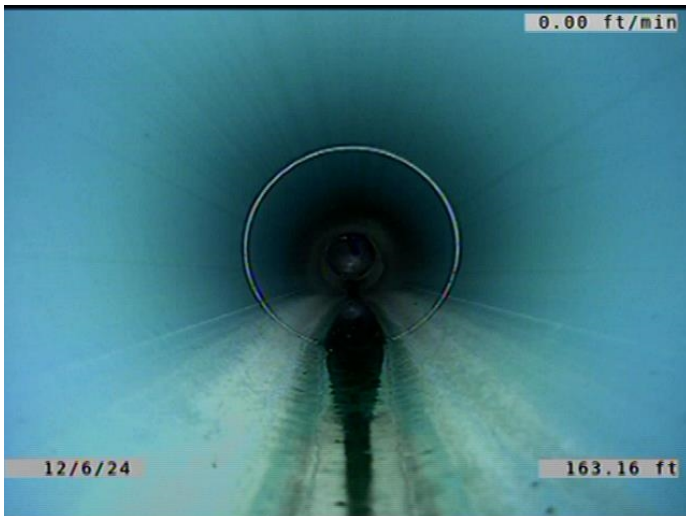
Code: **MWLS**  
Description: **Miscellaneous Water Level Sag**

Distance (ft): **163.2**  
Structural Grade: **2**  
O&M Grade: **0**  
Clock Start/From:  
Clock To:  
1st Value:  
2nd Value:  
Value Percent: **5.000**  
Continuous Index: **S02**  
Within 8" of Joint: **NO**  
Remarks:

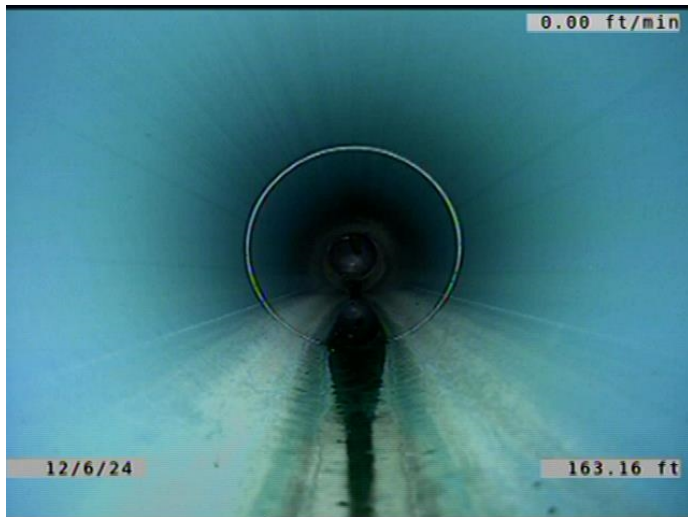
Code: **MWL**  
Description: **Miscellaneous Water Level**

Distance (ft): **163.2**  
Structural Grade: **0**  
O&M Grade: **0**  
Clock Start/From:  
Clock To:  
1st Value:  
2nd Value:  
Value Percent: **5.000**  
Continuous Index:  
Within 8" of Joint: **NO**  
Remarks:

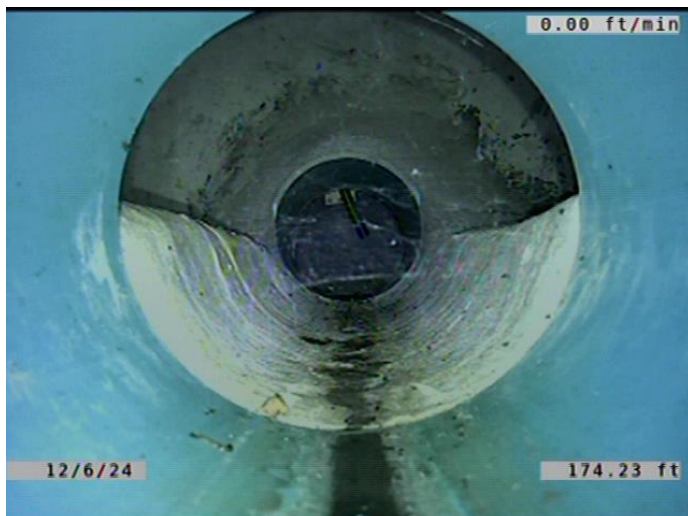
Code: **MWLS**  
Description: **Miscellaneous Water Level Sag**

Distance (ft): **174.2**  
Structural Grade: **2**  
O&M Grade: **0**  
Clock Start/From:  
Clock To:  
1st Value:  
2nd Value:  
Value Percent: **5.000**  
Continuous Index: **F02**  
Within 8" of Joint: **NO**  
Remarks:

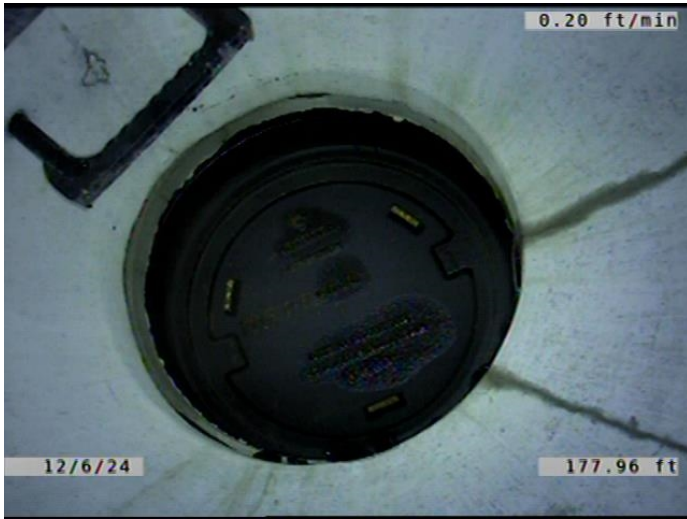
Code:	AMH
Description:	Manhole
Distance (ft):	178.0
Structural Grade:	0
O&M Grade:	0
Clock Start/From:	
Clock To:	
1st Value:	
2nd Value:	
Value Percent:	
Continuous Index:	
Within 8" of Joint:	NO
Remarks:	M-507-078.1
