## Profile/Photo Observation Report

Date:	<b>12/12/2024</b>	Weather:		Coding:	<b>PACP 7.0</b>
Pipe Length (ft):	<b>173.0</b>	Owner:	<b>City of Hobart</b>	Pre Clean:	<b>Heavy Cleaning</b>
P.O.#:	<b>YES502259</b>	Surveyor:	<b>S. Bucklin</b>	PSR:	<b>P-507-085-084</b>
Customer:	<b>City of Hobart</b>	Clean Date:	<b>09/11/2024</b>	Shape:	<b>C</b>

Street:	<b>South Colorado Street</b>	Flow Control:	<b>Not Controlled</b>
City:	<b>Hobart, IN</b>	Year Renewed:	
Location:	<b>Local rural streets with light traffic, t</b>	Tape/Media #:	
Purpose:	<b>Sewer System Evaluation Survey (SS</b>	Dia/Height:	<b>8"</b>
Use:	<b>Sanitary Sewage Pipe</b>	Material:	<b>PVC</b>
Drain Area:		Lining:	<b>None</b>
Category:	<b>NA</b>		
Comment:			
Location Details:		Direction of Survey:	<b>Upstream</b>
US MH:	<b>M-507-084</b>	DS MH:	<b>M-507-085</b>
		Total Length Surveyed (ft):	<b>167.5</b>

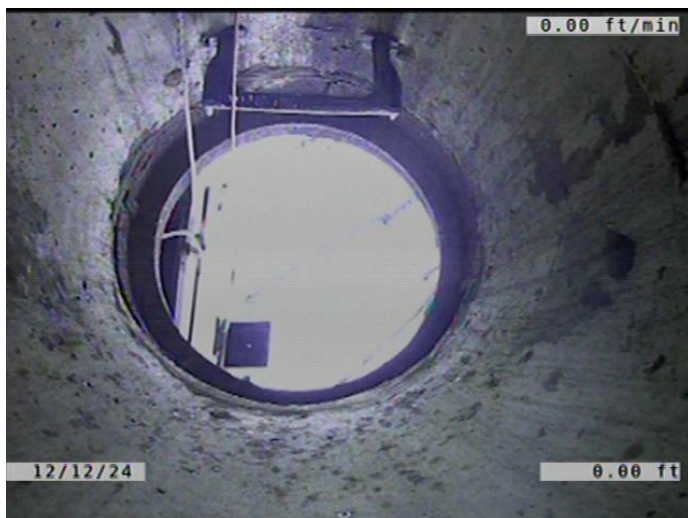
Code: **AMH**  
Description: **Manhole**

Distance (ft): **.0**  
Structural Grade: **0**  
O&M Grade: **0**  
Clock Start/From:  
Clock To:  
1st Value:  
2nd Value:  
Value Percent:  
Continuous Index:  
Within 8" of Joint: **NO**  
Remarks: **M-507-085**

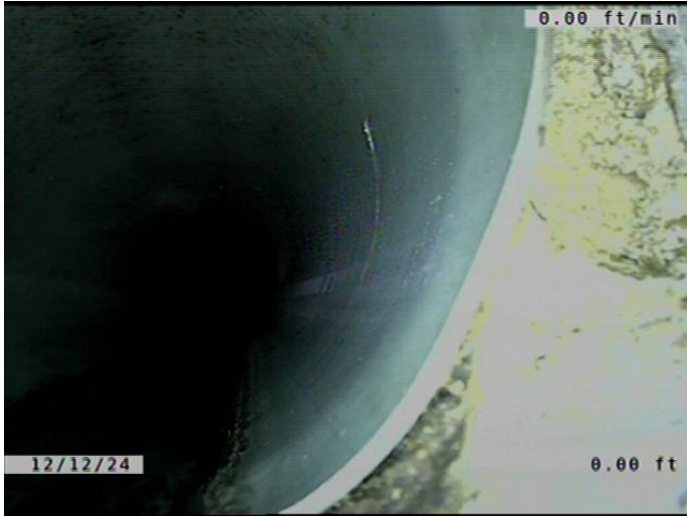
Code: **MWL**  
Description: **Miscellaneous Water Level**

Distance (ft): **.0**  
Structural Grade: **0**  
O&M Grade: **0**  
Clock Start/From:  
Clock To:  
1st Value:  
2nd Value:  
Value Percent: **5.000**  
Continuous Index:  
Within 8" of Joint: **NO**  
Remarks:

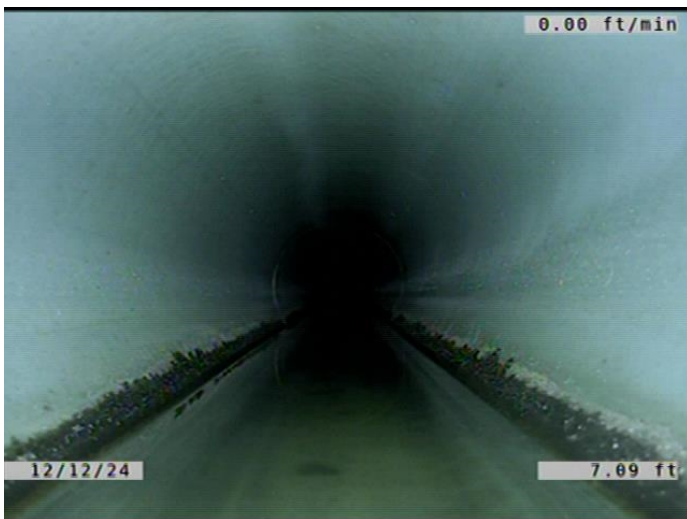
Code: **MWLS**  
Description: **Miscellaneous Water Level Sag**

Distance (ft): **7.1**  
Structural Grade: **2**  
O&M Grade: **0**  
Clock Start/From:  
Clock To:  
1st Value:  
2nd Value:  
Value Percent: **20.000**  
Continuous Index: **S01**  
Within 8" of Joint: **NO**  
Remarks:

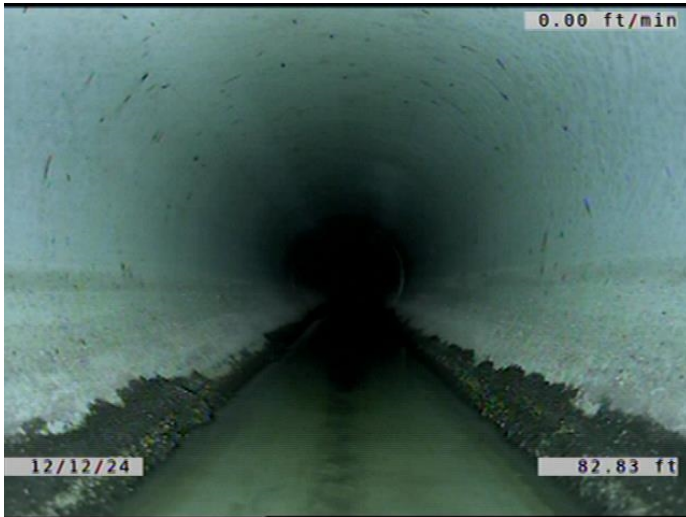
Code: **MWLS**  
Description: **Miscellaneous Water Level Sag**

Distance (ft): **82.8**  
Structural Grade: **2**  
O&M Grade: **0**  
Clock Start/From:  
Clock To:  
1st Value:  
2nd Value:  
Value Percent: **20.000**  
Continuous Index: **F01**  
Within 8" of Joint: **NO**  
Remarks:

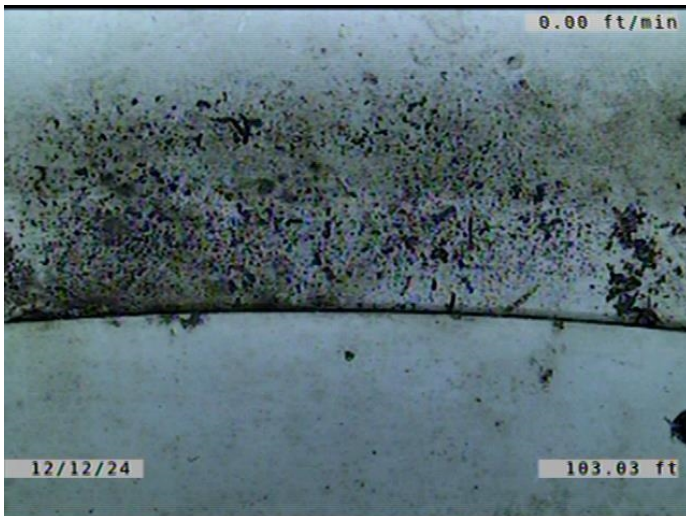
Code: **MGO**  
Description: **Miscellaneous General Observation**

Distance (ft): **103.0**  
Structural Grade: **0**  
O&M Grade: **0**  
Clock Start/From:  
Clock To:  
1st Value:  
2nd Value:  
Value Percent:  
Continuous Index:  
Within 8" of Joint: **NO**  
Remarks: **PIPES/ JOINT NOT PUSHED  
TOGETHER ALL THE WAY WHEN INS**

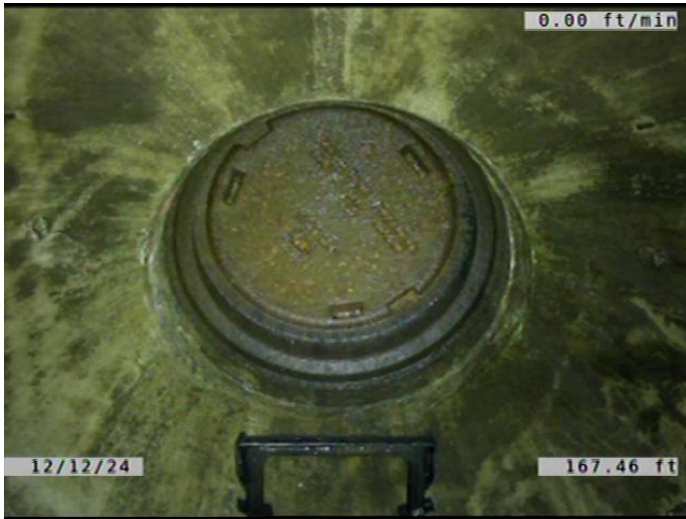
Code:	AMH
Description:	Manhole
Distance (ft):	167.5
Structural Grade:	0
O&M Grade:	0
Clock Start/From:	
Clock To:	
1st Value:	
2nd Value:	
Value Percent:	
Continuous Index:	
Within 8" of Joint:	NO
Remarks:	M-507-084
