Manhole Inspection Report

Date:	**05/11/2018**	Weather:			Coding:	**RZMACP**
MH#:	**M-1004-047**	Owner:	**NA**		Len. Surveyed:	**8.9**
P.O.#:		Surveyor:	**Jen Costello**		Rim to Invert:	**8.4**
Customer:		Cert. #:	**U-907-5518**		Wall Material:	**Concrete (reinforced)**

Street:	**McAfee Dr. 23' South of Cypress Ln.**	Project:	**Hobart, IN**
City:	**Hobart, IN**	GPS Northing:	**2914498.161**
Location:		GPS Easting:	**2914498.161**
Drain Area:	**Northeast**	GPS Accuracy:	**Sub-Meter**
Cover Shape:	**Circular**	Evidence of Surcharge:	**No**
Cover Size:	**22.5**	Potential for Runoff:	**None**
Comments:

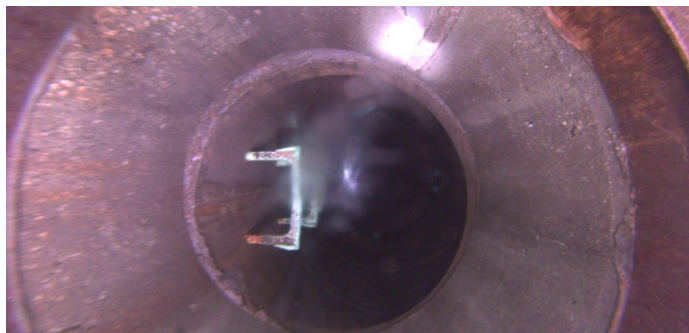
Code: **MGO**
Description: **General Observation**

Distance (ft): **.0**
Structural Grade: **0**
O&M Grade: **0**
Clock Start/From:
Clock To:
1st Value:
2nd Value:
Value Percent:
Step: **NO**
Remarks: **access MH**

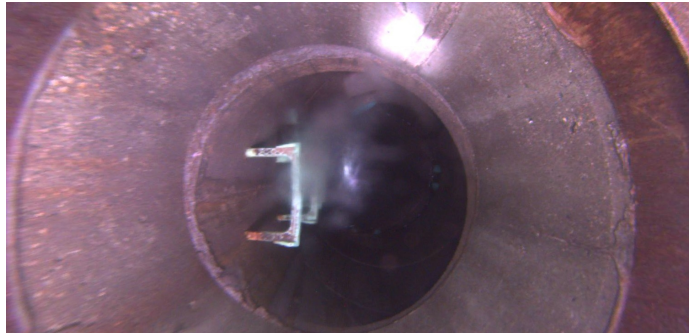
Code: **SAV**
Description: **Surface Aggregate Visible**

Distance (ft): **.0**
Structural Grade: **3**
O&M Grade: **0**
Clock Start/From: **12**
Clock To: **12**
1st Value:

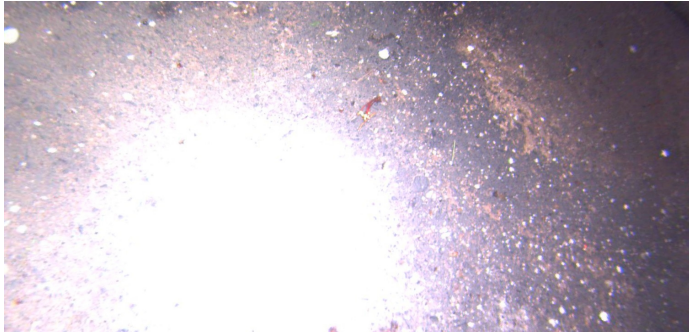
Code: **MGO**
Description: **General Observation**

Distance (ft): **2.0**
Structural Grade: **0**
O&M Grade: **0**
Clock Start/From:
Clock To:
1st Value:
2nd Value:
Value Percent:
Step: **NO**
Remarks: **UNDERSIDE OF FRAME**

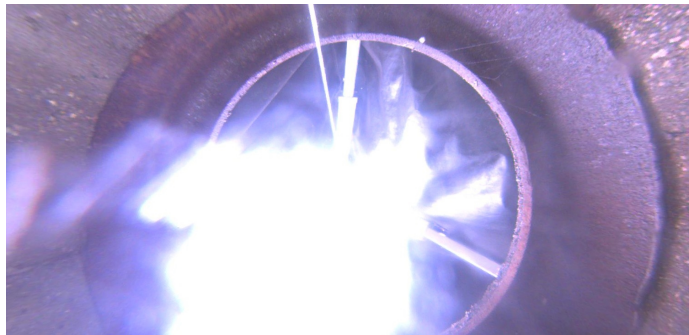
Code: **SAV**
Description: **Surface Aggregate Visible**

Distance (ft): **8.9**
Structural Grade: **3**
O&M Grade: **0**
Clock Start/From: **12**
Clock To: **12**
1st Value:
2nd Value:
Value Percent:
Step: **NO**
Remarks:
