# Manhole Inspection Report

| MH#: | **M-1004-061** | Owner: | **NA** | Len. Surveyed: | **9.4** |

| Street: | **Hillcrest Ave. 186' South of Barberry** | Project: | **Hobart, IN** |

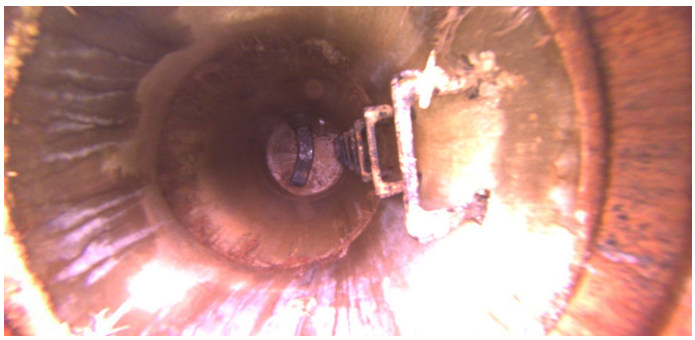
Code: **MGP**
Description: **General Photo**

Distance (ft): **.0**
Structural Grade: **0**
O&M Grade: **0**
Clock Start/From:
Clock To:
1st Value:
2nd Value:
Value Percent:
Step: **NO**
Remarks: **access MH**

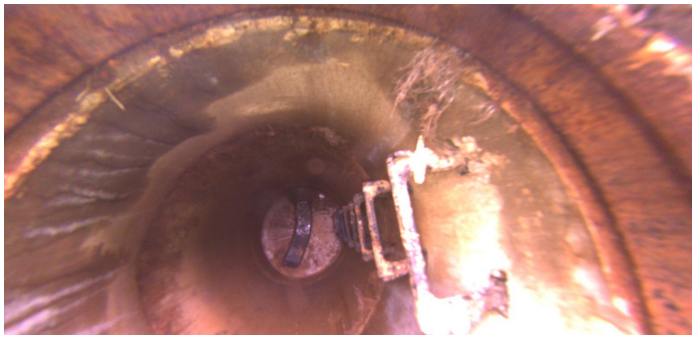
| Description: | **Roots Fine Joint** |
| Distance (ft): | **.0** |
| O&M Grade: | **1** |

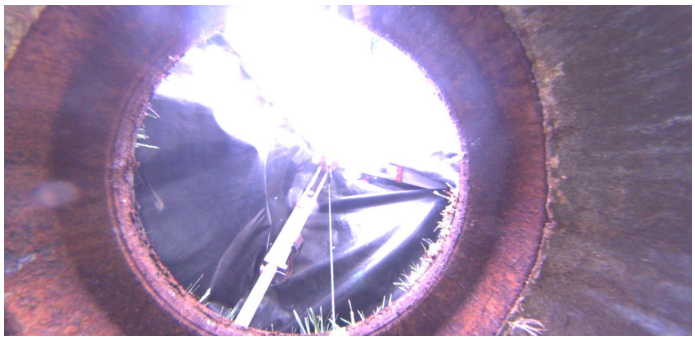
| Description: | **General Observation** |
| Distance (ft): | **1.4** |
| Remarks: | **UNDERSIDE OF FRAME** |

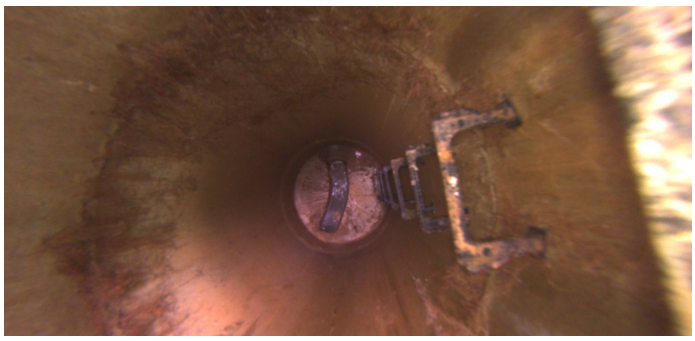
| Description: | **Roots Fine Joint** |
| Distance (ft): | **1.7** |
| O&M Grade: | **1** |

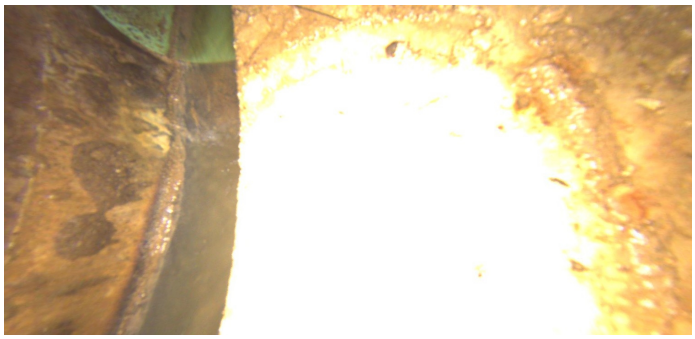
| Description: | **Roots Fine Joint** |
| Distance (ft): | **7.1** |
| O&M Grade: | **1** |
