Manhole Inspection Report

Date:	**05/14/2018**	Weather:		Coding:	**RZMACP**
MH#:	**M-404-010**	Owner:	**NA**	Len. Surveyed:	**3.5**
P.O.#:		Surveyor:	**Jen Costello**	Rim to Invert:	**4.3**
Customer:		Cert. #:	**U-907-5518**	Wall Material:	**Concrete (reinforced)**

Street:	**Wabash St. 176' South of Old Ridge**	Project:	**Hobart, IN**
City:	**Hobart, IN**	GPS Northing:	**41.54072571**
Location:		GPS Easting:	**-87.27948761**
Drain Area:	**West**	GPS Accuracy:	**Nearest Meter**
Cover Shape:	**Circular**	Evidence of Surcharge:	**No**
Cover Size:	**22.5**	Potential for Runoff:	**None**
Comments:

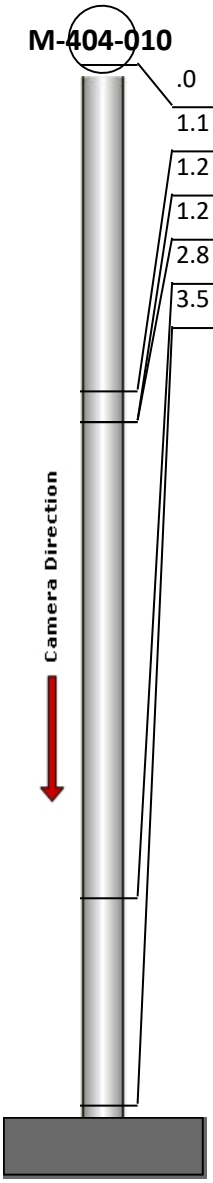
Position	Code	Observation	Video (sec)	Grade
M-404-010				
.0	MGO	General Observation	10	NA
1.1	SAV	Surface Aggregate Visible	23	S 3
1.2	MGO	General Observation	36	NA
1.2	FL	Fracture Longitudinal	46	S 3
2.8	OBR	Obstacle Rocks	62	M 2
3.5	MGO	General Observation	74	NA
