Manhole Inspection Report

Date:	**04/28/2018**	Weather:		Coding:	**RZMACP**
MH#:	**M-505-090**	Owner:	**NA**	Len. Surveyed:	**7.3**
P.O.#:		Surveyor:	**Jen Costello**	Rim to Invert:	**7.6**
Customer:		Cert. #:	**U-907-5518**	Wall Material:	**Concrete (reinforced)**

Street:	**4th Pl. 358' East of Wabash Pl.**	Project:	**Hobart, IN**
City:	**Hobart, IN**	GPS Northing:	**2899662.974**
Location:		GPS Easting:	**2899662.974**
Drain Area:	**West**	GPS Accuracy:	**Sub-Meter**
Cover Shape:	**Circular**	Evidence of Surcharge:	**No**
Cover Size:	**22.5**	Potential for Runoff:	**None**
Comments:

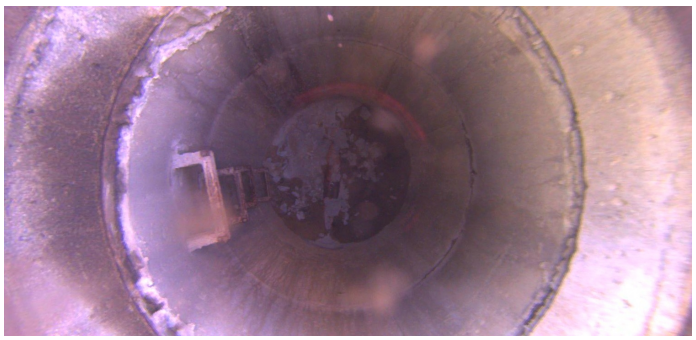
Code: **MGO**
Description: **General Observation**

Distance (ft): **.0**
Structural Grade: **0**
O&M Grade: **0**
Clock Start/From:
Clock To:
1st Value:
2nd Value:
Value Percent:
Step: **NO**
Remarks: **ACCESS MH**

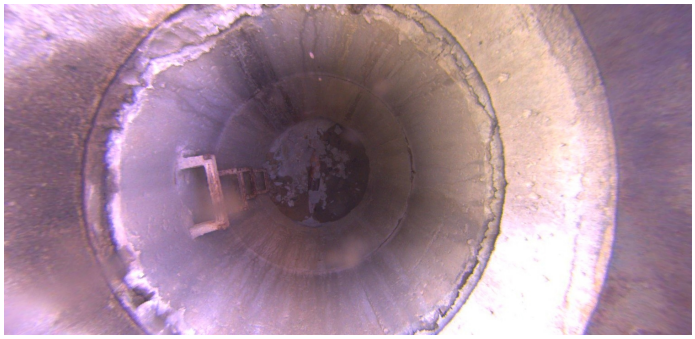
Code:	**FC**
Description:	**Fracture Circumferential**
Distance (ft):	**.4**
Structural Grade:	**2**
O&M Grade:	**0**
Clock Start/From:	**12**
Clock To:	**12**
1st Value:	
2nd Value:	
Value Percent:	
Step:	**NO**
Remarks:

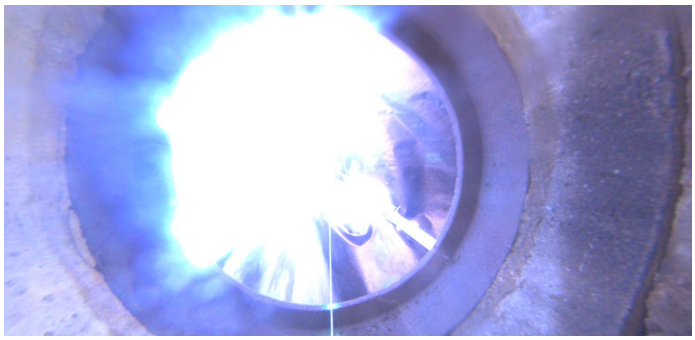
Code:	**MGP**
Description:	**General Photo**
Distance (ft):	**1.8**
Structural Grade:	**0**
O&M Grade:	**0**
Clock Start/From:	
Clock To:	
1st Value:	
2nd Value:	
Value Percent:	
Step:	**NO**
Remarks:	**UNDERSIDE OF FRAME**

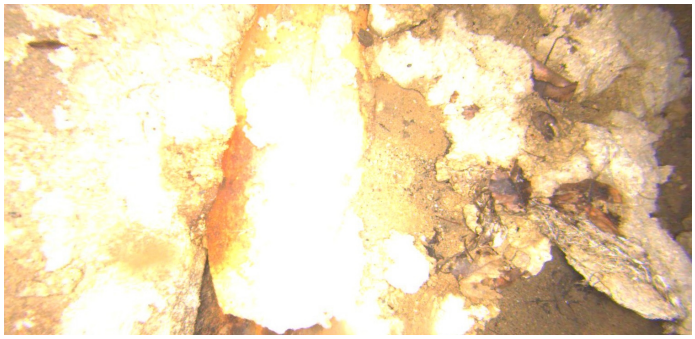
Code:	**OBR**
Description:	**Obstacle Rocks**
Distance (ft):	**6.3**
Structural Grade:	**0**
O&M Grade:	**2**
Clock Start/From:	**12**
Clock To:	**12**
1st Value:	
2nd Value:	
Value Percent:	**10.000**
Step:	**NO**
Remarks:
