Manhole Inspection Report

Date:	**04/24/2018**	Weather:		Coding:	**RZMACP**
MH#:	**M-506-008**	Owner:	**NA**	Len. Surveyed:	**9.0**
P.O.#:		Surveyor:	**Jen Costello**	Rim to Invert:	**9.6**
Customer:		Cert. #:	**U-907-5518**	Wall Material:	**Concrete (reinforced)**

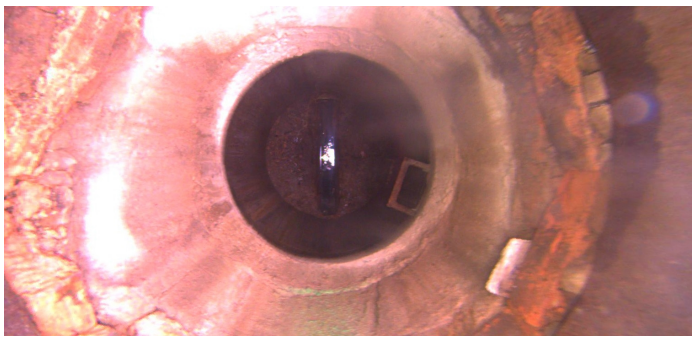
Code: **MGO**
Description: **General Observation**

Distance (ft): **.0**
Structural Grade: **0**
O&M Grade: **0**
Clock Start/From:
Clock To:
1st Value:
2nd Value:
Value Percent:
Step: **NO**
Remarks: **access MH**

Code:	**SSS**
Description:	**Surface Spalling**
Distance (ft):	**1.3**
Structural Grade:	**2**
O&M Grade:	**0**
Clock Start/From:	**12**
Clock To:	**12**
1st Value:	
2nd Value:	
Value Percent:	
Step:	**NO**
Remarks:

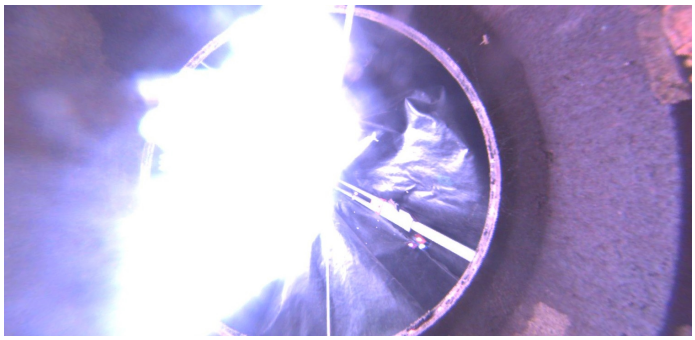
Code:	**MGO**
Description:	**General Observation**
Distance (ft):	**1.3**
Structural Grade:	**0**
O&M Grade:	**0**
Clock Start/From:	
Clock To:	
1st Value:	
2nd Value:	
Value Percent:	
Step:	**NO**
Remarks:	**UNDERSIDE OF FRAME**

Code:	**IS**
Description:	**Infil Stain**
Distance (ft):	**3.1**
Structural Grade:	**0**
O&M Grade:	**0**
Clock Start/From:	**12**
Clock To:	**12**
1st Value:	
2nd Value:	
Value Percent:	
Step:	**NO**
Remarks:

Code:	**FM**
Description:	**Fracture Multiple**
Distance (ft):	**7.8**
Structural Grade:	**4**
O&M Grade:	**0**
Clock Start/From:	**12**
Clock To:	**2**
1st Value:	
2nd Value:	
Value Percent:	
Step:	**NO**
Remarks:

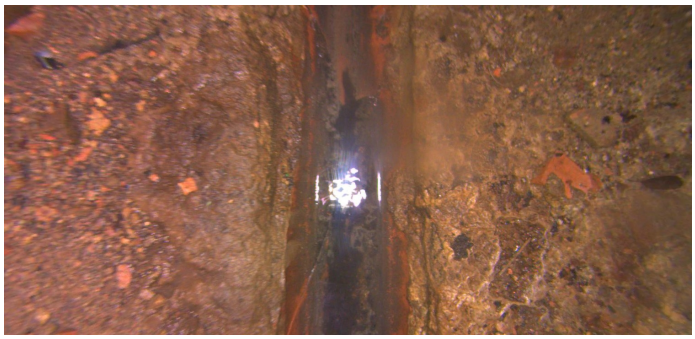
Code:	**DSF**
Description:	**Deposits Settled Fine**
Distance (ft):	**7.8**
Structural Grade:	**0**
O&M Grade:	**2**
Clock Start/From:	**12**
Clock To:	**12**
1st Value:	
2nd Value:	
Value Percent:	**5.000**
Step:	**NO**
Remarks:

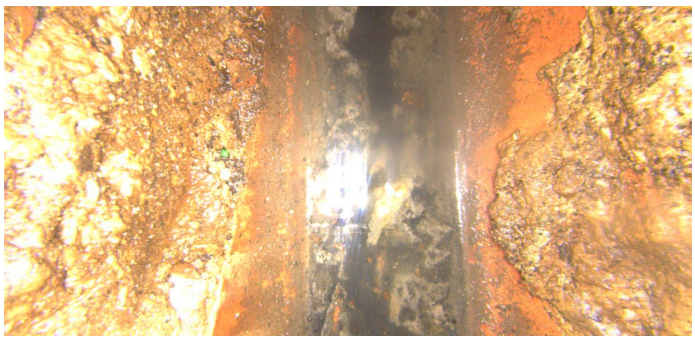
Code:	**MGO**
Description:	**General Observation**
Distance (ft):	**9.0**
Structural Grade:	**0**
O&M Grade:	**0**
Clock Start/From:	
Clock To:	
1st Value:	
2nd Value:	
Value Percent:	
Step:	**NO**
Remarks:	**END SURVEY**
