Manhole Inspection Report

Date:	**05/02/2018**	Weather:		Coding:	**RZMACP**
MH#:	**M-605-036**	Owner:	**NA**	Len. Surveyed:	**6.7**
P.O.#:		Surveyor:	**Jen Costello**	Rim to Invert:	**7.6**
Customer:		Cert. #:	**U-907-5518**	Wall Material:	**Brick**

Street:	**Pennsylvania St. 284' North of 3rd St**	Project:	**Hobart, IN**
City:	**Hobart, IN**	GPS Northing:	**41.53316116**
Location:		GPS Easting:	**-87.26685333**
Drain Area:	**West**	GPS Accuracy:	**Nearest Meter**
Cover Shape:	**Circular**	Evidence of Surcharge:	**No**
Cover Size:	**22.5**	Potential for Runoff:	**None**
Comments:

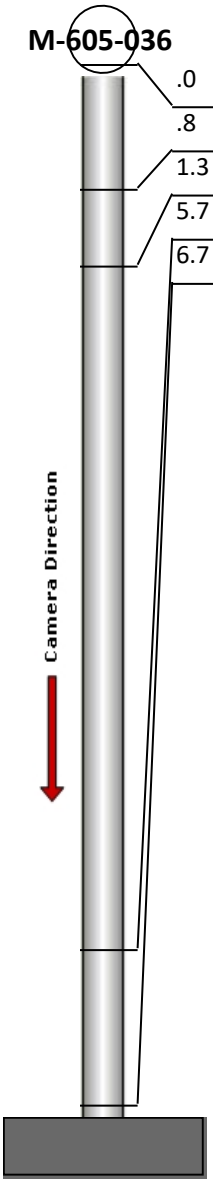
Code: **MGP**
Description: **General Photo**

Distance (ft): **.0**
Structural Grade: **0**
O&M Grade: **0**
Clock Start/From:
Clock To:
1st Value:
2nd Value:
Value Percent:
Step: **NO**
Remarks: **access mh**

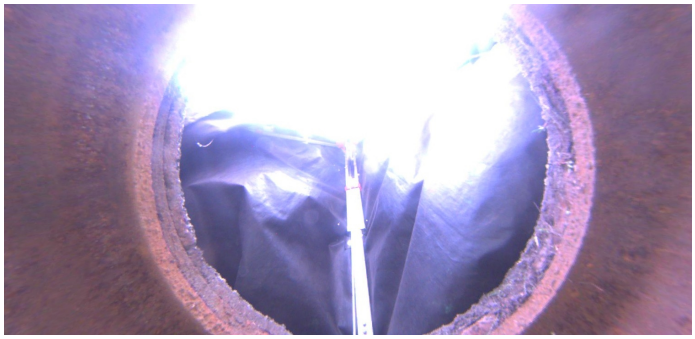
Code:	**DB**
Description:	**Displaced Brick**
Distance (ft):	**.8**
Structural Grade:	**3**
O&M Grade:	**0**
Clock Start/From:	**11**
Clock To:	
1st Value:	
2nd Value:	
Value Percent:	
Step:	**NO**
Remarks:

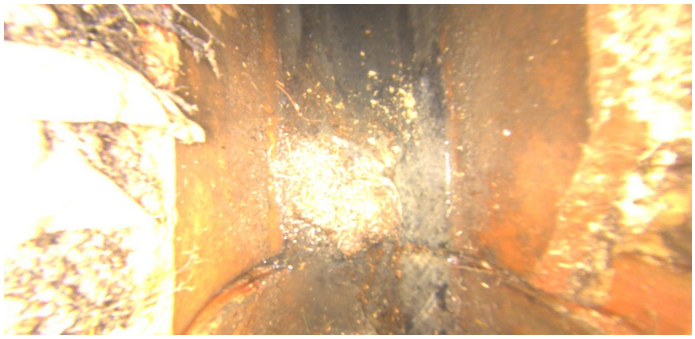
Code:	**DSGV**
Description:	**Deposits Settled Gravel**
Distance (ft):	**5.7**
Structural Grade:	**0**
O&M Grade:	**2**
Clock Start/From:	**12**
Clock To:	**12**
1st Value:	
2nd Value:	
Value Percent:	**5.000**
Step:	**NO**
Remarks:
