# Manhole Inspection Report

| MH#: | **M-704-018** | Owner: | **NA** | Len. Surveyed: | **5.3** |

| Street: | **Michigan Ave. 736' South of South S** | Project: | **Hobart, IN** |

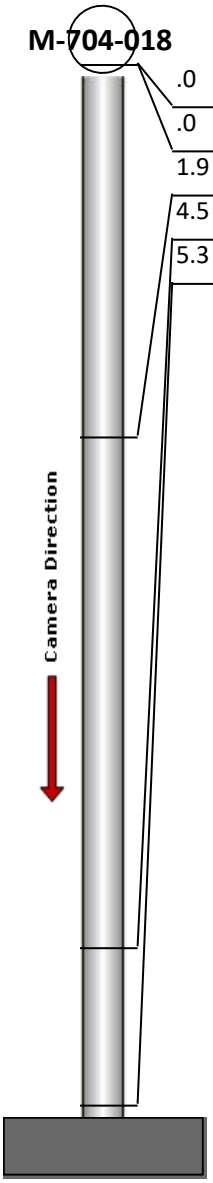
Code: **DB**
Description: **Displaced Brick**

Distance (ft): **.0**
Structural Grade: **3**
O&M Grade: **0**
Clock Start/From: **12**
Clock To: **12**
1st Value:
2nd Value:
Value Percent:
Step: **NO**
Remarks:

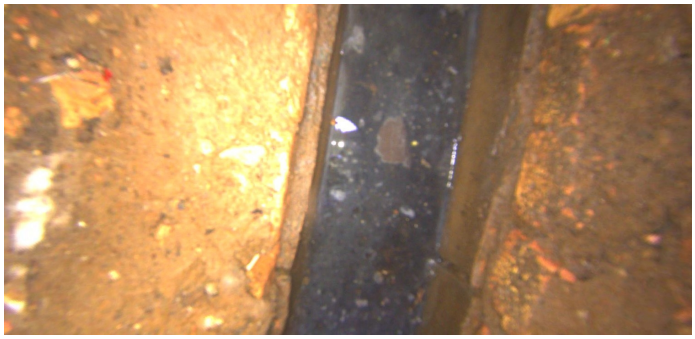
| Code: | **DSF** |
| Description: | **Deposits Settled Fine** |
| O&M Grade: | **2** |
