Manhole Inspection Report

Date:	**04/24/2018**	Weather:		Coding:	**RZMACP**
MH#:	**M-707-033**	Owner:	**NA**	Len. Surveyed:	**7.0**
P.O.#:		Surveyor:	**John Kuglmaier**	Rim to Invert:	**6.7**
Customer:	**8.7**	Cert. #:	**U-1215-07002349**	Wall Material:	**Brick**

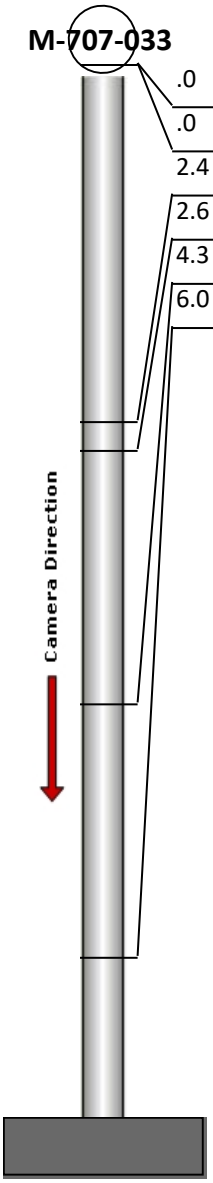
Position	Code	Observation	Video (sec)	Grade
M-707-033				
.0	MGP	General Photo	10	NA
.0	MGP	General Photo	21	NA
2.4	CS	Crack Spiral	38	S 2
2.6	MGP	General Photo	52	NA
4.3	DAZ	Deposits Attached Other	69	M 3
6.0	MGO	General Observation	84	NA

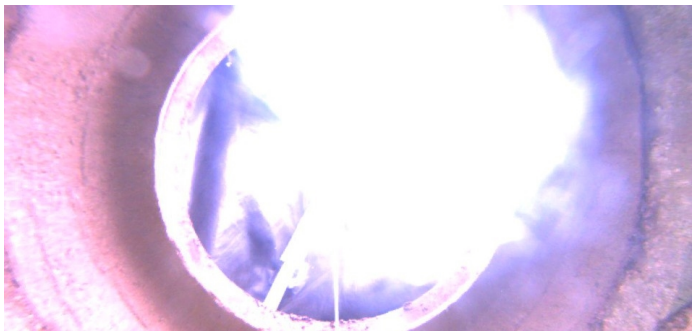
Code: **CS**
Description: **Crack Spiral**

Distance (ft): **2.4**
Structural Grade: **2**
O&M Grade: **0**
Clock Start/From: **4**
Clock To: **5**
1st Value:
2nd Value:
Value Percent:
Step: **NO**
Remarks:
