Manhole Inspection Report

Date:	**10/11/2022**	Weather:		Coding:	**RZMACP**
MH#:	**M-804-052**	Owner:	**NA**	Len. Surveyed:	**9.4**
P.O.#:		Surveyor:	**Jen Costello**	Rim to Invert:	**11.1**
Customer:		Cert. #:	**U-907-5518**	Wall Material:	**Brick**

Street:	**Kelly St. 216' North of Hickey St.**	Project:	**Hobart, IN**
City:	**Hobart, IN**	GPS Northing:	**2291945.029**
Location:	**Local Rural Streets**	GPS Easting:	**2907736.983**
Drain Area:	**Northeast**	GPS Accuracy:	**Sub-Meter**
Cover Shape:	**Circular**	Evidence of Surcharge:	**No**
Cover Size:	**24.0**	Potential for Runoff:	**None**
Comments:

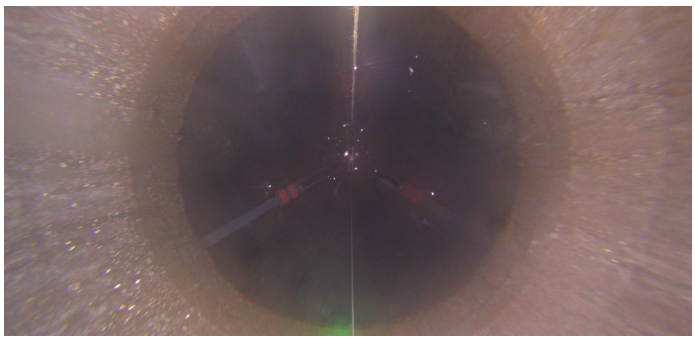
Code: **MMC**
Description: **Material Change**

Distance (ft): **1.3**
Structural Grade: **0**
O&M Grade: **0**
Clock Start/From:
Clock To:
1st Value:
2nd Value:
Value Percent:
Step: **NO**
Remarks: **brick**
