Manhole Inspection Report

Date:	**03/28/2018**	Weather:		Coding:	**RZMACP**
MH#:	**M-903-029**	Owner:	**NA**	Len. Surveyed:	**9.3**
P.O.#:		Surveyor:	**John Kuglmaier**	Rim to Invert:	**11.3**
Customer:		Cert. #:	**U-1215-07002349**	Wall Material:	**Concrete (reinforced)**

Street:	**Rand St. 161' East of Hwy 51.**	Project:	**Hobart, IN**
City:	**Hobart, IN**	GPS Northing:	**0.0**
Location:		GPS Easting:	**0.0**
Drain Area:	**Northeast**	GPS Accuracy:	**Nearest Meter**
Cover Shape:	**Circular**	Evidence of Surcharge:	**Yes**
Cover Size:	**23.0**	Potential for Runoff:	**None**
Comments:

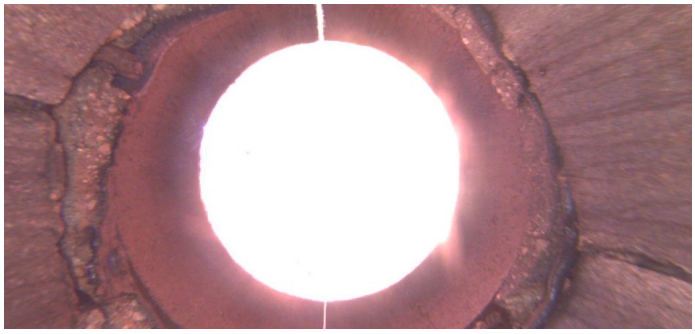
Code: **OBZ**
Description: **Obstacle Other**

Distance (ft): **.8**
Structural Grade: **0**
O&M Grade: **2**
Clock Start/From: **11**
Clock To:
1st Value:
2nd Value:
Value Percent: **5.000**
Step: **YES**
Remarks: **Metal rod**

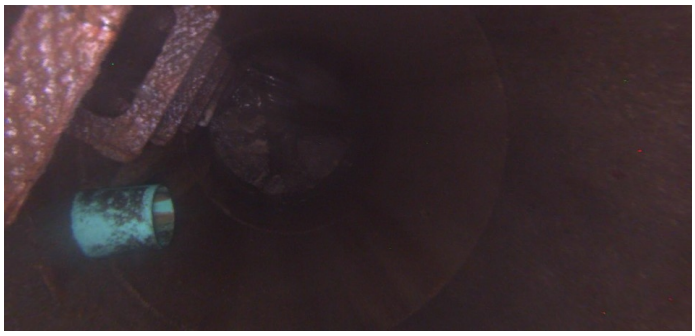
Code: **MGP**
Description: **General Photo**

Distance (ft): **2.2**
Structural Grade: **0**
O&M Grade: **0**
Clock Start/From:
Clock To:
1st Value:
2nd Value:
Value Percent:
Step: **NO**
Remarks:

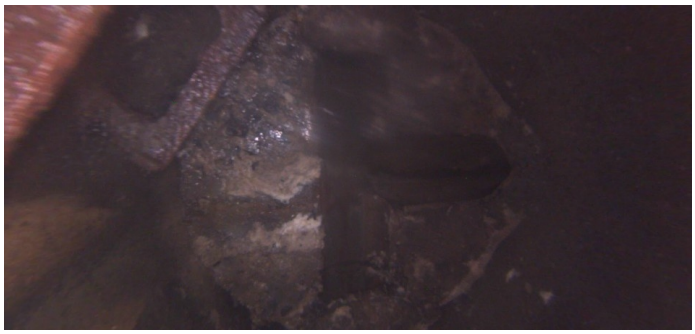
Code: **IS**
Description: **Infil Stain**

Distance (ft): **2.3**
Structural Grade: **0**
O&M Grade: **0**
Clock Start/From: **4**
Clock To: **5**
1st Value:
2nd Value:
Value Percent:
Step: **NO**
Remarks:
