Manhole Inspection Report

Date:	**05/15/2018**	Weather:		Coding:	**RZMACP**
MH#:	**M-904-034**	Owner:	**NA**	Len. Surveyed:	**5.8**
P.O.#:		Surveyor:	**Jen Costello**	Rim to Invert:	**6.4**
Customer:		Cert. #:	**U-907-5518**	Wall Material:	**Concrete (reinforced)**

Street:	**E. Cleveland Terrace. 877' North of C**	Project:	**Hobart, IN**
City:	**Hobart, IN**	GPS Northing:	**2910904.904**
Location:		GPS Easting:	**2910904.904**
Drain Area:	**Northeast**	GPS Accuracy:	**Sub-Meter**
Cover Shape:	**Circular**	Evidence of Surcharge:	**No**
Cover Size:	**22.5**	Potential for Runoff:	**None**
Comments:

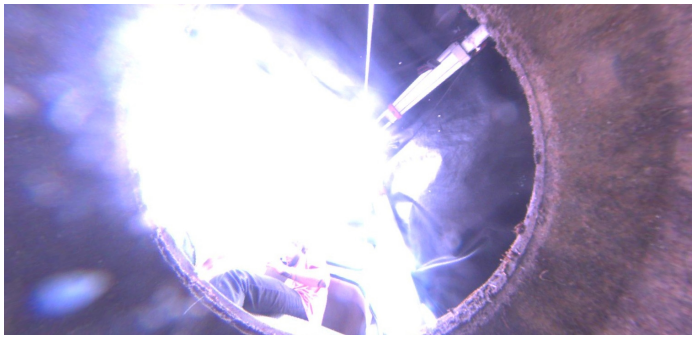
Code: **MGP**
Description: **General Photo**

Distance (ft): **.0**
Structural Grade: **0**
O&M Grade: **0**
Clock Start/From:
Clock To:
1st Value:
2nd Value:
Value Percent:
Step: **NO**
Remarks: **ACCESS MH**
