Profile/Photo Observation Report

Street:	**FOXCROFT STREET**	Flow Control:	**Not Controlled**
City:	**Hobart, IN**	Year Renewed:	
Location:	**Light Highway**	Tape/Media #:	
Purpose:	**Routine Assessment**	Dia/Height:	**8"**
Use:	**Sanitary**	Material:	**PVC**
Drain Area:	**NA**	Lining:	
Category:	**NA**		
Comment:	**Flow direction wrong**		
Location Details:		Direction of Survey:	**Downstream**

US MH: **M-208-025** DS MH: **M-208-026** Total Length Surveyed (ft): **158.4**

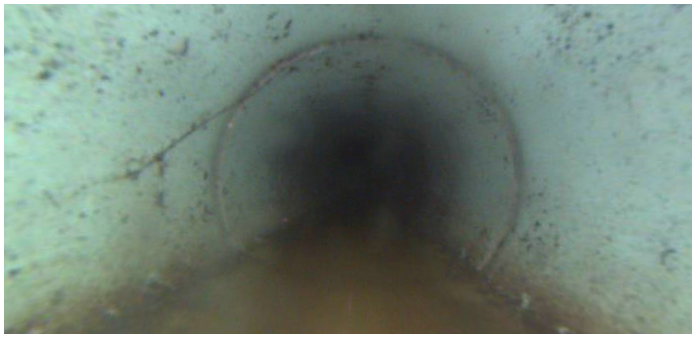
Code:	**MWL**
Description:	**Water Level**
Distance (ft):	**.0**
Structural Grade:	**0**
O&M Grade:	**0**
Clock Start/From:	
Clock To:	
1st Value:	
2nd Value:	
Value Percent:	**5.000**
Continuous Index:	
Within 8" of Joint:	**NO**
Remarks:

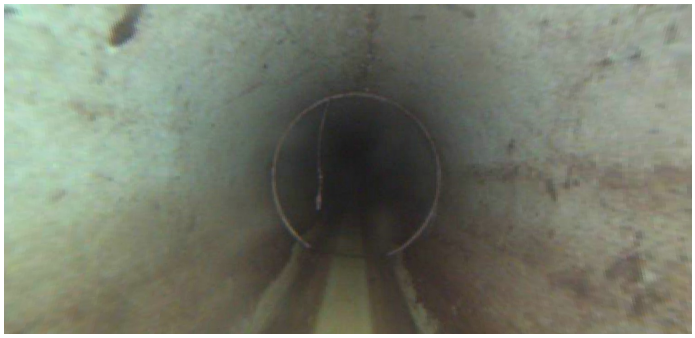
Code:	**RFJ**
Description:	**Roots Fine Joint**
Distance (ft):	**12.0**
Structural Grade:	**0**
O&M Grade:	**1**
Clock Start/From:	**12**
Clock To:	
1st Value:	
2nd Value:	
Value Percent:	
Continuous Index:	
Within 8" of Joint:	**YES**
Remarks:
