Profile/Photo Observation Report

Date:	**04/16/2018**	Weather:		Coding:	**PACP 6.0**	
Pipe Length (ft):	**320.0**	Owner:	**NA**	Pre Clean:	**Not Known**	
P.O.#:		Surveyor:	**Selasie Honu**	PSR:	**P-504-126.1-126**	
Customer:		Clean Date:	**01/01/1900**	Shape:	**C**

Street:	**ALLEY BETWEEN N GUYER ST & N WI**	Flow Control:	**Not Controlled**
City:	**Hobart, IN**	Year Renewed:	
Location:	**Light Highway**	Tape/Media #:	
Purpose:	**Not Known**	Dia/Height:	**10"**
Use:	**Sanitary**	Material:	**CP**
Drain Area:	**NA**	Lining:	
Category:	**NA**		
Comment:			
Location Details:		Direction of Survey:	**Downstream**
US MH:	**M-504-126**	DS MH: **M-504-126.1**	Total Length Surveyed (ft): **4.8**

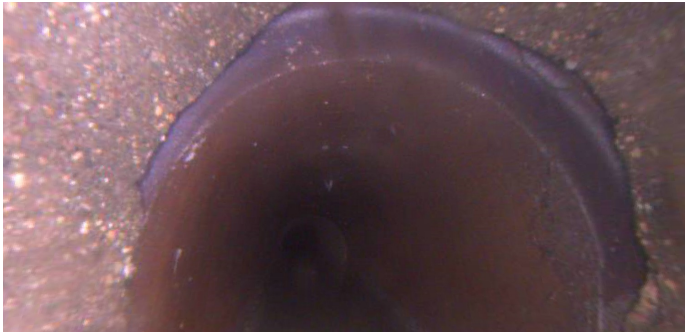
Code:	**SAP**
Description:	**Surface Aggregate Projecting**
Distance (ft):	**.0**
Structural Grade:	**3**
O&M Grade:	**0**
Clock Start/From:	**7**
Clock To:	**5**
1st Value:	
2nd Value:	
Value Percent:	
Continuous Index:	
Within 8" of Joint:	**NO**
Remarks:	**M-504-126.1**

Code:	**MMC**
Description:	**Material Change**
Distance (ft):	**.0**
Structural Grade:	**0**
O&M Grade:	**0**
Clock Start/From:	
Clock To:	
1st Value:	
2nd Value:	
Value Percent:	
Continuous Index:	
Within 8" of Joint:	**NO**
Remarks:	**VCP**

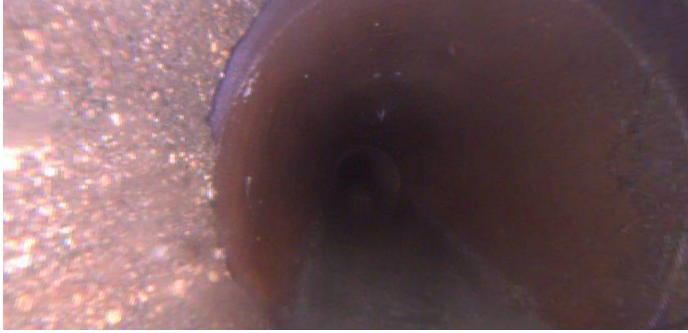
Code:	**AMH**
Description:	**Manhole**
Distance (ft):	**.0**
Structural Grade:	**0**
O&M Grade:	**0**
Clock Start/From:	
Clock To:	
1st Value:	
2nd Value:	
Value Percent:	
Continuous Index:	
Within 8" of Joint:	**NO**
Remarks:	**M-504-126**
