Profile/Photo Observation Report

Street:	**FOXCROFT STREET**	Flow Control:	**Not Controlled**
City:	**Hobart, IN**	Year Renewed:	
Location:	**Light Highway**	Tape/Media #:	
Purpose:	**Routine Assessment**	Dia/Height:	**10"**
Use:	**Sanitary**	Material:	**VCP**
Drain Area:	**NA**	Lining:	
Category:	**NA**		
Comment:	**P_C at 20 ft roots. Flow direction wrong**		
Location Details:		Direction of Survey:	**Downstream**

US MH: **M-505-069** DS MH: **M-505-068** Total Length Surveyed (ft): **21.8**

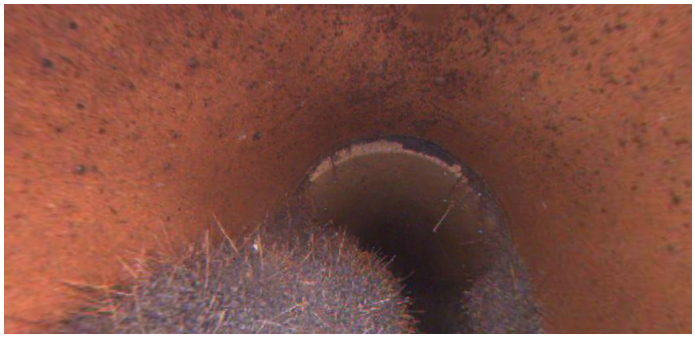
Code:	**RMJ**
Description:	**Roots Medium Joint**
Distance (ft):	**17.3**
Structural Grade:	**0**
O&M Grade:	**3**
Clock Start/From:	**8**
Clock To:	**9**
1st Value:	
2nd Value:	
Value Percent:	**5.000**
Continuous Index:	
Within 8" of Joint:	**YES**
Remarks:

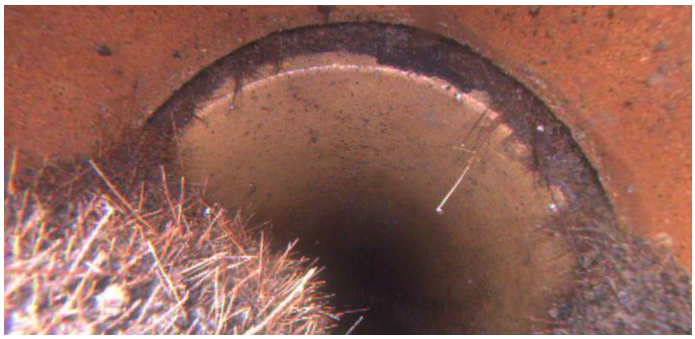
Code:	**RMJ**
Description:	**Roots Medium Joint**
Distance (ft):	**20.7**
Structural Grade:	**0**
O&M Grade:	**3**
Clock Start/From:	**7**
Clock To:	**5**
1st Value:	
2nd Value:	
Value Percent:	**30.000**
Continuous Index:	
Within 8" of Joint:	**YES**
Remarks:
