Profile/Photo Observation Report

Date:	**04/10/2018**	Weather:		Coding:	**PACP 6.0**
Pipe Length (ft):	**146.0**	Owner:	**NA**	Pre Clean:	**Not Known**
P.O.#:		Surveyor:	**Mark Ruby**	PSR:	**P-704-067-063**
Customer:		Clean Date:	**01/01/1900**	Shape:	**C**

Street:	**EDGEWATER DR**	Flow Control:	**Not Controlled**
City:	**Hobart, IN**	Year Renewed:	
Location:	**Other**	Tape/Media #:	
Purpose:	**Not Known**	Dia/Height:	**8"**
Use:	**Sanitary**	Material:	**PVC**
Drain Area:	**NA**	Lining:	
Category:	**NA**		
Comment:			
Location Details:		Direction of Survey:	**Downstream**
US MH:	**M-704-067**	DS MH: **M-704-063**	Total Length Surveyed (ft): **140.4**

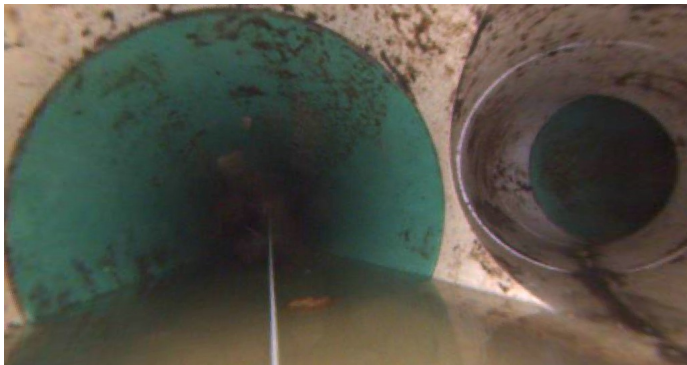
Code:	**MWL**
Description:	**Water Level**
Distance (ft):	**.0**
Structural Grade:	**0**
O&M Grade:	**0**
Clock Start/From:	
Clock To:	
1st Value:	
2nd Value:	
Value Percent:	**10.000**
Continuous Index:	
Within 8" of Joint:	**NO**
Remarks:
