Profile/Photo Observation Report

Date:	**04/05/2018**	Weather:		Coding:	**PACP 6.0**
Pipe Length (ft):	**391.8**	Owner:	**NA**	Pre Clean:	**Not Known**
P.O.#:		Surveyor:	**Jen Costello**	PSR:	**P-808-029-030**
Customer:		Clean Date:	**01/01/1900**	Shape:	**C**

Street:	**Hobart**	Flow Control:	**Not Controlled**
City:	**Hobart, IN**	Year Renewed:	
Location:	**Ditch**	Tape/Media #:	
Purpose:	**Maintenance Related**	Dia/Height:	**12"**
Use:	**Sanitary**	Material:	**PVC**
Drain Area:	**NA**	Lining:	**Cured in Place**
Category:	**NA**		
Comment:	**Flow direction wrong.**		
Location Details:		Direction of Survey:	**Upstream**
US MH:	**M-808-030**	DS MH: **M-808-029** Total Length Surveyed (ft):	**16.0**

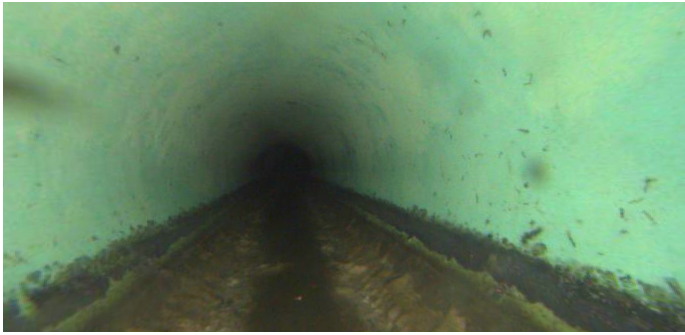
Code:	**DAGS**
Description:	**Deposits Attached Grease**
Distance (ft):	**.0**
Structural Grade:	**0**
O&M Grade:	**2**
Clock Start/From:	**7**
Clock To:	**5**
1st Value:	
2nd Value:	
Value Percent:	**5.000**
Continuous Index:	**S01**
Within 8" of Joint:	**NO**
Remarks:
