Manhole Inspection Report

Date:	05/08/2018	Weather:		Coding:	RZMACP
MH#:	M-1004-011	Owner:	NA	Len. Surveyed:	5.7
P.O.#:		Surveyor:	Jen Costello	Rim to Invert:	6.2
Customer:		Cert. #:	U-907-5518	Wall Material:	Concrete (reinforced)

Street:	Intersection of McAfee Ct. and McAf	Project:	Hobart, IN
City:	Hobart, IN	GPS Northing:	2914505.321
Location:		GPS Easting:	2914505.321
Drain Area:	Northeast	GPS Accuracy:	Sub-Meter
Cover Shape:	Circular	Evidence of Surcharge:	No
Cover Size:	22.5	Potential for Runoff:	None
Comments:

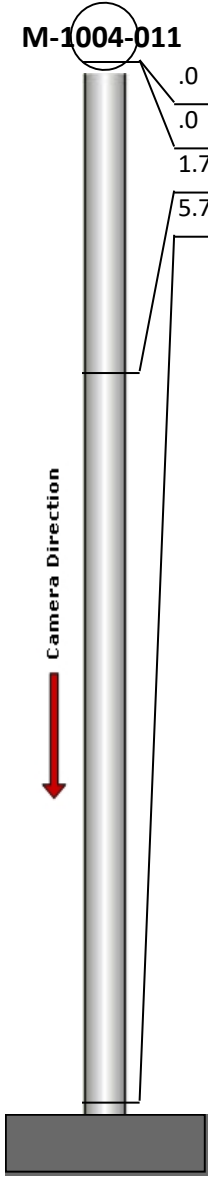
Position	Code	Observation	Video (sec)	Grade

.0	MGP	General Photo	10	NA
	.0	FM	Fracture Multiple	21	S 4
	1.7	MGO	General Observation	38	NA
	5.7	MGO	General Observation	59	NA
