Manhole Inspection Report

Date:	05/08/2018	Weather:		Coding:	RZMACP
MH#:	M-1004-012	Owner:	NA	Len. Surveyed:	6.1
P.O.#:		Surveyor:	Jen Costello	Rim to Invert:	6.1
Customer:		Cert. #:	U-907-5518	Wall Material:	Concrete (reinforced)

Street:	McAfee Ct.	Project:	Hobart, IN
City:	Hobart, IN	GPS Northing:	2914664.362
Location:		GPS Easting:	2914664.362
Drain Area:	Northeast	GPS Accuracy:	Sub-Meter
Cover Shape:	Circular	Evidence of Surcharge:	No
Cover Size:	22.5	Potential for Runoff:	None
Comments:

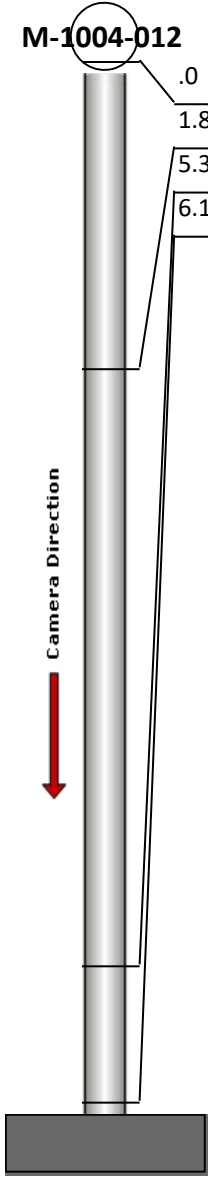
.0	MGP	General Photo	10	NA
	1.8	MGO	General Observation	27	NA
	5.3	DSF	Deposits Settled Fine	47	M 2
	6.1	MGO	General Observation	60	NA
