Manhole Inspection Report

Date:	05/11/2018	Weather:		Coding:	RZMACP
MH#:	M-1004-037	Owner:	NA	Len. Surveyed:	9.9
P.O.#:		Surveyor:	Jen Costello	Rim to Invert:	10.8
Customer:		Cert. #:	U-907-5518	Wall Material:	Concrete (reinforced)

Street:	Intersection of Hickey St. and Hillcre	Project:	Hobart, IN
City:	Hobart, IN	GPS Northing:	2912731.71
Location:		GPS Easting:	2912731.71
Drain Area:	Northeast	GPS Accuracy:	Sub-Meter
Cover Shape:	Circular	Evidence of Surcharge:	No
Cover Size:	22.5	Potential for Runoff:	None
Comments:

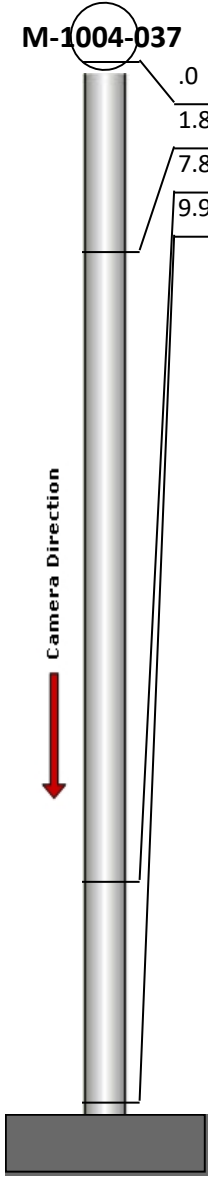
.0	MGO	General Observation	10	NA
	1.8	MGO	General Observation	26	NA
	7.8	SAV	Surface Aggregate Visible	52	S 3
	9.9	MGO	General Observation	67	NA
