Manhole Inspection Report

Date:	05/11/2018	Weather:		Coding:	RZMACP
MH#:	M-1004-044	Owner:	NA	Len. Surveyed:	5.2
P.O.#:		Surveyor:	Jen Costello	Rim to Invert:	5.3
Customer:		Cert. #:	U-907-5518	Wall Material:	Concrete (reinforced)

Street:	Ryan Ct. at the North End.	Project:	Hobart, IN
City:	Hobart, IN	GPS Northing:	2914835.508
Location:		GPS Easting:	2914835.508
Drain Area:	Northeast	GPS Accuracy:	Sub-Meter
Cover Shape:	Circular	Evidence of Surcharge:	No
Cover Size:	22.5	Potential for Runoff:	None
Comments:

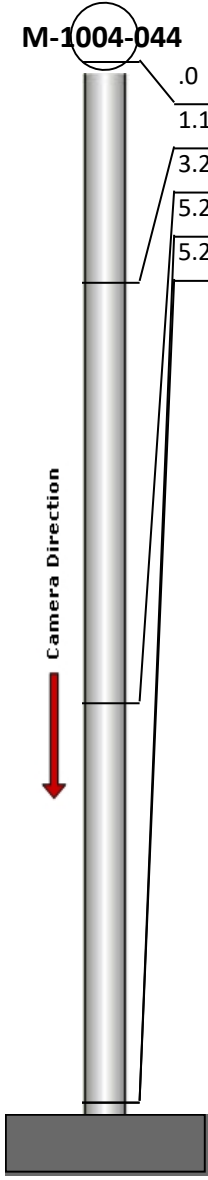
.0	MGO	General Observation	10	NA
	1.1	IS	Infil Stain	24	NA
	3.2	DSF	Deposits Settled Fine	39	M 2
	5.2	DSF	Deposits Settled Fine	55	M 2
	5.2	MGO	General Observation	66	NA
