Manhole Inspection Report

Date:	05/11/2018	Weather:		Coding:	RZMACP
MH#:	M-1004-060	Owner:	NA	Len. Surveyed:	8.1
P.O.#:		Surveyor:	Jen Costello	Rim to Invert:	8.8
Customer:		Cert. #:	U-907-5518	Wall Material:	Concrete (reinforced)

Street:	Intersection of Hillcrest Ave. and Ba	Project:	Hobart, IN
City:	Hobart, IN	GPS Northing:	2912838.769
Location:		GPS Easting:	2912838.769
Drain Area:	Northeast	GPS Accuracy:	Sub-Meter
Cover Shape:	Circular	Evidence of Surcharge:	No
Cover Size:	22.5	Potential for Runoff:	None
Comments:

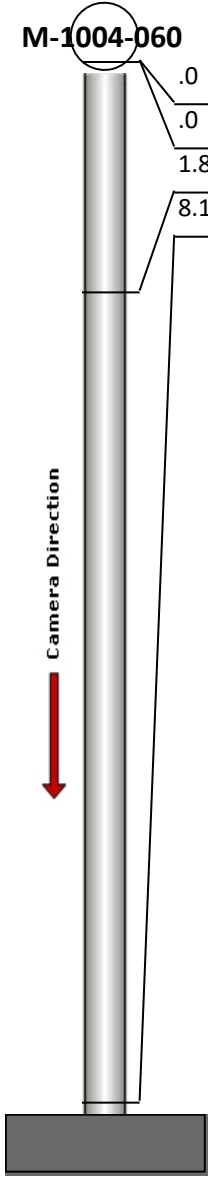
M-1004-060				
	.0	MGP	General Photo	10	NA
	.0	RFJ	Roots Fine Joint	21	M 1
	1.8	MGO	General Observation	38	NA
	8.1	MGO	General Observation	64	NA
