Manhole Inspection Report

Date:	05/11/2018	Weather:		Coding:	RZMACP
MH#:	M-1004-072	Owner:	NA	Len. Surveyed:	5.3
P.O.#:		Surveyor:	Jen Costello	Rim to Invert:	5.3
Customer:		Cert. #:	U-907-5518	Wall Material:	Concrete (reinforced)

Street:	Tulip Ln. 1099' East of Union St.	Project:	Hobart, IN
City:	Hobart, IN	GPS Northing:	2913461.29
Location:		GPS Easting:	2913461.29
Drain Area:	Northeast	GPS Accuracy:	Sub-Meter
Cover Shape:	Circular	Evidence of Surcharge:	No
Cover Size:	22.5	Potential for Runoff:	None
Comments:

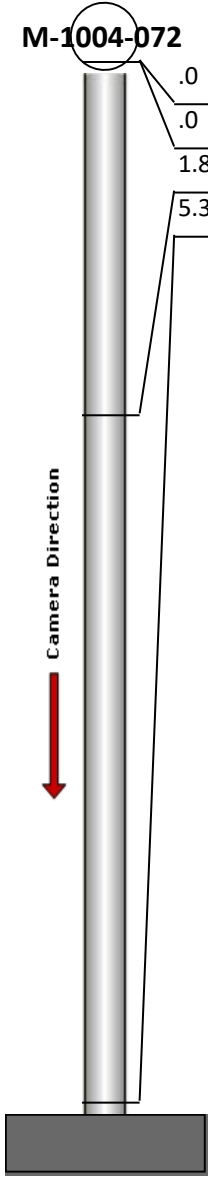
.0	MGP	General Photo	10	NA
	.0	RFJ	Roots Fine Joint	21	M 1
	1.8	MGO	General Observation	38	NA
	5.3	MGO	General Observation	59	NA
