Manhole Inspection Report

Date:	05/11/2018	Weather:		Coding:	RZMACP
MH#:	M-1004-077	Owner:	NA	Len. Surveyed:	10.8
P.O.#:		Surveyor:	Jen Costello	Rim to Invert:	12.1
Customer:		Cert. #:	U-907-5518	Wall Material:	Concrete (reinforced)

Street:	Hemlock Dr. North of Tulip Ln.	Project:	Hobart, IN
City:	Hobart, IN	GPS Northing:	2913834.41
Location:		GPS Easting:	2913834.41
Drain Area:	Northeast	GPS Accuracy:	Sub-Meter
Cover Shape:	Circular	Evidence of Surcharge:	No
Cover Size:	22.5	Potential for Runoff:	None
Comments:

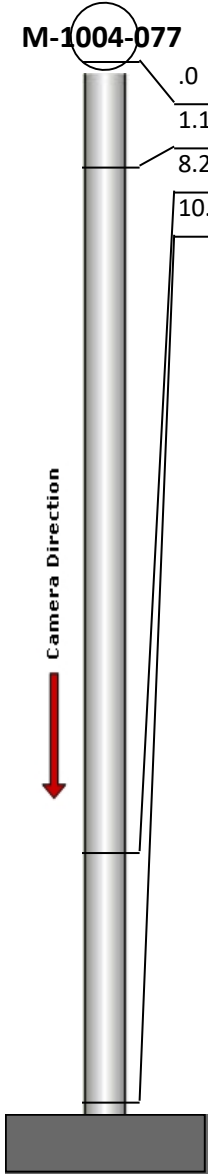
.0	MGP	General Photo	10	NA
	1.1	MGO	General Observation	25	NA
	8.2	OBR	Obstacle Rocks	53	M 2
	10.8	MGO	General Observation	69	NA
