Manhole Inspection Report

Date:	05/11/2018	Weather:		Coding:	RZMACP
MH#:	M-1004-086	Owner:	NA	Len. Surveyed:	4.0
P.O.#:		Surveyor:	Jen Costello	Rim to Invert:	4.4
Customer:		Cert. #:	U-907-5518	Wall Material:	Concrete (reinforced)

Street:	Cypress Ln. 166' West of Hemlock Dr	Project:	Hobart, IN
City:	Hobart, IN	GPS Northing:	2913720.342
Location:		GPS Easting:	2913720.342
Drain Area:	Northeast	GPS Accuracy:	Sub-Meter
Cover Shape:	Circular	Evidence of Surcharge:	No
Cover Size:	22.5	Potential for Runoff:	None
Comments:

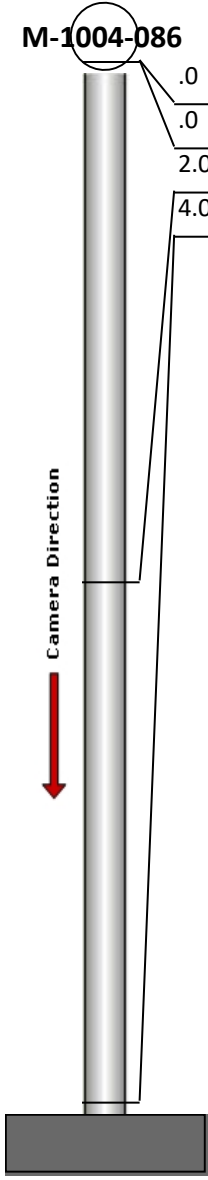
.0	MGP	General Photo	10	NA
	.0	RFJ	Roots Fine Joint	21	M 1
	2.0	MGO	General Observation	39	NA
	4.0	MGP	General Photo	57	NA
