Manhole Inspection Report

| MH#: | M-1004-098 | Owner: | NA | Len. Surveyed: | 3.9 |

| Street: | The West Side of Union St. 168' Nort | Project: | Hobart, IN |

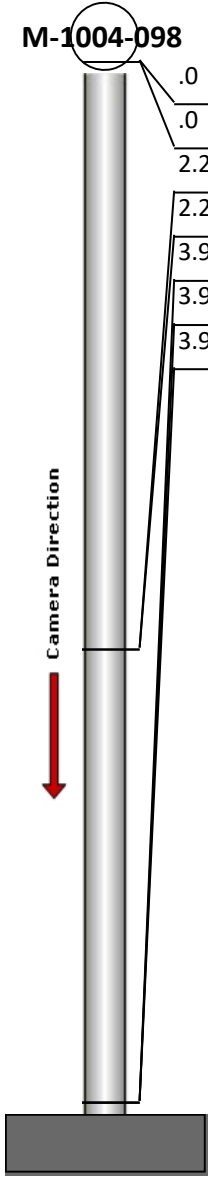
| | Position | Code | Observation | Video (sec) | Grade |
|--|---|---|---|---|---|
| | .0 | MGO | General Observation | 10 | NA |
| | .0 | SRI | Surface Roughness Increased | 21 | S 1 |
| | 2.2 | MGO | General Observation | 39 | NA |
| | 2.2 | IW | Infil Weeper | 52 | M 2 |
| | 3.9 | DSF | Deposits Settled Fine | 68 | M 2 |
| | 3.9 | SRI | Surface Roughness Increased | 79 | S 1 |
| | 3.9 | MGO | General Observation | 90 | NA |
